Göran Danielsson, SWEDEC

## Flail Hammer Head Test and Evaluation

2005

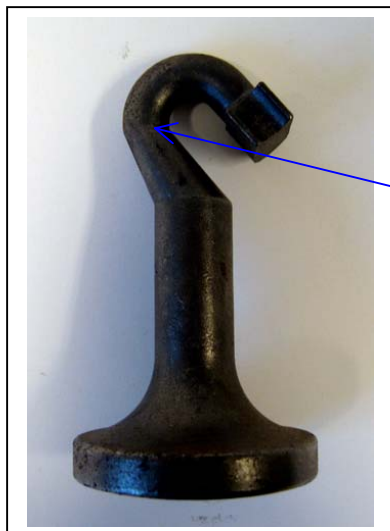
The MV-4 super tool mark I was tested in April 2005. Most of the hammers were lost during the first 20 min of flailing. A mark II tool was developed with a slightly modified design.

*Figure 3: Mark I of MV-4 Super Tool  
Wear plate Ø 60 mm, thickness 10 mm  
Weight: 496 grams  
Material: Cast Iron*

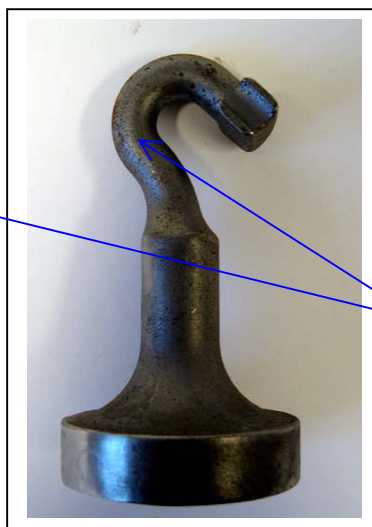
Modified design of the neck

*Figure 4: Mark II of MV-4 Super Tool  
Wear plate Ø 60 mm, thickness 15 mm  
Weight: 577 grams  
Material: Cast Iron*

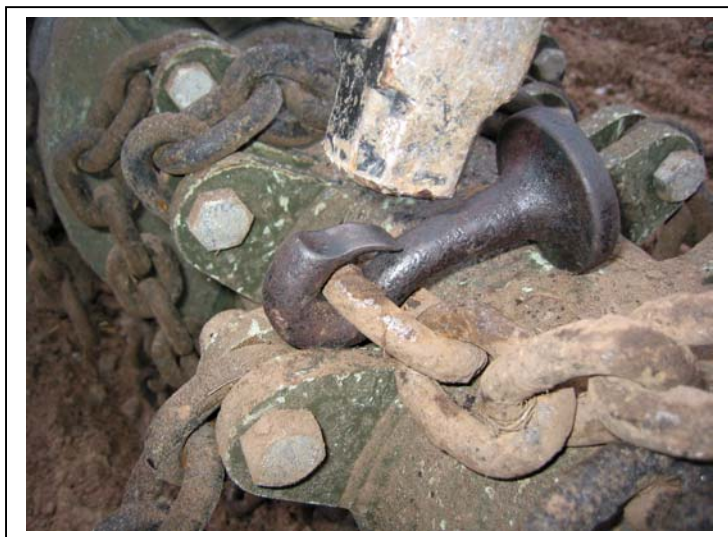
The hammer is attached to the chain by deforming the lip (figure 8)

Figure 8: A sledge hammer is used in order to deform the lip

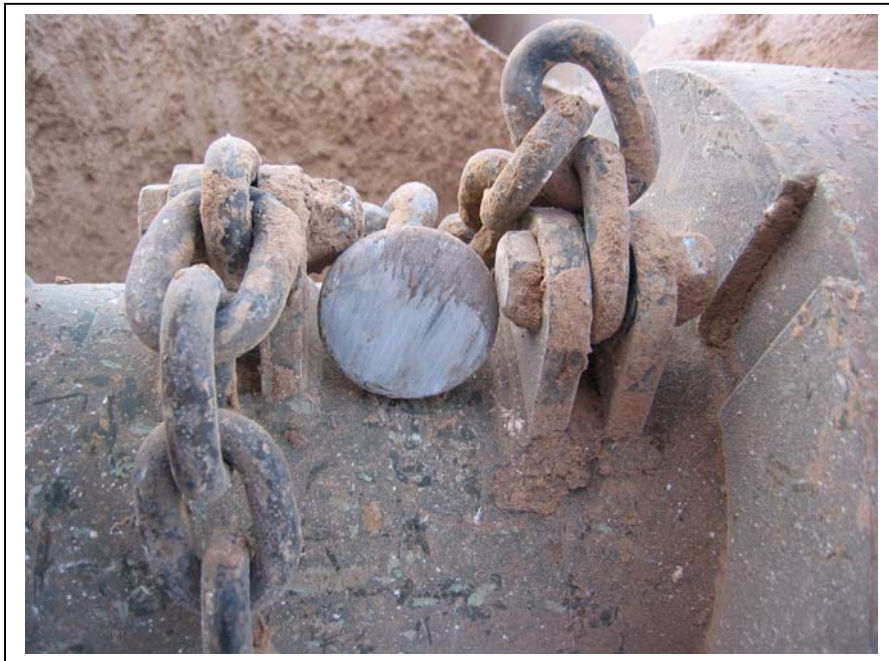
Both hammers with increased diameter tend to get stuck at the attachment point to the flail axle (Figure 13)

*Figure 13: Wrought iron Sprain Tool Ø73 mm stuck in the attachment to the flail axle*

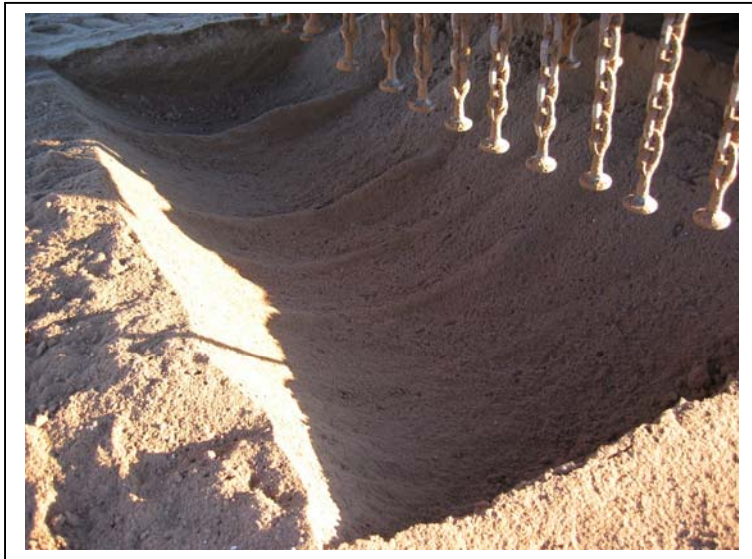
The performance results of either machine are equal or better than the results during the performance tests. Some evidence of ridges were seen at the rear flail. The rear flail axle speed was increased and the ridges went away. The witness panels showed that the machine performed a uniform cut down to a depth of 25-30 cm.

*Figure 16: Evidence of ridges at the rear flail after a test in the sand lane*

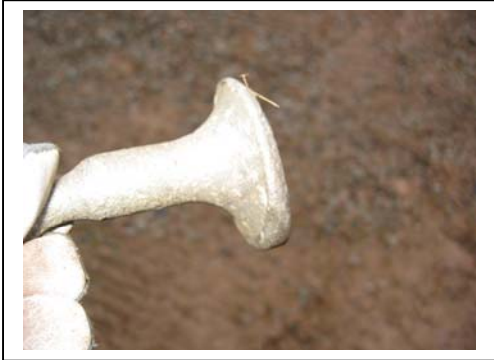
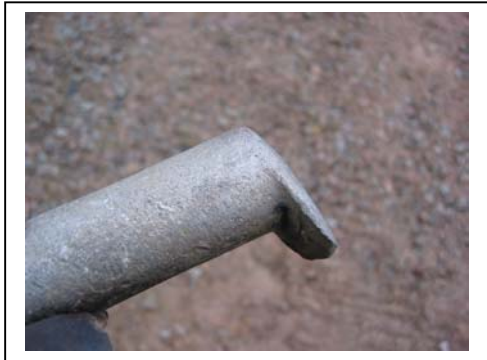
| <b>Test protocol Clearing Tools<br/>TMR</b> | | |
|--|---|---|
| <p><i>Figure 29: 130 min flailing</i></p> <p><i>Figure 30: Reference tool</i></p> | | |
| <p>The reference tool is worn out. Most of the tested tools have been lost. After a 40 min run in meadowland, the machine was moved to a soft gravel lane. The machine was working there for about one hour. It was then moved to a gravel road and was working there for another 30 minutes.</p> <p>The attachment and or the material (cast iron) will break before the tool is worn out. A wrought iron material in combination with an another attachment should be considered.</p> <p>Weight test tool: 934 gram<br/>Weight reference tool: 1212 gram</p> | | |

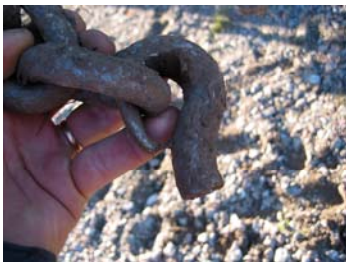
| <b>Test protocol Clearing Tools<br/>DMR</b> | | |
|---|--|---|
| <p>Photos taken after total time of 155 min flailing in meadowland.</p> <p>Rear flail: A total of 11 super tools and 1 sprain tool were missing<br/>Front flail: A total of 4 super tools and 4 sprain tools were missing</p> <p>Front flail speed/pressure: 7/180-200 bar<br/>Rear flail speed/pressure: 6/180-200 bar<br/>Depth meter: ~ 20 cm<br/>M2 engine rev: 1800 rpm<br/>M1 engine rev: 1300 rpm<br/>Clearing speed: ~300 m/h</p> | | |
