## Machine Demonstration Analysis and Preliminary Results

Geoff Coley<sup>36</sup>

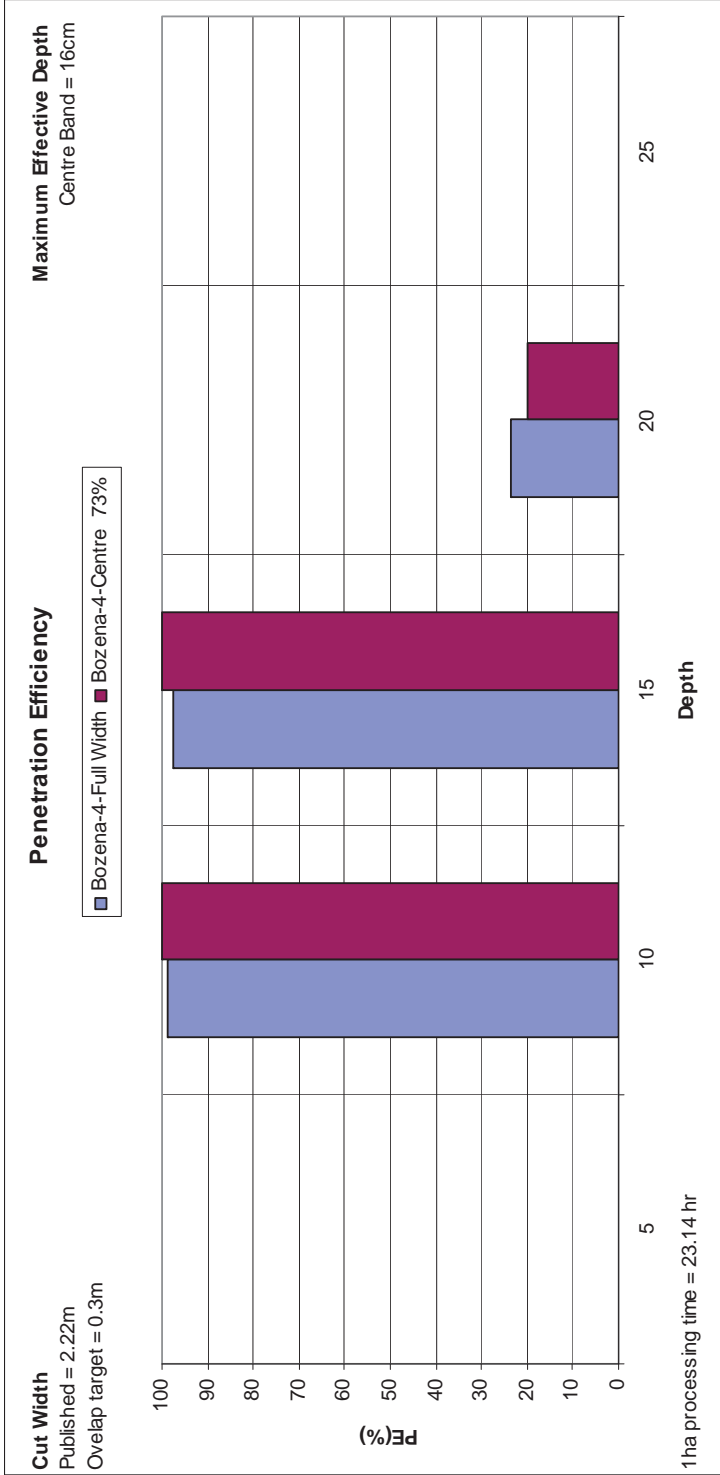
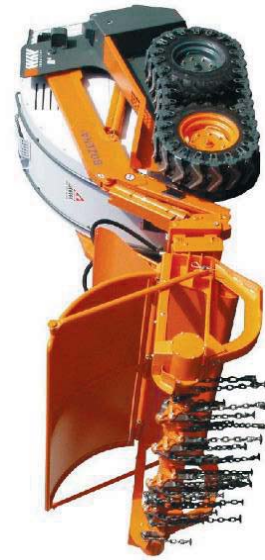
Appendix 1 – Bozena-4

- Dead crawl all the way through – appeared to have consistent speed control. Some evidence of soil wave suggesting that machine may have been under manual depth control.

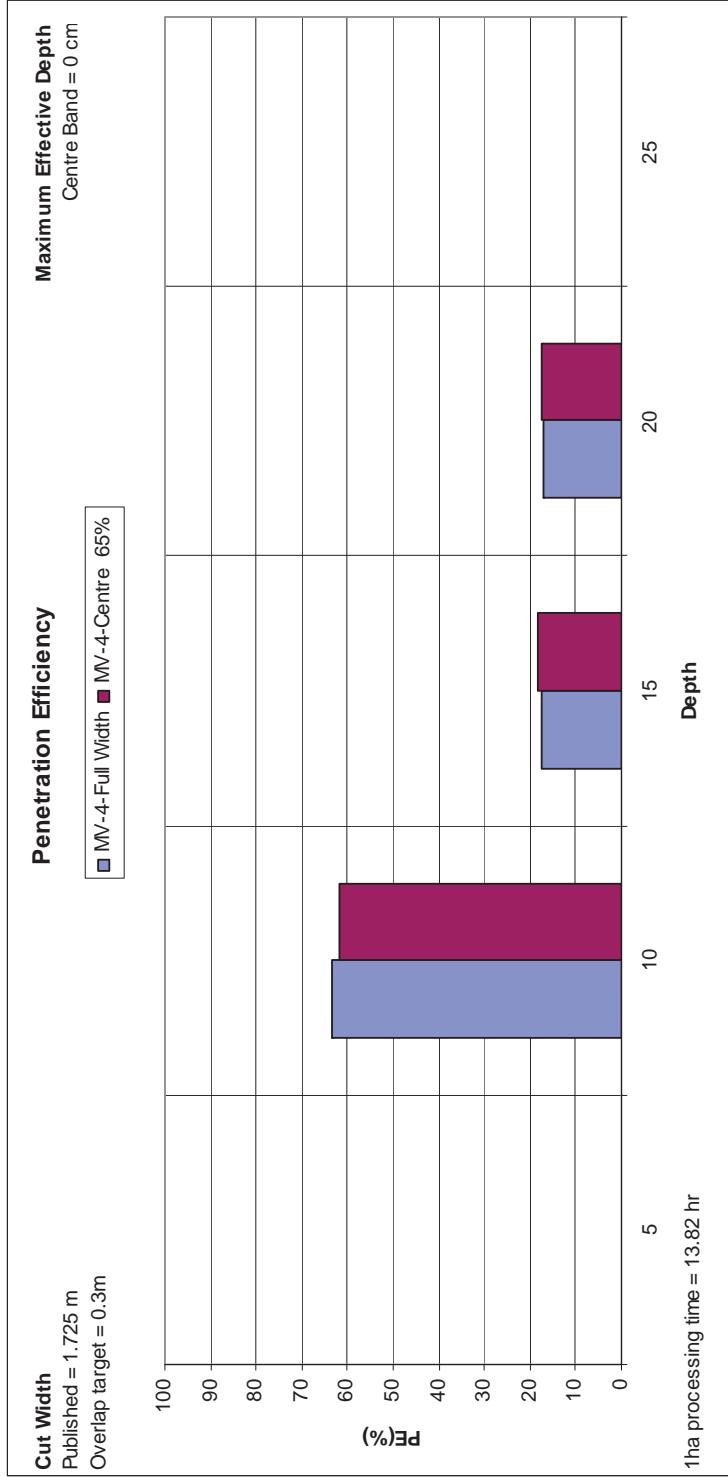
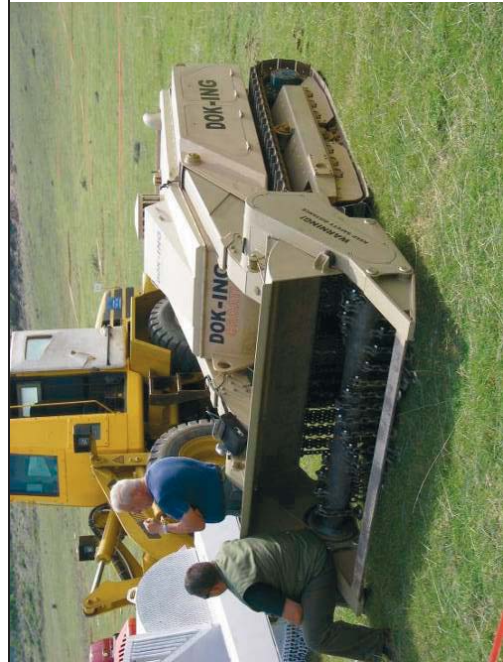
Appendix 2 – MV-4

- Out of the gate very fast but slowed to a crawl, possibly stopping right at strip 2. Very erratic speed control – stop/start movement in some places. Erratic depth control throughout – flail head completely clear of the ground near strip 4. Appeared to stop near 4<sup>th</sup> strip. Quit working altogether part of the way back. Claimed equipment malfunction.

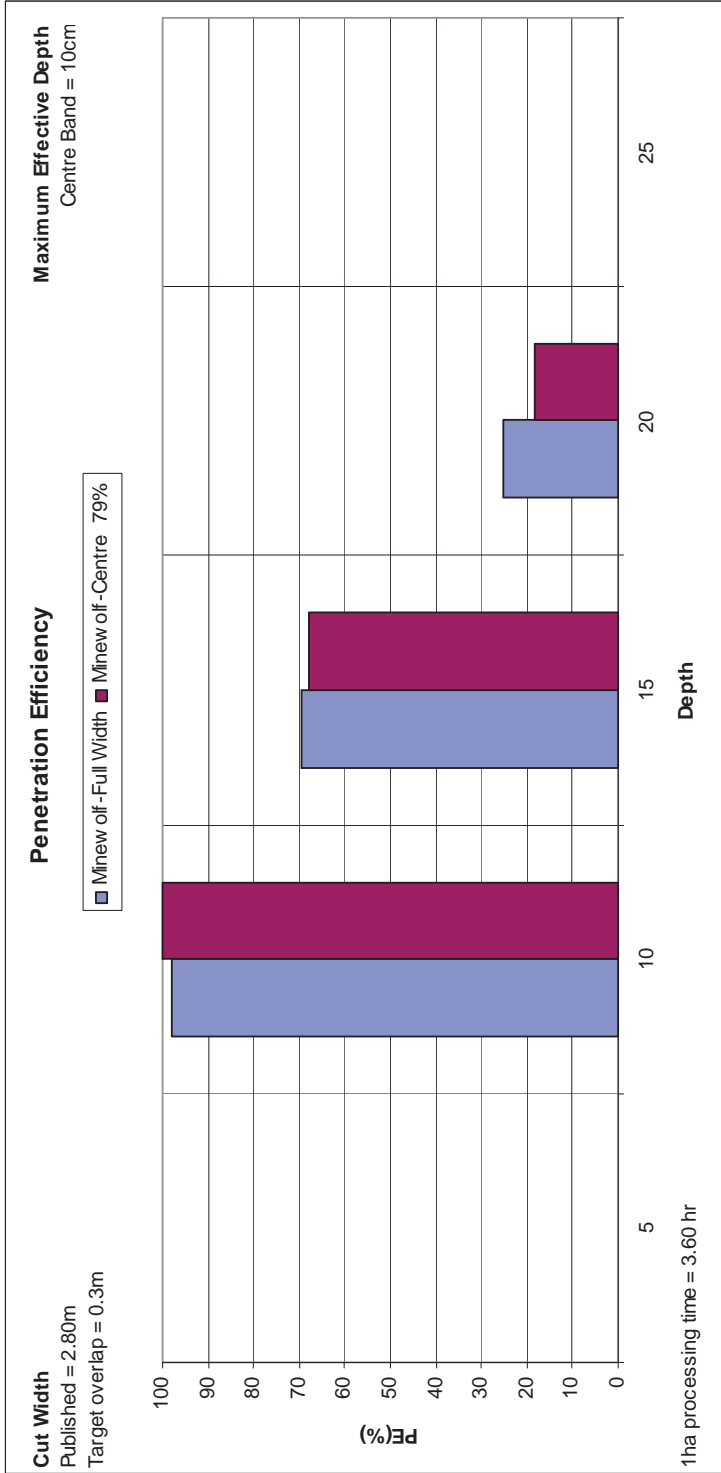
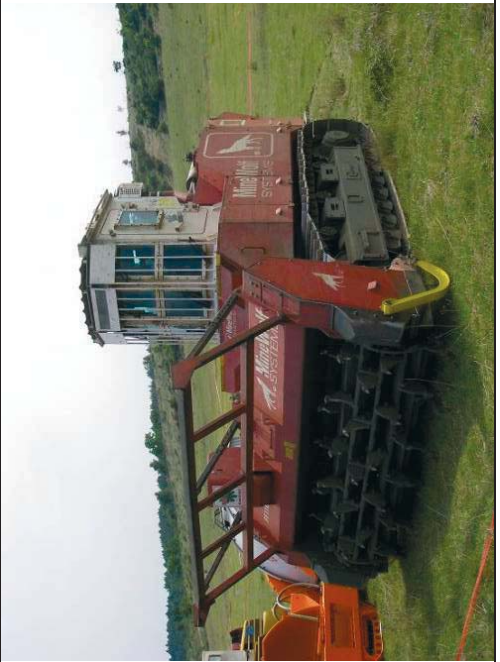
Appendix 3 – Minewolf

- Operated very fast and with erratic depth control. Very little dust cloud as soil is sliced, not pulverized. Throws a lot of debris under/behind machine. Speed consistent throughout. Tiller head porpoised its way through the test – operator control or a lag in the feedback?

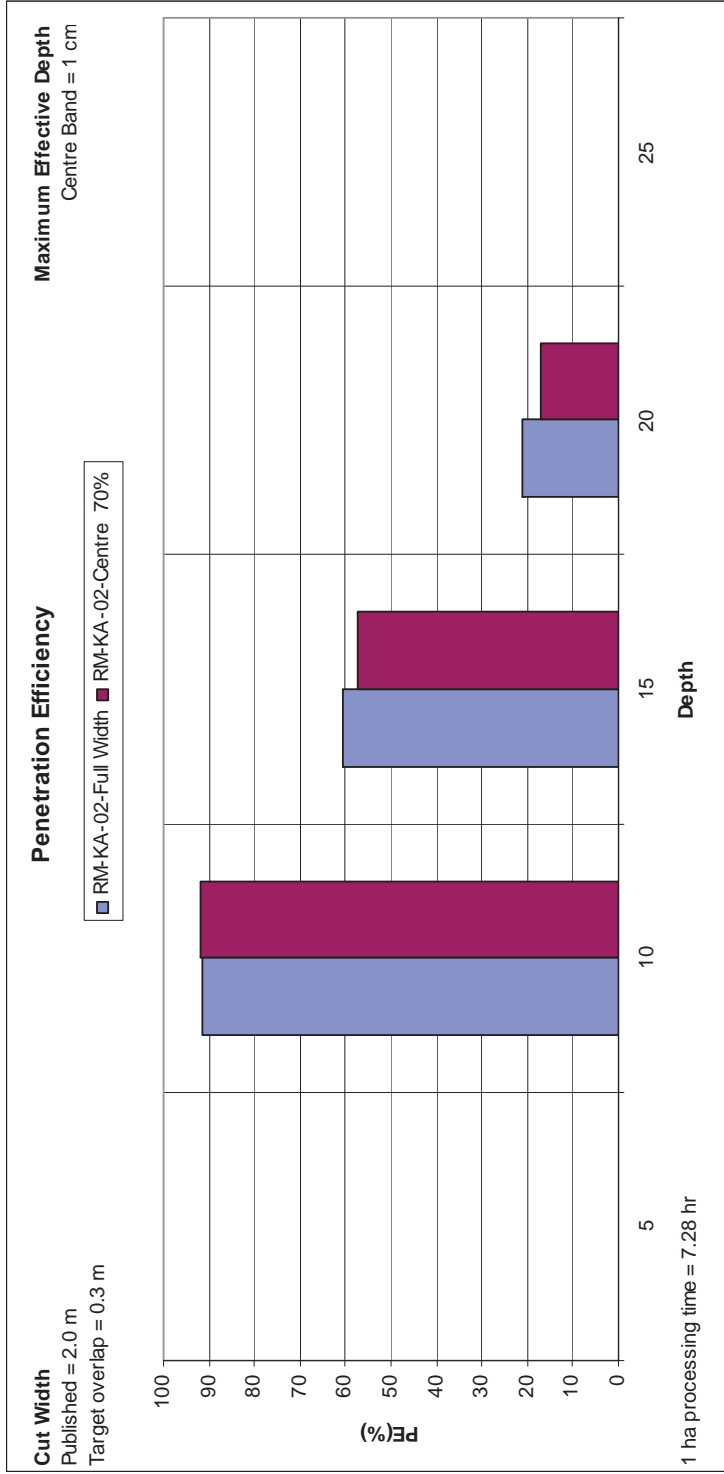
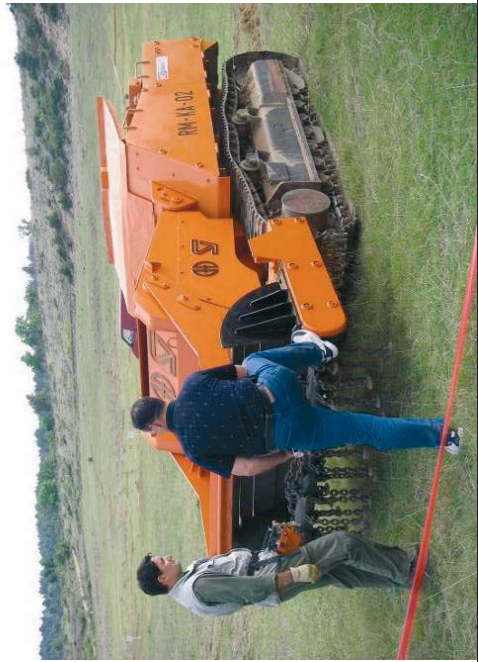
Appendix 4 – RM-KA-02

- RC operator wandered well into the test lane following the machine (far closer than the 50m requirement) until called back by official. (Was first machine to run so requirement may not have been clear to the operator.) Was forced to stop once on the return run because the visibility of the operator was obscured by a cloud of dust created by the operation of the Samson machine.

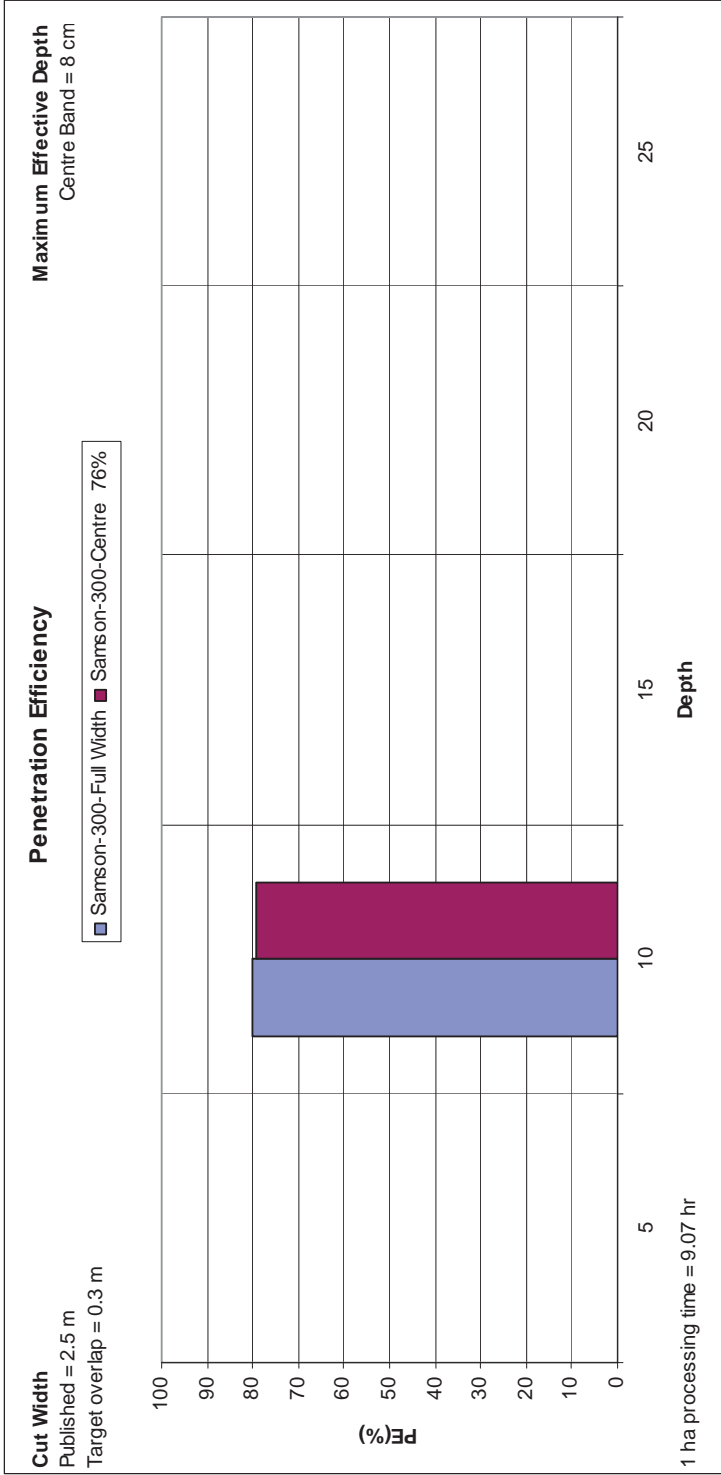
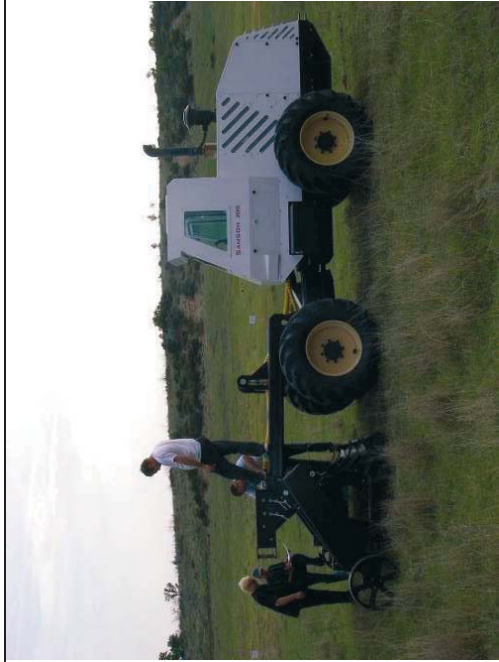
Appendix 5 – Samson 300

- Driver stopped briefly on return trip 3-4 times – probably a visibility issue. Huge dust cloud (partly caused by lack of shroud, partly because the machine worked to a shallow depth where the ground was dry). Apparently misunderstood requirement and thought depth of interest was only 15cm instead of 20cm.

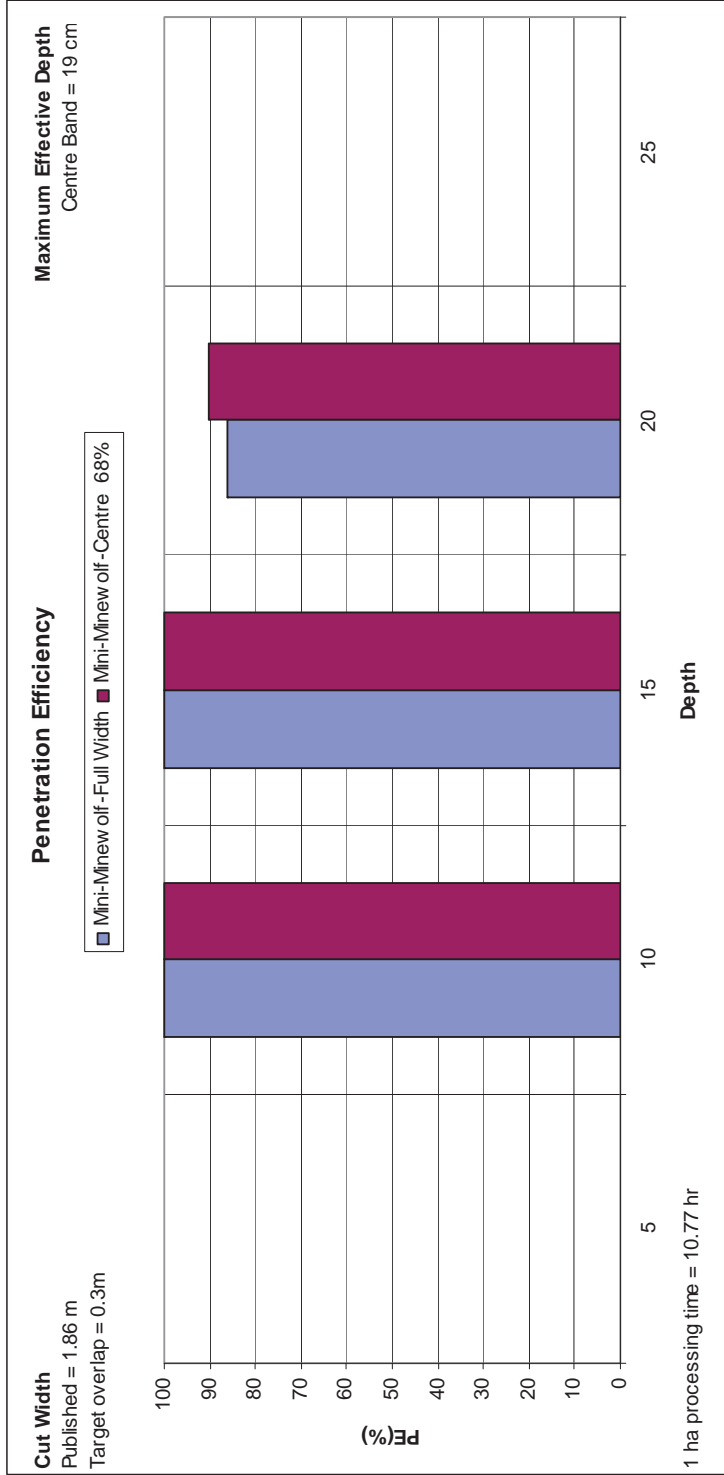
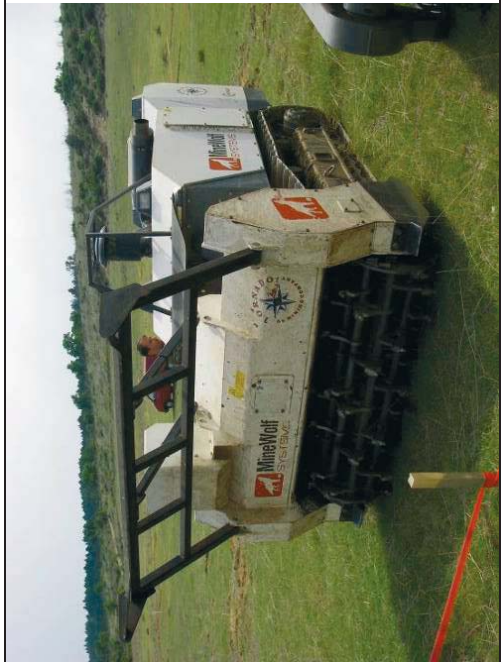
Appendix 6 – Mini-Minewolf

- Very little dust as soil is sliced, not pulverized. Soil only thrown a short distance ahead. From fibreboards, 30cm overlap not really achieved. Obviously a driver error issue not a machine performance issue.

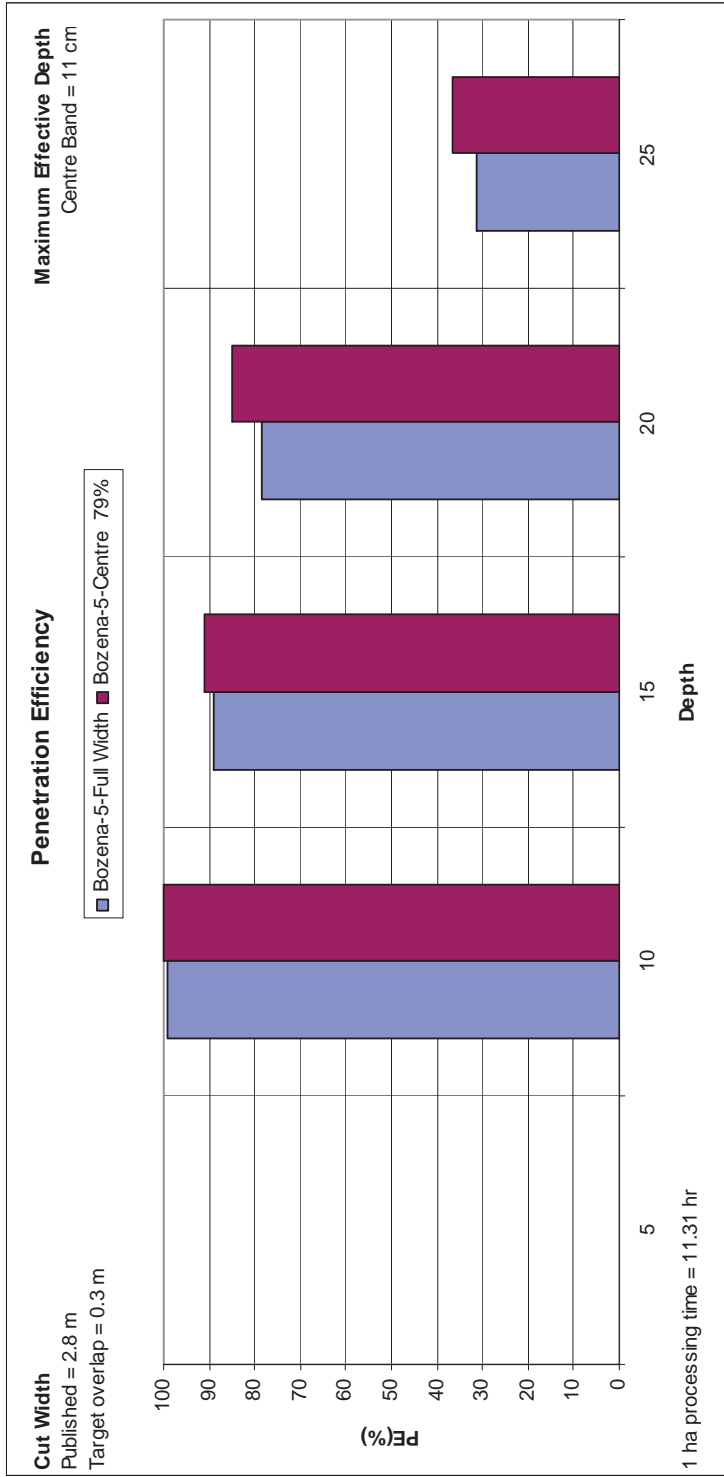
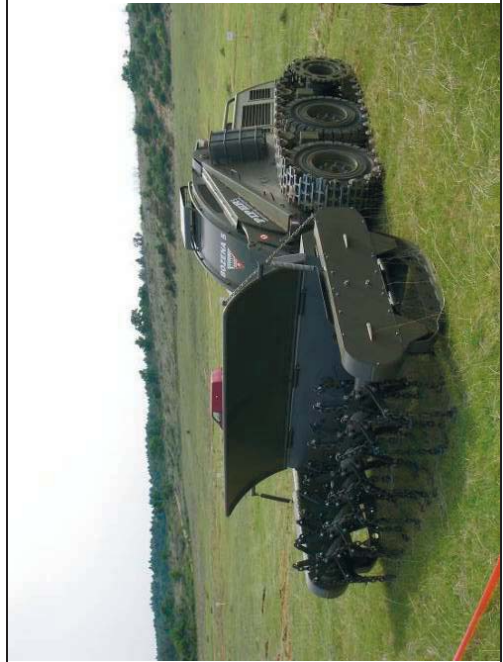
Appendix 7 – Bozena-5

- Consistent speed control.

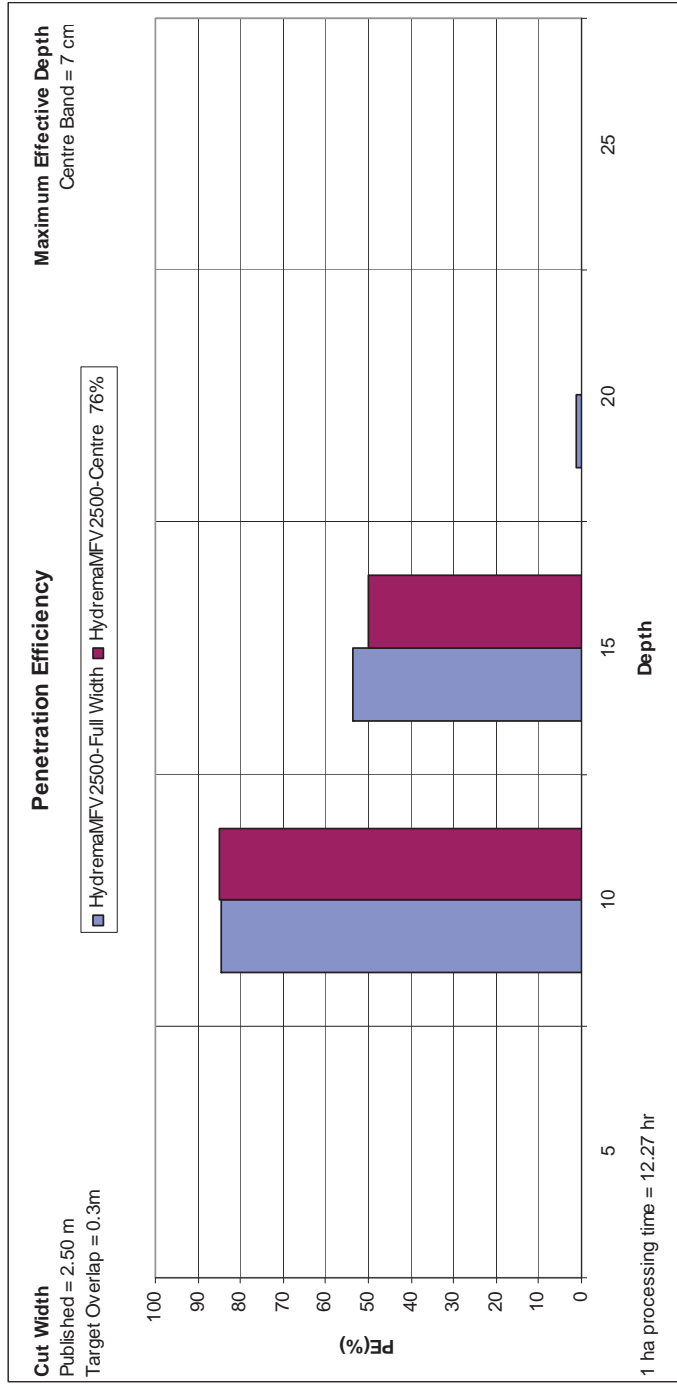
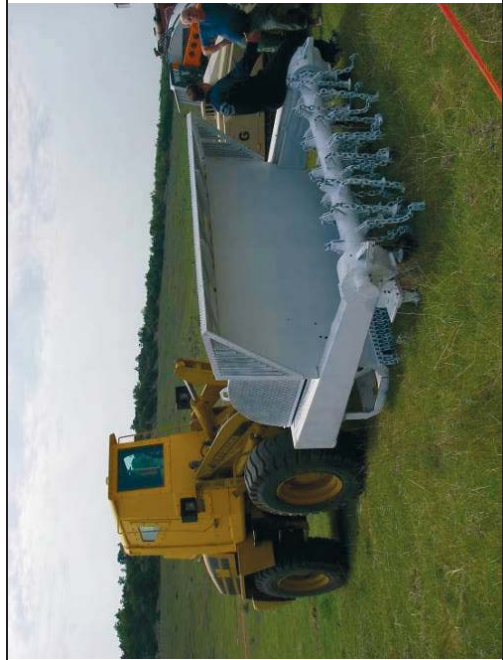
Appendix 8 – Hydrema MVF2500

- Exact PE(20cm) and MED values may be slightly off since the middle fibreboard was hit so far across the board that only 190cm of the cut could be captured. The difference should be minor.
- Great variations in speed. Slowed visibly near board/decoy strips 1 and 2. Flail head stalled near strip 5. Machine stopped moving while trying to restart flail engine. Lots of smoke on restart of the flail engine. Happened again near strip 6. Slowed several times on return trip.

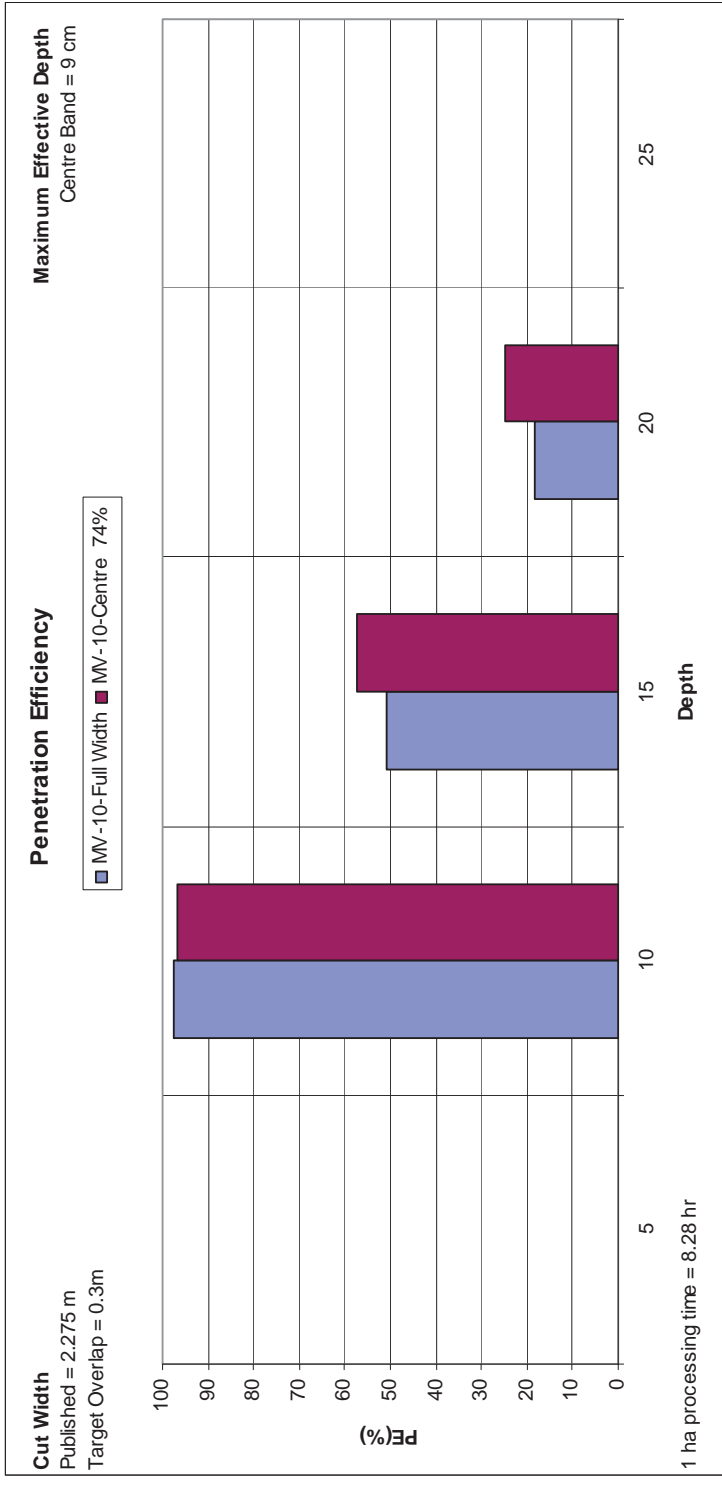
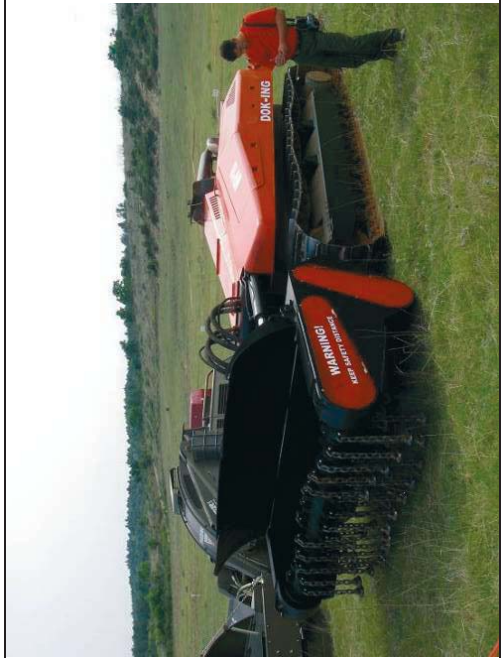
Appendix 9 – MV-10

- Head was lifted a couple times between the first and second fibreboard/decoy strips. Reasonably consistent speed throughout run but may have been a little slower on the return trip.
