Performance test of Demining machines performed by SWEDEC (Swedish EOD and Demining Centre).

The following report on performance test of demining machines are from tests performed by SWEDEC (Swedish EOD and Demining Centre), an independent body within the Swedish Armed Forces.

BOFORS MINEGUZZLER

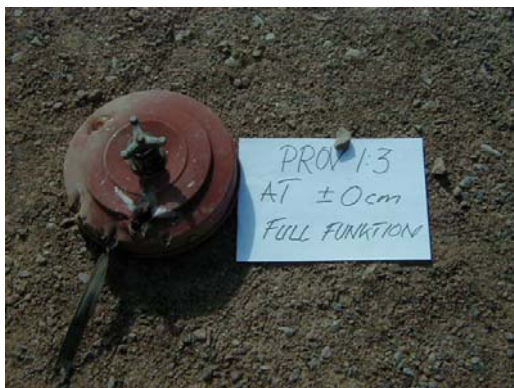
** Cover damaged, yet still full functional. (see picture)

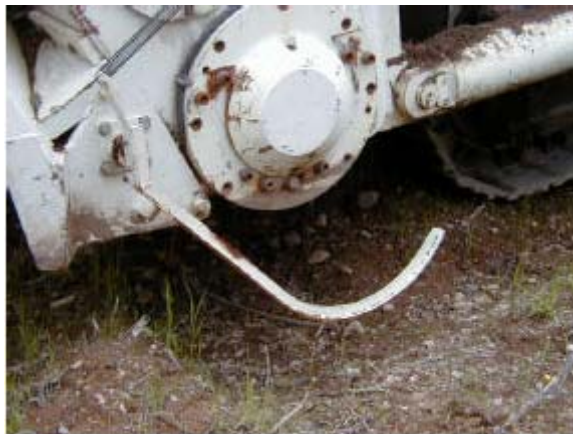
- ** 1 no. of completely functioning loose igniter found in cleared track
- The mine objects provided with ID-chips
- Ground tracking without any problem. Still a replacement of other skids was made for deep attitude. (see photo)

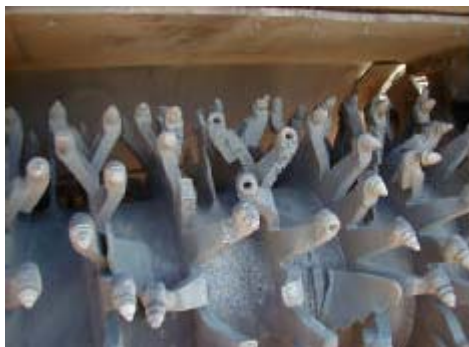
The picture shows the clearing roller where the mine was detonated

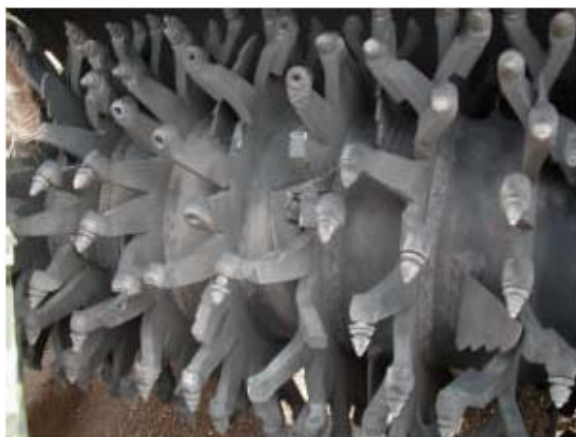
The picture shows damages caused by strv 5 on the clearing roller

- 5 nos. of tooth holder (of which 1 no. clearing arm) was missing
- 12 nos. of bits missing
- 1 no. of shark fin missing
- 1 no. of shark fin damaged
- The mudguard behind the roller is loose

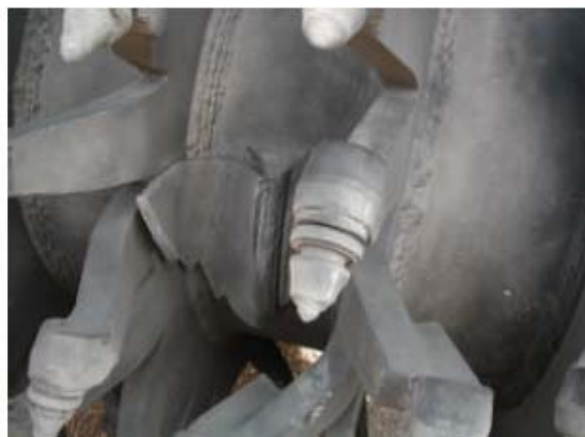
The picture shows damaged shark fin

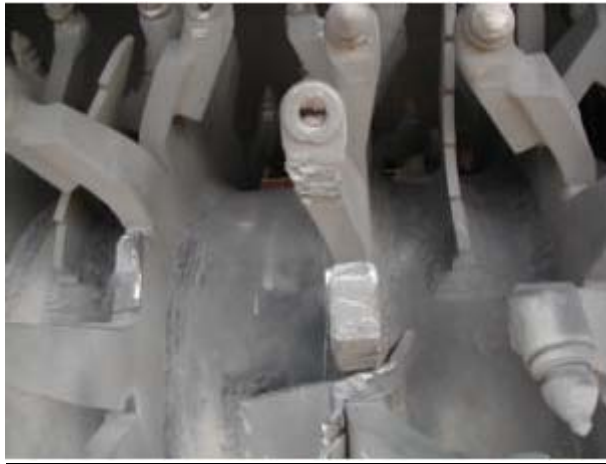
The picture shows destroyed shark fin

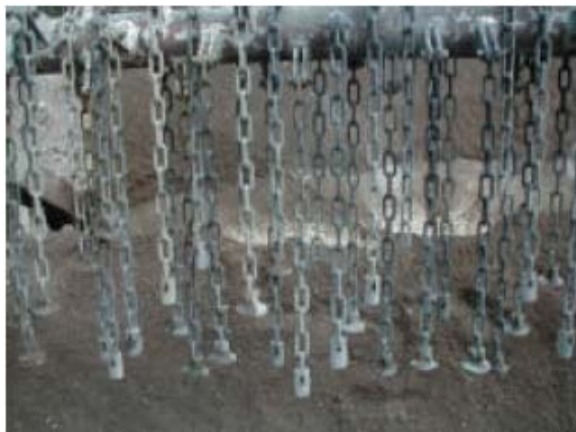
The picture shows the clearing unit after the test

- 5 nos. of striking tools have to be changed
- An electrical outlet at the back side of the shield has split.

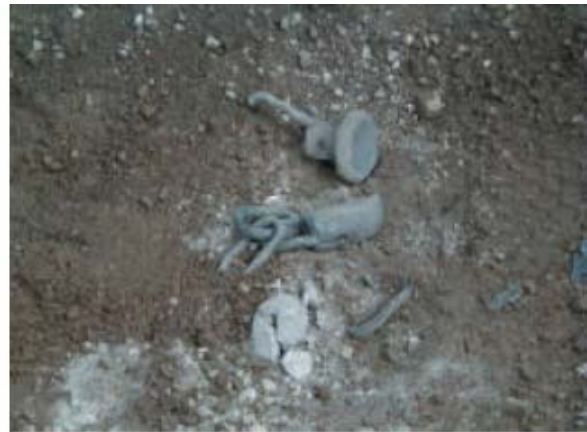
The picture shows worn out weight

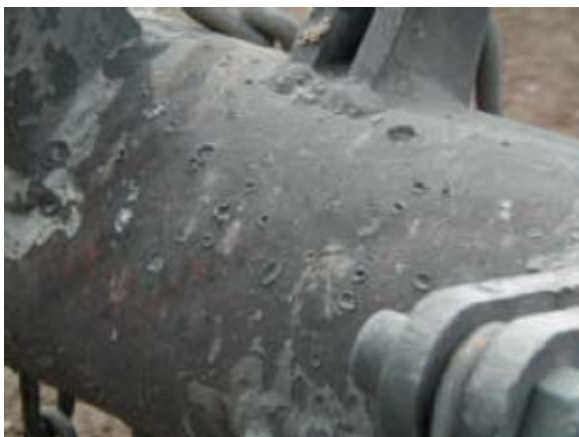
The picture shows splinter damages to the flail pipe

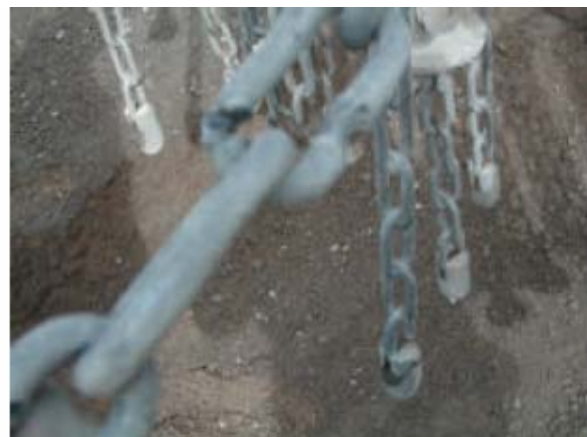
The picture shows splinter damages to chains

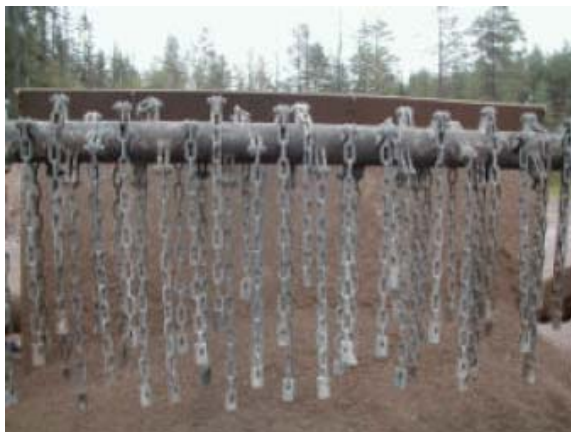
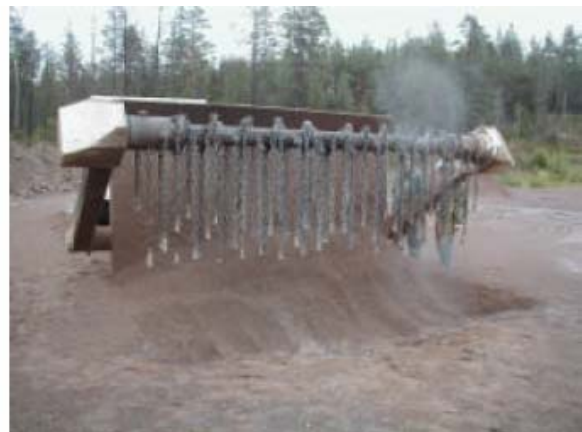
The pictures show the clearing unit after carrying out test

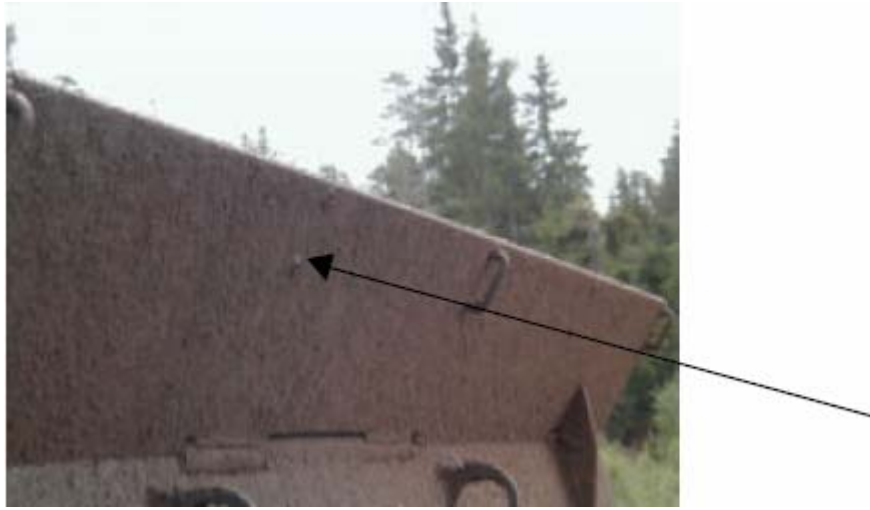
The picture shows worn out grip

- 1 no. brass plummet is missing
- 1 no. grip is missing, as shown in the picture

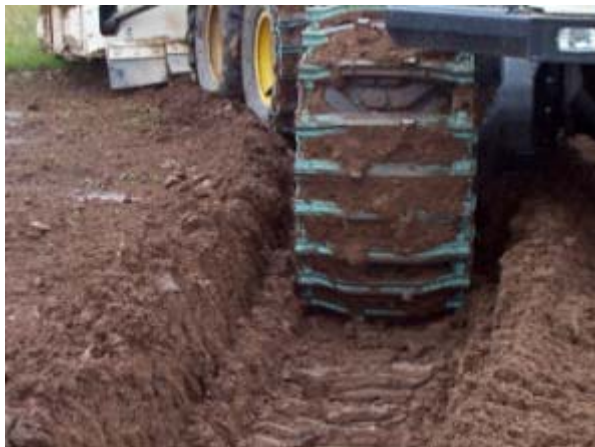
The test had to be made ones again after the first test. The machine was turning to much On the inside wheel, on the front axis, went on unclear ground. Turning radius was then 26 m.

The picture shows front pair of wheels on the uncleared track

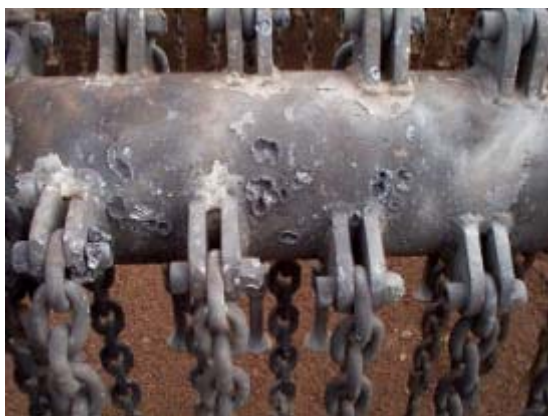
The picture shows splinter damages on the flail pipe

- 2 nos was missing and a part of the chain
- 2 nos was damage
- Various superficial splinterdamages on the cylinder and some damages on screw joint reinforcement

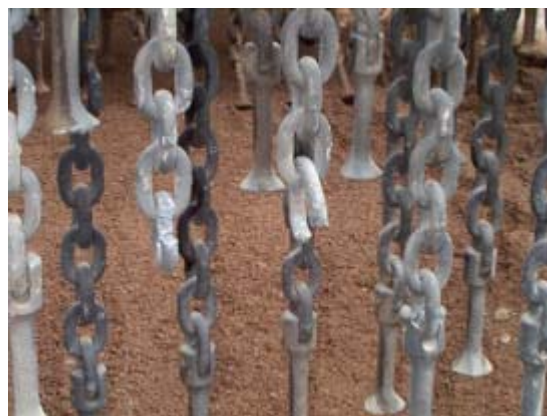
The picture shows worn out plummets

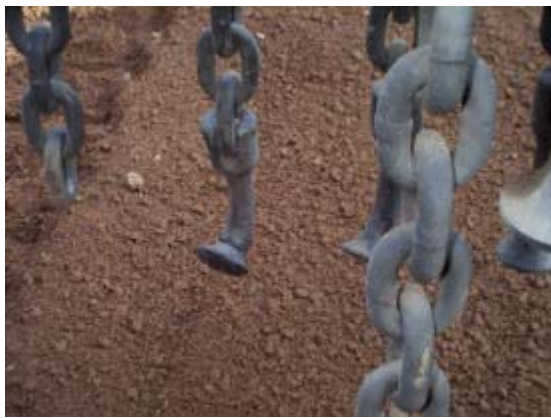
The pictures show damages to the clearing tool after carrying out the test

- 1 no. plummet is missing
- 2 no. plummet damaged / deformed
