Göran Danielsson, SWEDEC

HYDREMA 910 MCV

September 2004

During the days of September 28-30 2004, the HYDREMA 910 MCV-flail was tested at the SWEDEC facilities outside of Eksjö, Sweden. This test was a repetition of the performance test made in 2001.

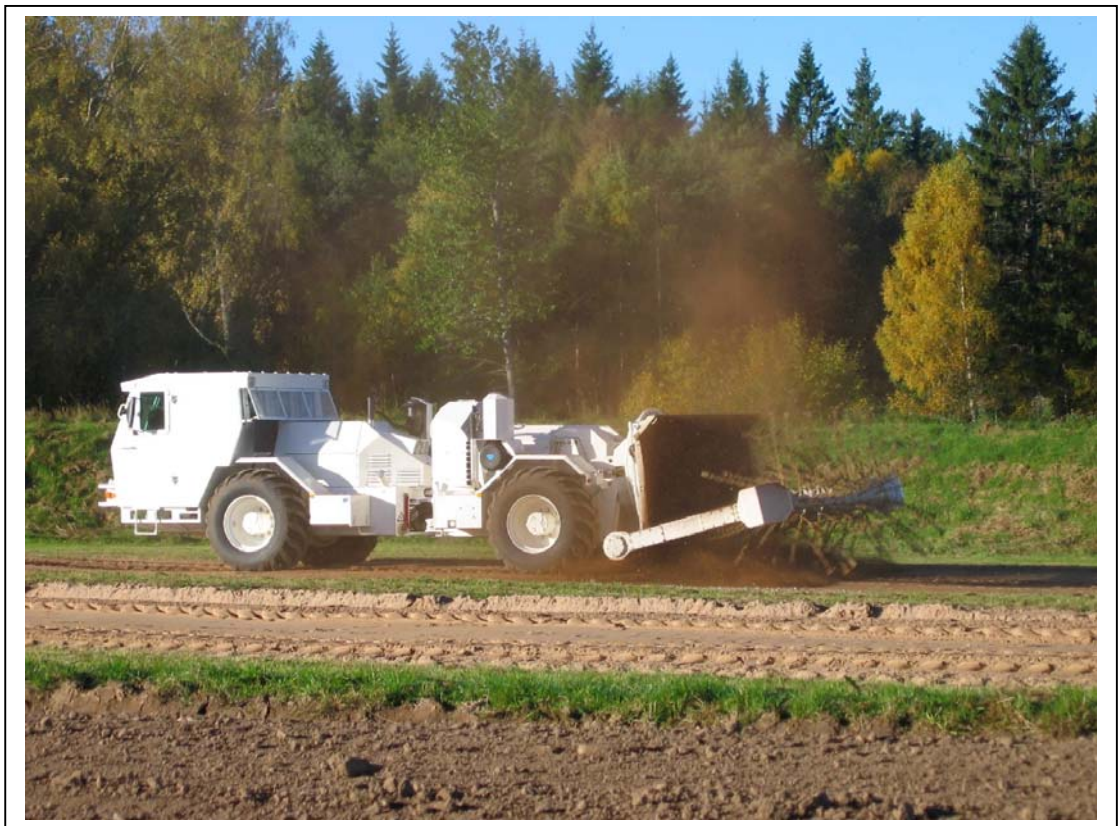
*Figure 1. Soil Preparation – Loosening the Soil*

The soil in each test lane is prepared as follows. Prior to a test the soil is loosened with ordinary agricultural or construction equipment ([Figure 1](#)). It is then compacted using the vibratory compactor shown in [Figure 2](#). The soil compaction and moisture content are monitored until the compaction reaches the defined level (shown below) for that soil type. Compaction and moisture content are measured using the CPN International model MC-3 Portaprobe shown in [Figure 3](#). Ideally the soil would be compacted to virtually 100%, or its theoretical maximum level of compaction. This is very difficult to achieve, and depends on the moisture content of the soil. The compaction level selected allows testing over a range of soil moisture contents, and is a reasonable and practical approximation of well compacted soil.

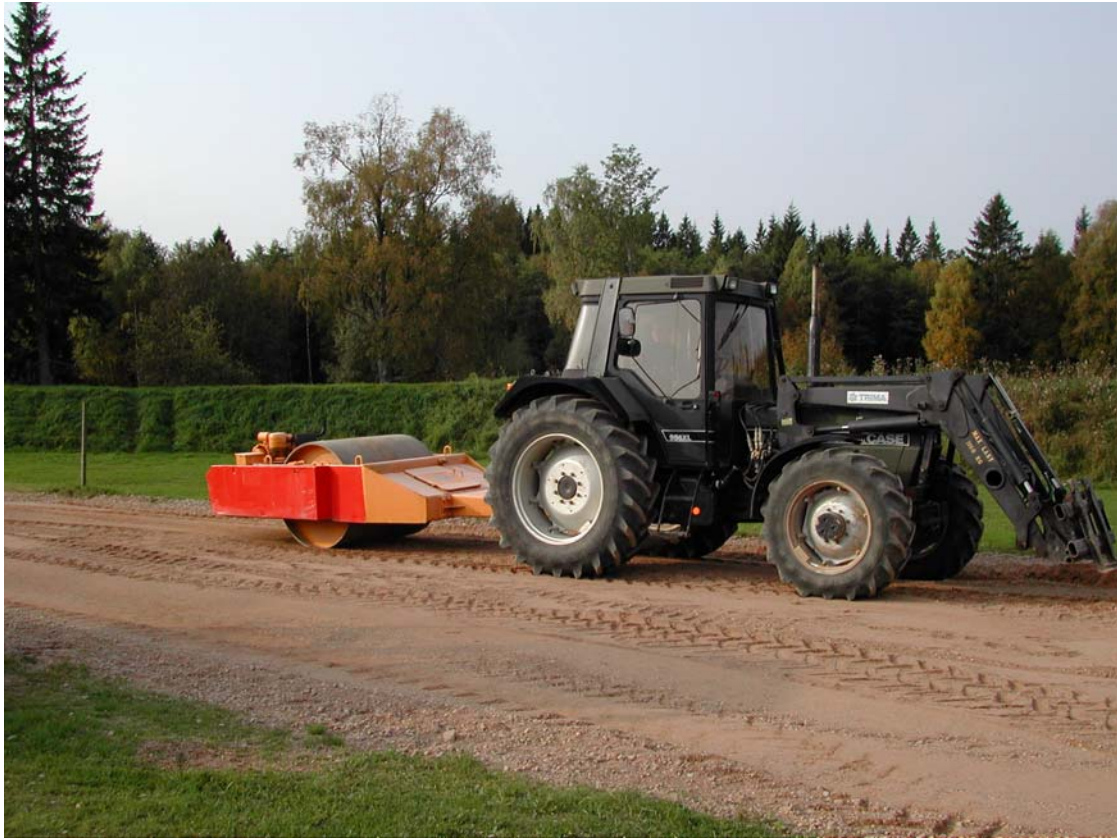
**Figure 2.** Soil Preparation – Compacting the Soil

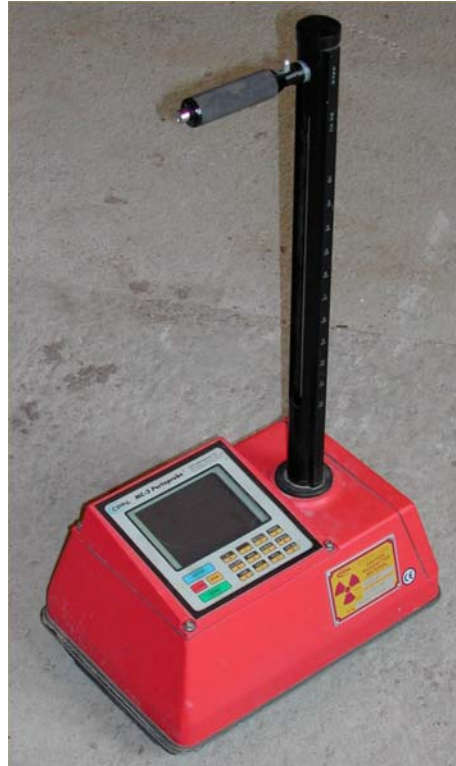
*Figure 3. MC-3 Portaprobe for Measuring Soil Compaction and Moisture Content*

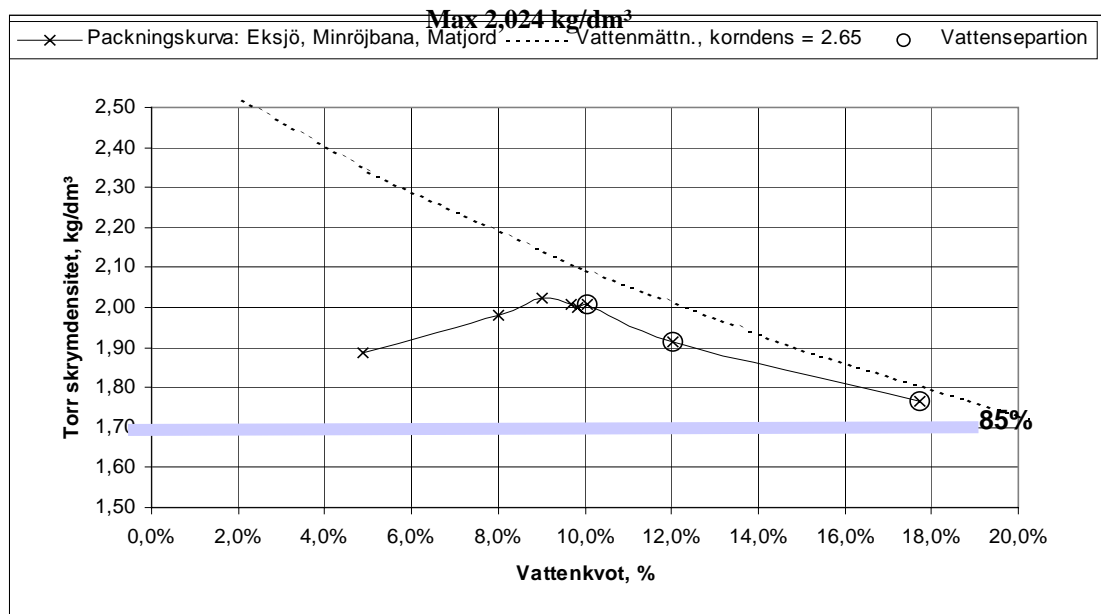
An example of soil analysis for the topsoil is shown in Figure 4. The horizontal axis refers to the moisture content while the vertical axis shows the density, with a maximum occurring at 2,024 kg/dm<sup>3</sup>. By compacting the lane to 85% of its theoretical maximum, tests can be performed in most weather conditions.

Figure 4. Soil Analysis - Topsoil

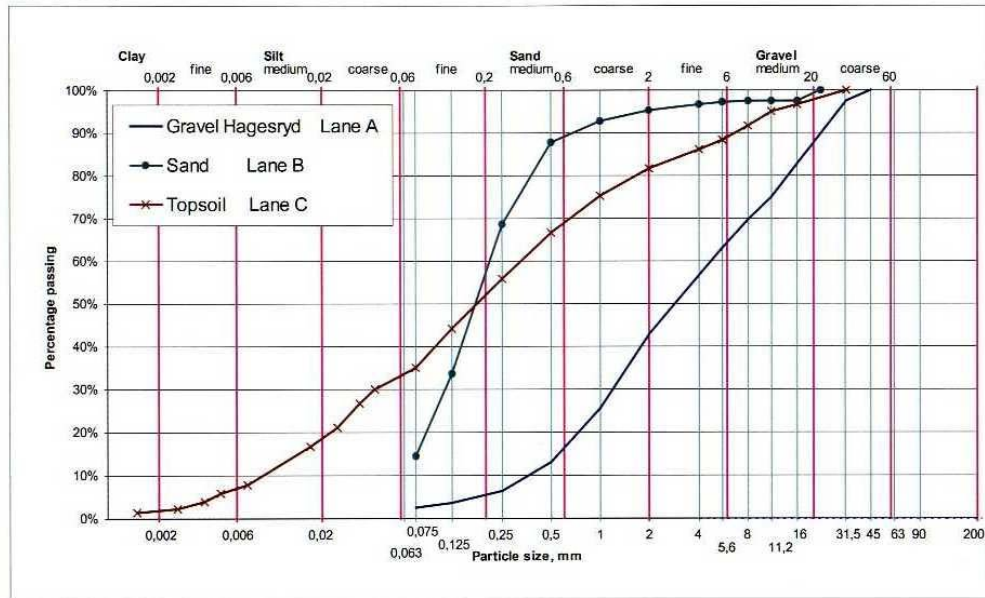
Lane A-C

Samples from the sand, gravel and topsoil lanes were analysed to determine particle size distribution, with Figure 5 showing the results.

Figure 5. Soil Particle Distributions

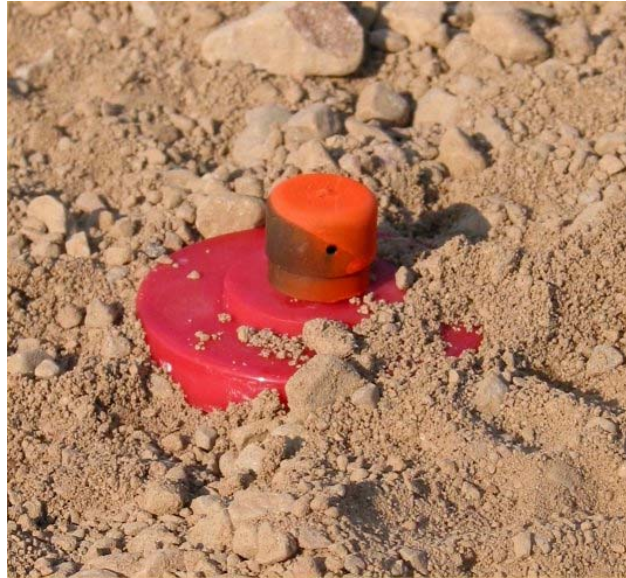
The test targets used in this trial were the standard SWEDEC mine surrogates shown in [Figure 6](#). The AP blast targets make use of live fuzes from the m/49 B anti personnel mine, installed in inert, plaster-filled plastic bodies. These targets closely replicate many typical, small, antipersonnel landmines which a flail might be expected to encounter.

**Figure 6.** SWEDEC Antipersonnel Mine Surrogates

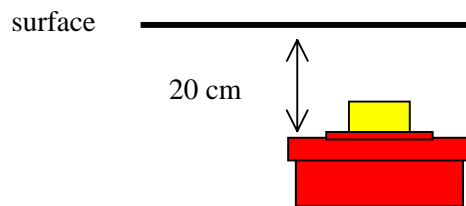
In all cases, the AP blast targets were buried as shown in [Figure 7](#). The depth of burial (DOB) was measured from the top surface of the mine (not the top surface of the fuze), to the ground surface. The targets were buried in a pattern as in [Figure 8](#). To minimize soil disturbance, the tool shown in [Figure 9](#) was used to pull out a soil core just slightly larger than the mine body. The live fuzes were installed only just before the test began.

**Figure 7.** Depth of Burial For AP blast Targets

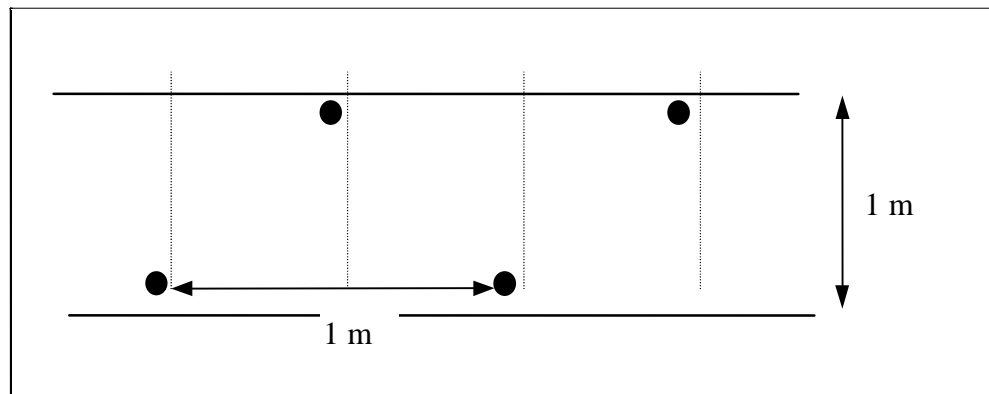
**Figure 8.** Mine Target Burial Pattern.

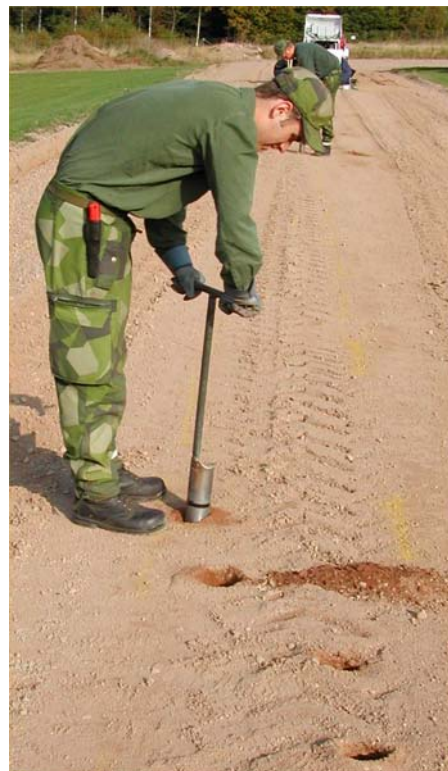
**Figure 9.** Mine Target Burial Tool To Minimize Soil Disturbance.

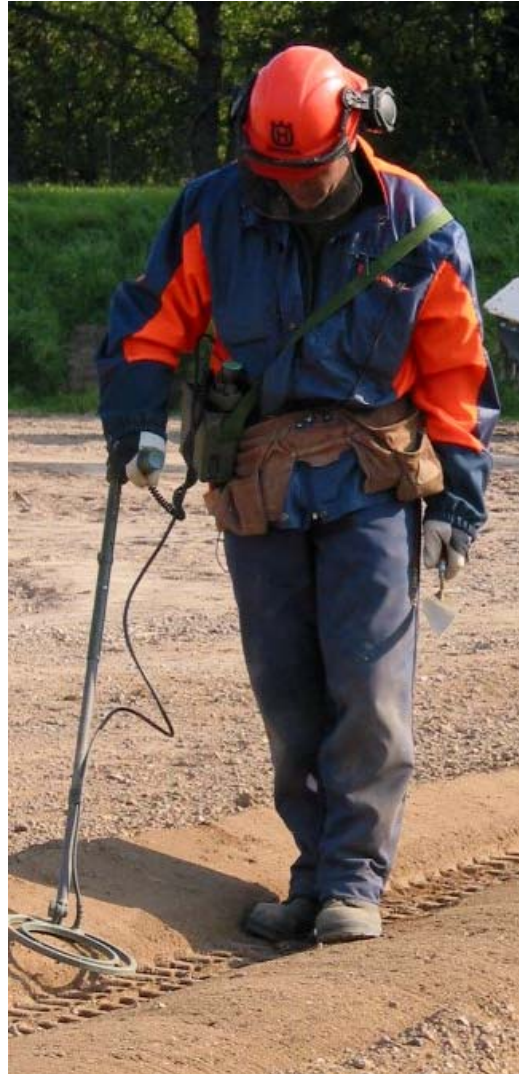
Following the test, metal detectors were used to locate any untriggered fuzes and also the metal washers in the plaster-filled bodies (Figure 10). In this way, the untriggered fuzes could be examined and ultimately discarded in a safe manner, and any untriggered or undamaged surrogate mine bodies could be inspected to determine the probable level of damage inflicted by the machine.

**Figure 10.** Locating Untriggered Fuzes After The Machine

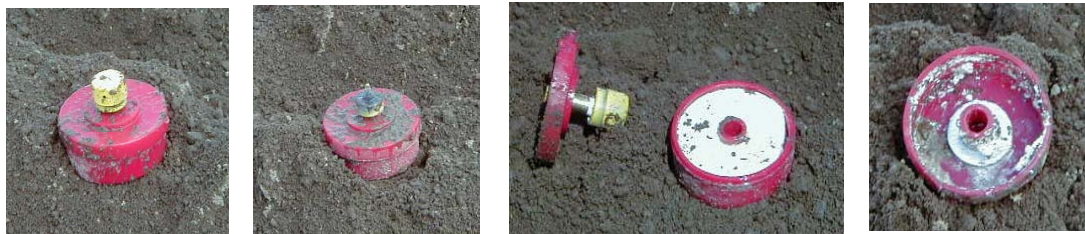
In Figure 11, the first figure shows intact, functional targets missed by a machine (Live). The next two pictures shows targets which do not work as supposed but fuze is still in the body (Live Damaged). Third picture shows an example of a target where the fuze has been separated from the mine body without triggering (Mechanically Neutralized), more than 50 % of the plaster is left (the main charge in a real mine). The fourth picture shows an example of a target where only the metal washer with less than 50% of the explosive is left..

**Figure 11.** Samples of Targets After Test

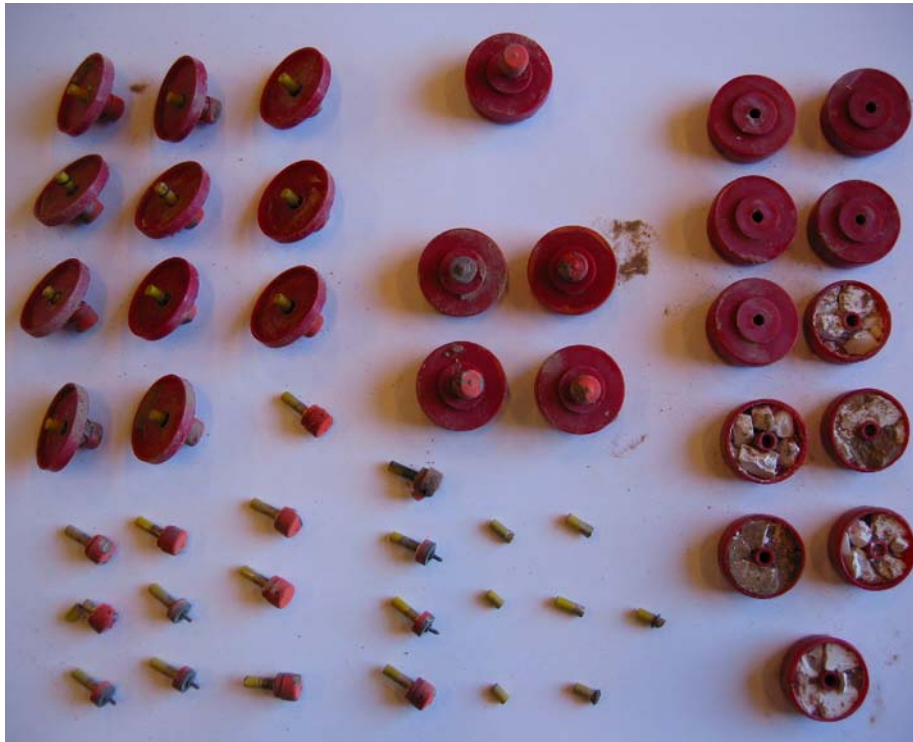
*Figure 12. Debris of Interest – Sand, 20 cm DOB*

**Single fuses AP blast:** 32 of which 22 were damaged

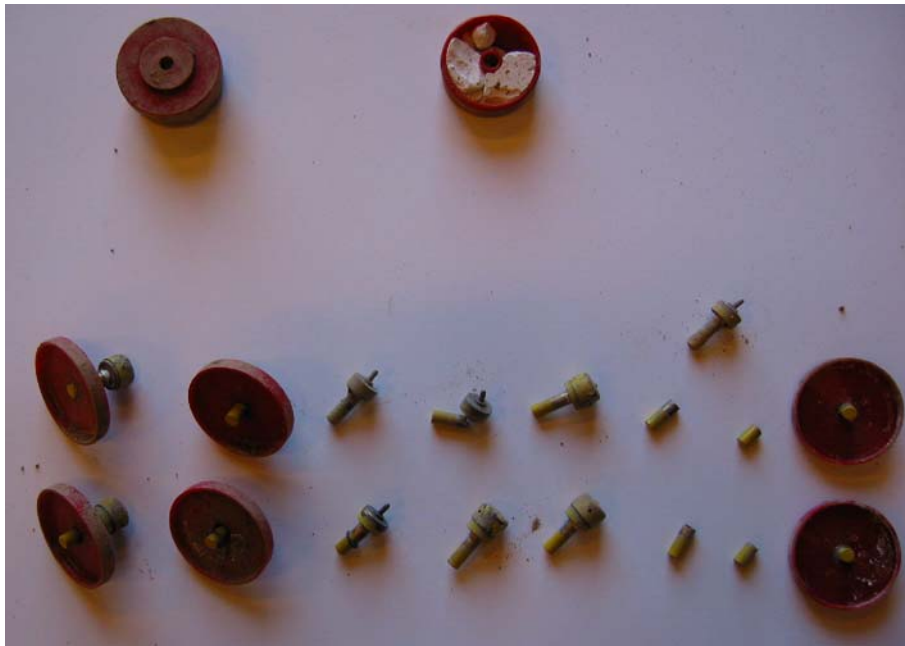
**Figure 13.** Debris of Interest – Gravel mix, 20cm DOB

**Single fuses AP blast:** 17 of which 12 were damaged

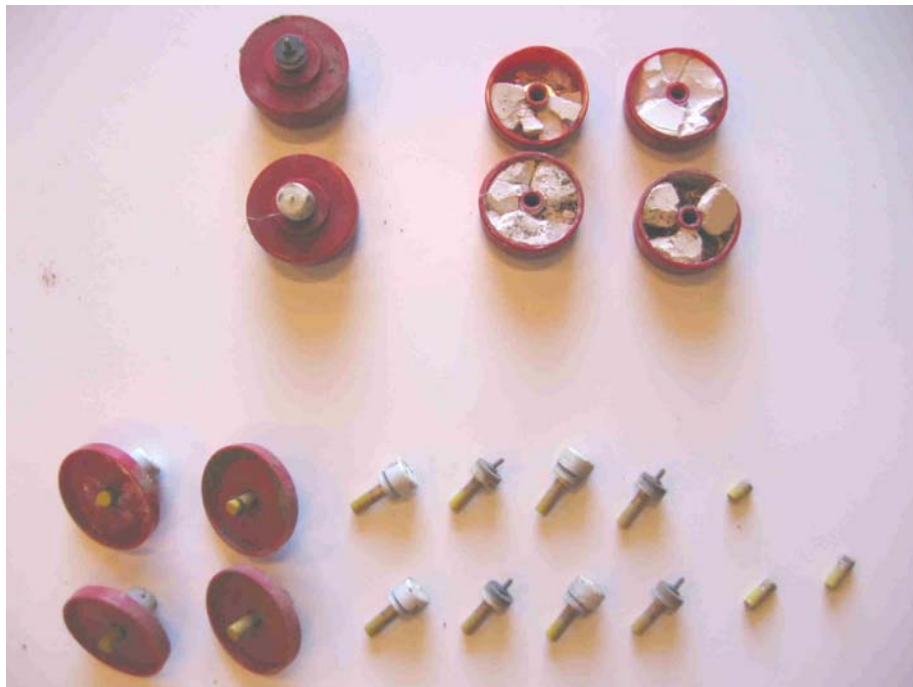
**Figure 14.** Debris of Interest – Top Soil, 20cm DOB

**Single fuses AP blast:** 15 of which 9 were damaged
