## BOZENA 4 Mini Mineclearance System Assessment Phase 1

Chris Leach  
QinetiQ/FST/LDS/CR044502/1.0  
November 2004

This report summarises the results of an assessment of the Mini Mine Clearance System (B4 MMCS). The trial was designed to be the first phase of a three-phase assessment process evaluating handling and mobility characteristics and general performance capabilities. Phase two will be conducted in Sweden and will assess specific performance and survivability criteria. Phase 3 will be conducted in a mine-affected country and will be in the form of a reliability and user acceptance test.

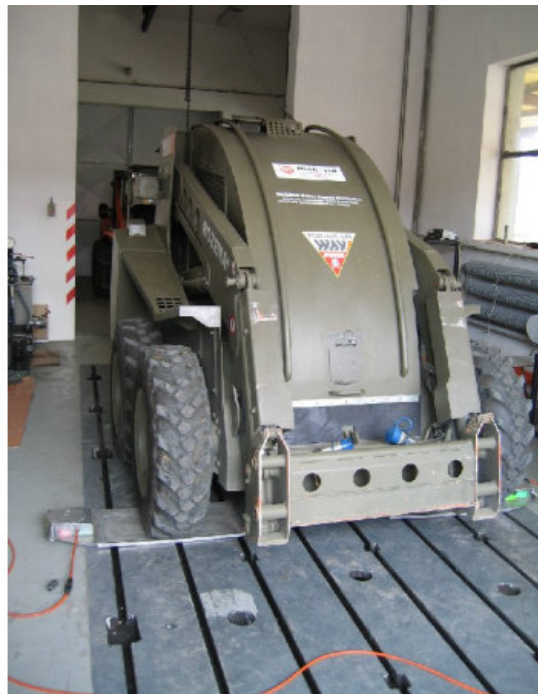
Note: Figure 5.2 shows the machine on the scales with no flail to show the method of measurement. The flail unit was attached for the actual measurement.

Figure 5-2: B4 MMCS on the load cells (without flail unit)

Mass
Left front wheel weight (without tracks)	1594kg
Right front wheel weight (without tracks)	2130kg
Left rear wheel weight (without tracks)	974kg
Right rear wheel weight (without tracks)	1179kg
Front axle weight (without tracks)	3725kg
Rear axle weight (without tracks)	2153kg
Weight of tracks	242kg
Gross vehicle weight	5878kg
Weight of flail unit only	1068kg
<p><i>Note from manufacturer:</i> The fuel and hydraulic tanks are placed at right and left rear sides of the prime mover and as we can see the difference approx. 200 kg is quite normal. But whole weight of the attached flail head is kept on the front axle and the difference of more than 500 kg was because the flail head was supported by central pin and it leaned to the right side and put pressure on the right lock but the left lock had been lightened. This feature allows transverse ground following. The weight was oriented to the right side.</p> <p>If the locks had been locked and the flail head was fixed in horizontal position, the weight distribution would have been equal to the both sides.</p>

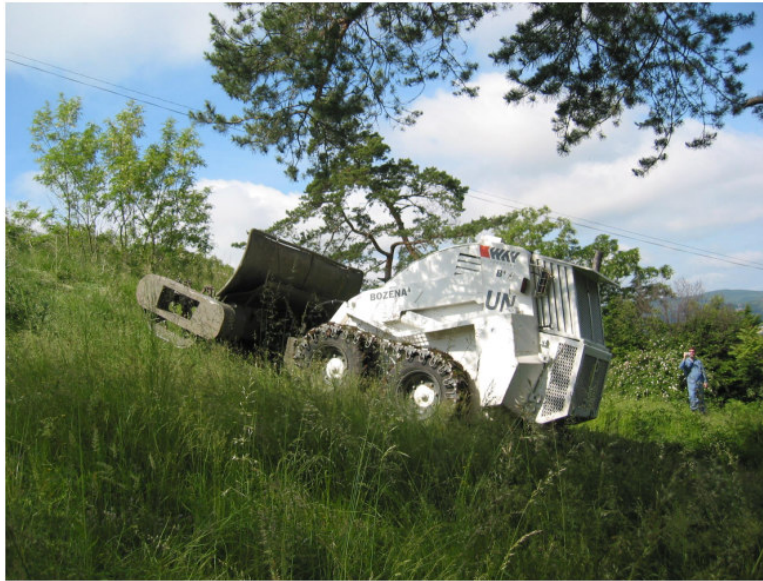
Figure 5-4: B4 MMCS climbing up the grass slope

Gradient	Terrain	Result
27° - Driving forward	Loamy Soil, light vegetation (Off-road)	Lost traction at the stated gradient. * B4 MMCS tended to creep back down the slope when instructed to stop. This was remedied by engaging a separate function via the remote control unit.
13° - Driving in reverse†	Loamy Soil, light vegetation (Off-road)	Lost traction at the stated gradient. B4 MMCS tended to creep back down the slope when instructed to stop. This was remedied by engaging a separate function via the remote control unit.
* - However there was evidence that B4 MMCS had climbed to the top of the hill on the previous day in better conditions. † - Gradient less in reverse due to direction of tread on tracks and differing axle weights

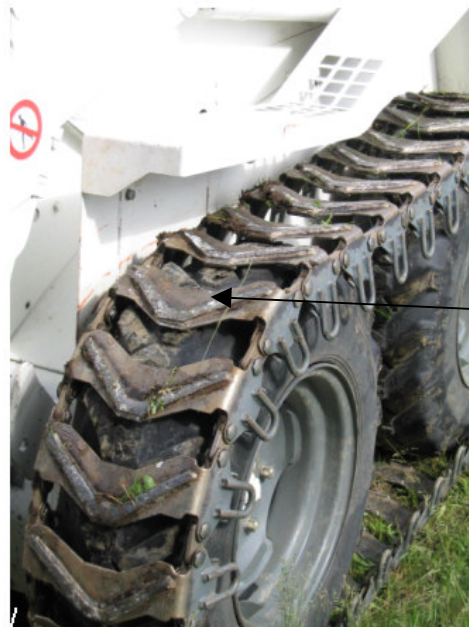
Directionally grooved tracks – Better going forward than in reverse

Figure 5-5: B4 MMCS climbing up the grass slope

- B4 MMCS is a compact system that can be transported on its own trailer by a small truck.
- Under its own power, B4 MMCS appears to have the ability to tackle fairly challenging terrain assisted by its tracked wheels giving it a relatively low ground pressure. However, due to the flail head, the B4 MMCS is front heavy – the front axle supports 63% of the vehicle mass. This combined with the short wheelbase could cause B4 MMCS problems backing up from ditches/ trenches or even driving up slopes (as seen in section 5.2.3). It was also noted that the directionally grooved tracks gave good traction in the forward direction but were less effective in reverse.

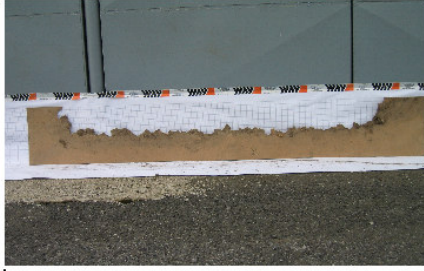
Figure 5-7: Example of a consistent cut across the width of the flail

The boards provided a clear indication of how deep the flail chains were cutting and whether they were achieving consistent cutting across the width of the flail. Previous tests on other machines had indicated that if flailing depth is too large, or forward speed too high or flail rotational speed too low, uneven flailing will occur and sections of the hardboard strips remain intact (see Figure 5-8), whereas correct flailing will cut away an even depth of the boards across the entire width. In the figures below the small squares on the background paper are 20mm X 20mm.

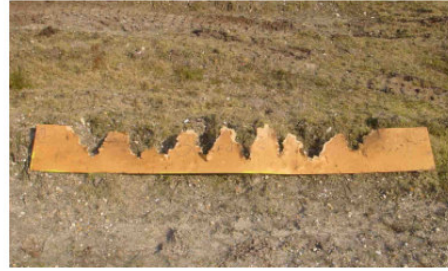
Figure 5-8: Example of an inconsistent cut across the width of the flail

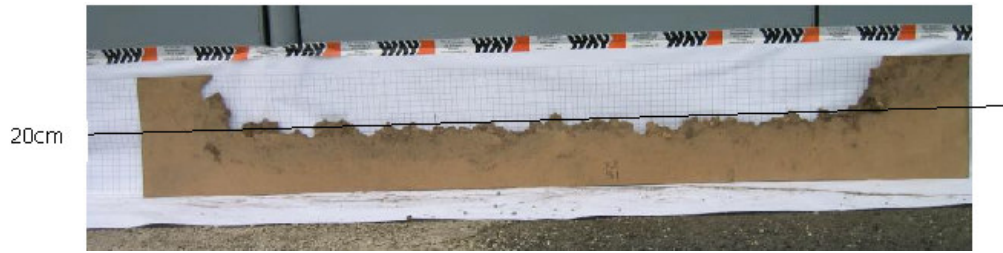
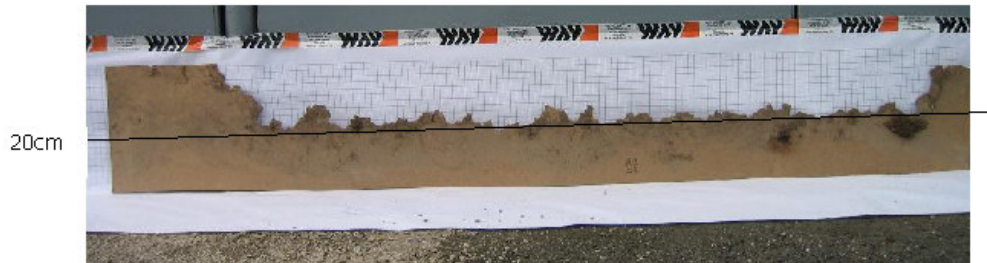
It can be seen that B4 MMCS managed a consistent cut across the width of the flail at approximately 200mm (deviating only slightly above and below this depth).

Figure 5-13: Run 2, Board 1

Figure 5-14: Run 2, Board 2

Figure 5-15: Run 2, Board 3

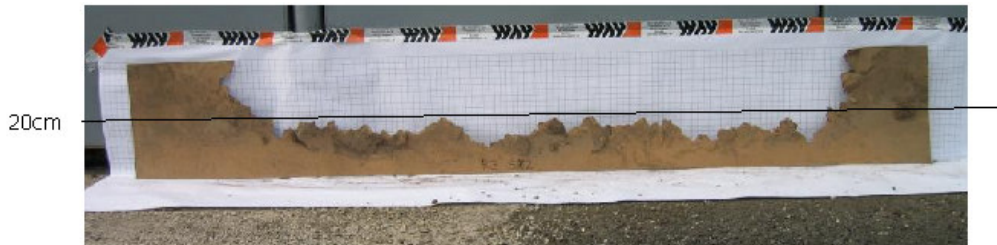
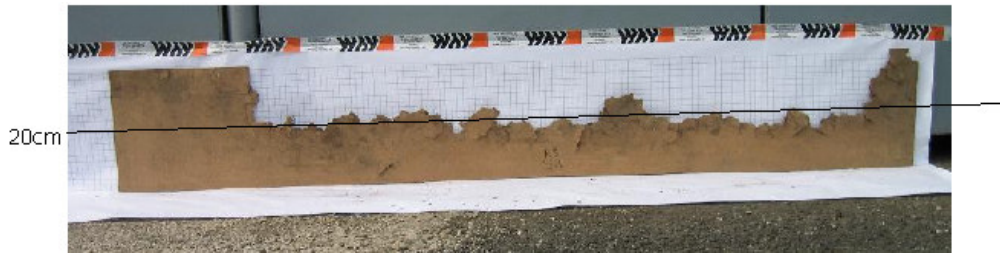
Again it can be seen in Figure 5-16 & Figure 5-17 that B4 MMCS managed a consistent cut across the width of the flail at approximately 200mm (deviating only slightly above and below this depth).

Figure 5-16: Run 3, Board 2

Figure 5-17: Run 3, Board 3

It appears that for this terrain type the maximum forward speed attainable without creating skip zones was approximately 0.29km/h. At speeds above this the cut profile became less consistent.

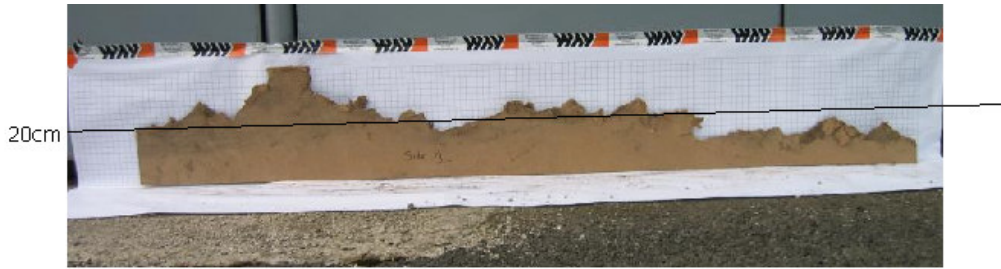
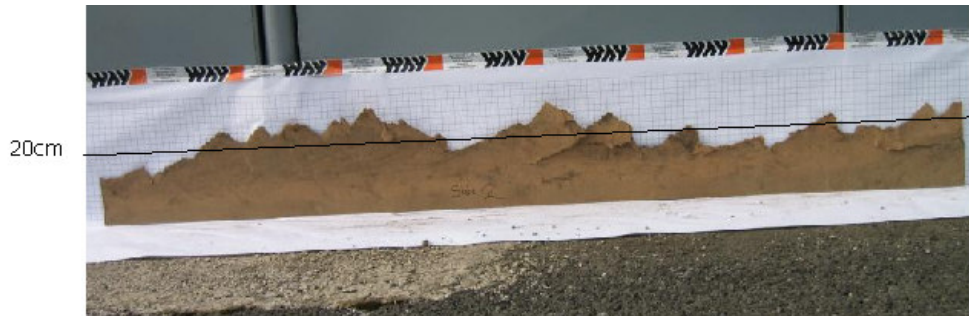
It should be noted that this test is not perfect since the aspect of the fibreboard shown towards the flail is relatively narrow. There is always a possibility that the board will pass between two flail chains undamaged. This test result should be seen as indicative and not an accurate representation of the flail's performance. If the boards are examined closely in Figure 5-19 & Figure 5-20 it can be seen that in addition to the sections of board that have broken away there are also scuffmarks along the board.

Figure 5-19: Run 4 Board 1

Figure 5-20: Run 4 Board 2

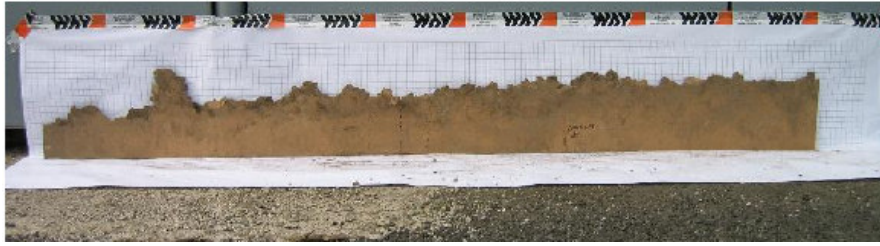
As can be seen in Figure 5-22 there was good consistency of cut at the overlap.

Figure 5-22: Overlap

- The stability skids allowed the flail head to follow ground well. No step or unevenness was observed between overlapping lanes – one skid on hard ground, one on soft. It was noted however that the skids tended to sink when in soft ground.

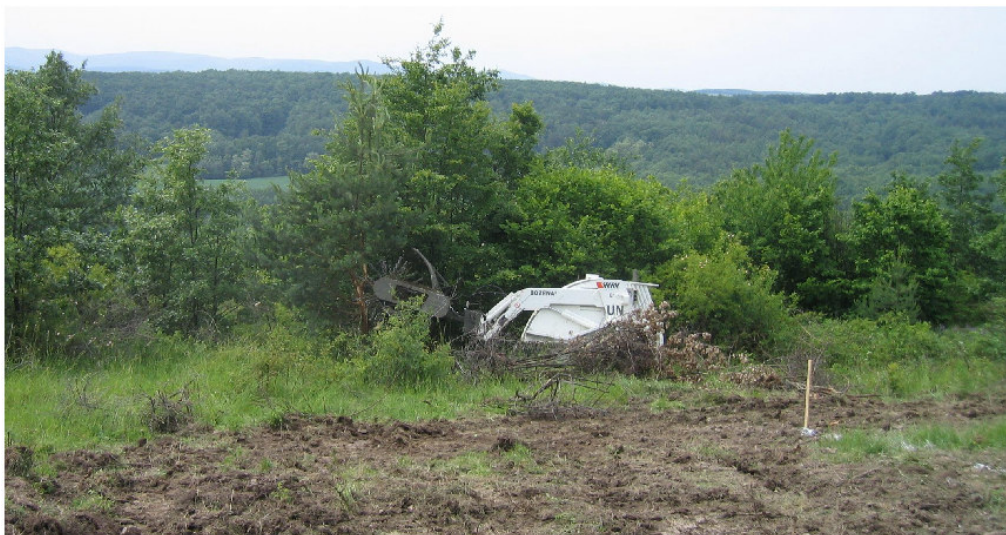
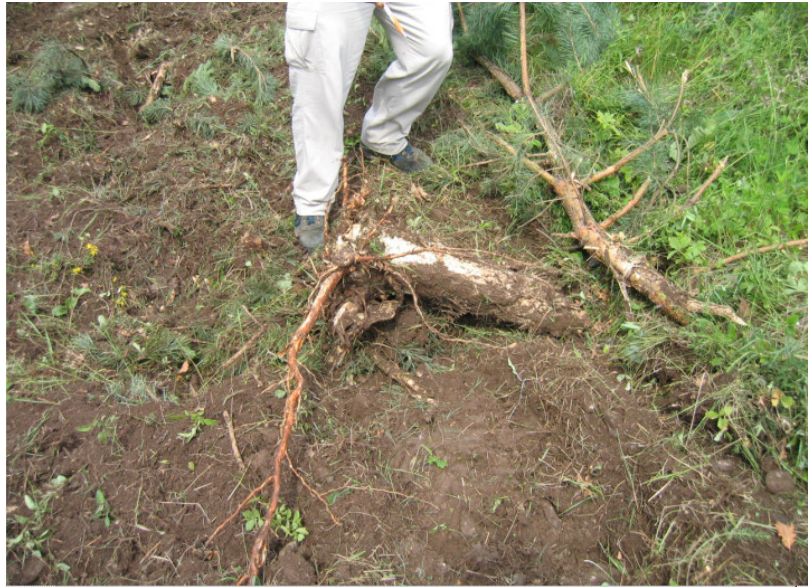
The B4 MMCS was able to clear the shrub, bushes and small trees with the flail head skids resting on the ground. However (unsurprisingly) it had to raise the flail head to tackle the larger trees. It conducted the task at a speed comparable to that of the other clearance runs described above.

Figure 5-23: B4 MMCS attacking a pine tree during the vegetation test

*Figure 5-24: Remnants of the pine tree after flailing*

Investigation of the cleared run it indicated that B4 MMCS has enough power to clear vegetation and maintain a good level cut through the ground.
