Proof of Performance Test Report on Mine Clearing/Survivable Vehicle

March 2005

Institute for Defense Analyses
4850 Mark Center Drive
Alexandria, VA 22311-1882

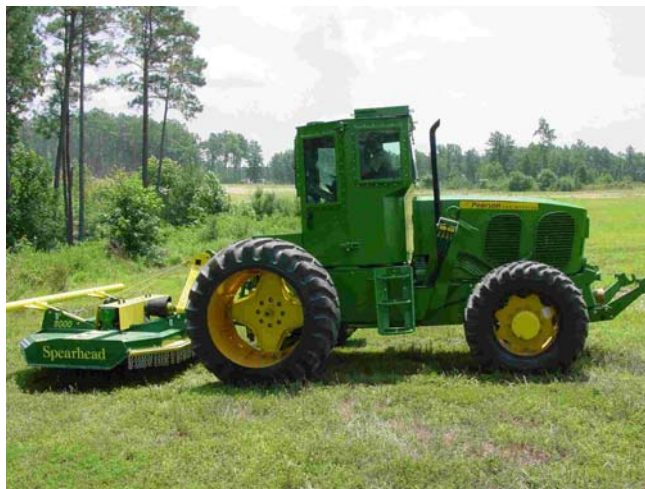
Figure 1: Mine Clearing/Survivable Vehicle (MCSV) with Rotary Mower

The intent of the MCSV is to provide a mine-survivable vehicle based on a commercial off-the-shelf (COTS) farm tractor. This tractor has been armored, fitted with a rotating driver's cab and antipersonnel (AP) mine survivable SETCO wheels with an innovative wheel hub interface incorporating a dowel and plate design. This design allows the wheel to separate from the axle in the event of an antitank (AT) mine detonation, thus reducing the shock effect through the axle and the tractor body to the operator. The SETCO wheels are also a commercial product. This vehicle is to act as the prime mover for a toolbox of COTS and specialized implements generally used by construction and earth-moving industries. Along with the mine resistant John Deere tractor, this toolbox currently consists of:

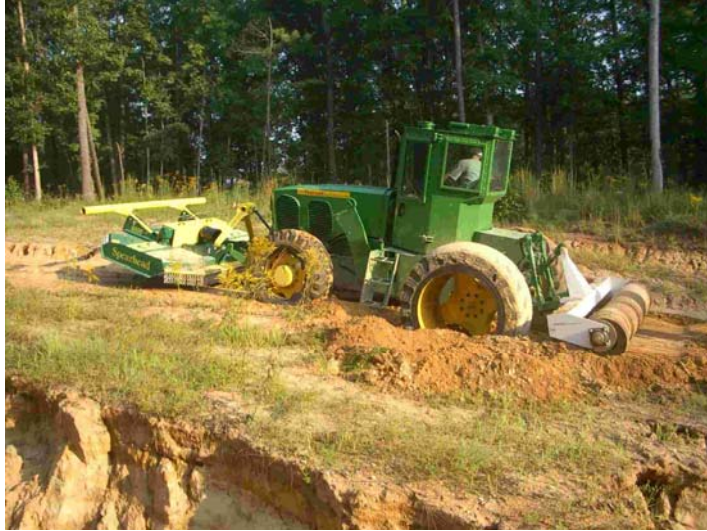
The MCSV, with SETCO tires and the rotary mower and area reduction roller mounted, got stuck on a section of the cross-country track that approximated a 20-degree slope in soft, damp sand. Getting stuck appeared to be caused by a combination of the rigidity of the solid tires and the molded traction cleats in the rear tires, which are close together, becoming packed solid with soil. This resulted in the rear, heavily cleated tires taking on the characteristics of “slick” tires, with no flexibility to self-clean (see Figure 19). The tractor was able to back out of the ruts, created in its attempt to go forward, after sections of logs were placed into the ruts behind the four driving wheels. A dozer was brought in to repair the damage done to the dirt road over the length of the hill

Figure 19: MCSV Stuck in Damp Sand Hill

Two days later, after the soil had a chance to drain, the run was made again with SETCO tires and the counterweight and area reduction roller attached. There were no problems and not a single hesitation or wheel spin when the MCSV climbed the portion of the hill where it had previously gotten stuck. The run was completed at an average speed of 8.97 mph (14.5 kph).

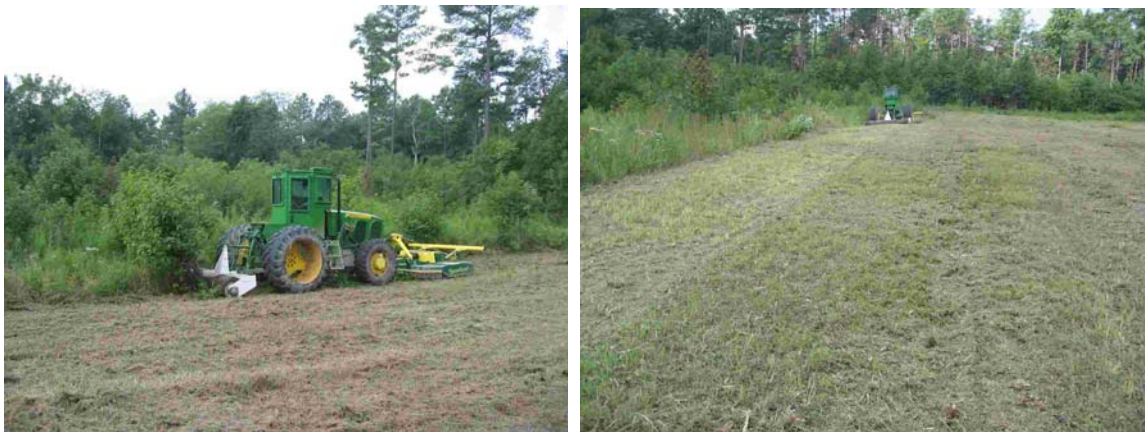
Figures 20 and 21 show the results of mowing with the use of the roller, and of the sheared universal joint (drive shaft yoke).

Figure 20: Area Reduction Roller and Mower Results

To demonstrate using the mower in an AP mined area, and to eliminate clutch disengagements in heavy Category 2 vegetation, the mower was used in tandem with the area reduction roller. On the first pass through a Category 2 vegetation area, the roller was pushed through the vegetation (cab facing to the rear and roller mounted on the rear), with the mower following and raised about 6 to 12 inches (15 to 30 cm) off the ground. At the end of the pass, the MCSV operator rotated the cab, dropped the mower to ground level, and retraced the path he had just taken, this time with the mower leading and the roller following. While this double-pass operation increased the mowing time, it resulted in a closer cut area and minimized the chance of the mower deck being caught on dirt or shrub growth, causing shaft damage as described above.

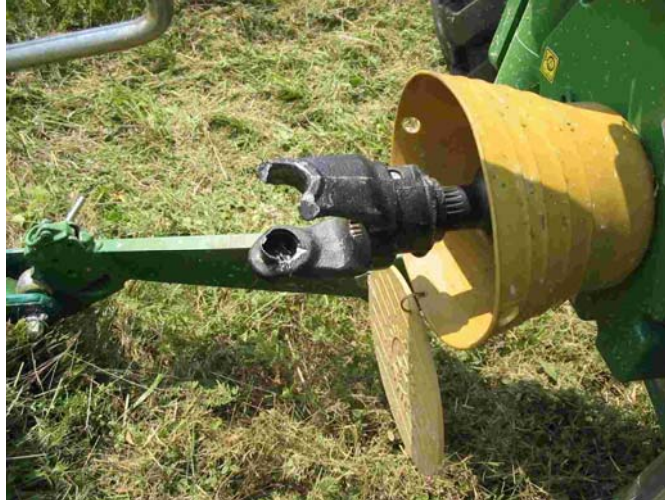
One such encounter caused the universal joint on the tractor end of the PTO shaft to shear. In this case, the mower was mounted on the front of the tractor, and the tractor was backing down a mowing lane, pulling the mower. The rear of the mower (side closest to the tractor) dug into the ground, causing the front of the mower deck to rise. This put the drive shaft into a bind while under power, which caused the universal joint (drive shaft yoke) to break. Parts were obtained from the local John Deere dealer, and the test continued on the following day.

Figure 21: Sheared Universal Joint

The prime mover, a commercial John Deere 6920 tractor, has a proven history of reliability and is supported by a worldwide network of commercial dealer organizations. The tools are off-the-shelf and commercially available, with spare parts support direct from manufacturers and dealers. During the performance demonstration, there was not a single unscheduled maintenance incident on either the tractor or any of the tools. The one repair to the tractor, the fuel tank leak, was caused by a change in design during manufacturing and resulted in the rework of a single item. The need for this rework will not be necessary on subsequent vehicles, thus eliminating the possibility of it happening again. The shearing of the PTO universal joint was the result of inexperience with the system and the tool.

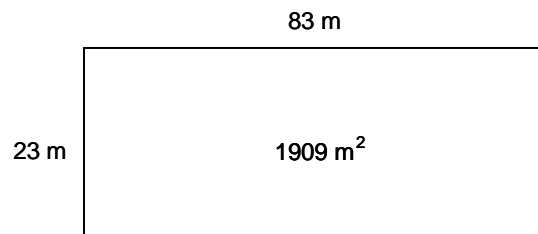
Two timed mowing tests were conducted to provide planning factors for field operations of the rotary mower. The first test was with the mower only on an area where the vegetation progressed from a heavy Category 1 to a mix of Categories 1 and 2. The area mowed was 1,909 m², the time required was 62 minutes. This equates to approximately 1,850 m² per hour. Figure 22 is a diagram of the mowed area.

Figure 22: Mowed Area (1900 m²/h), Mower Only, Single Pass

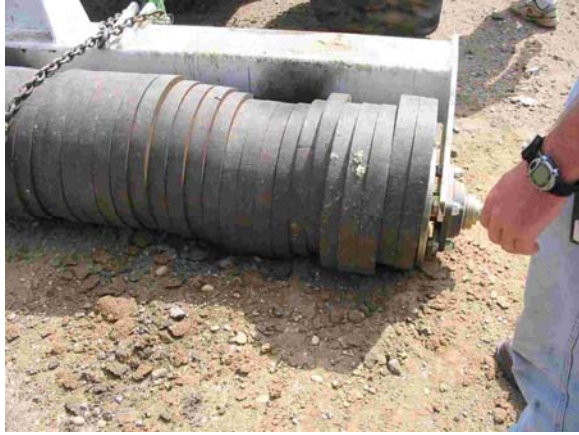
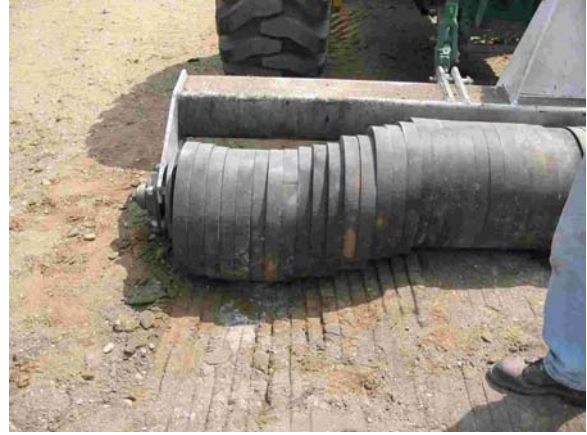
Blast tests were also conducted against the roller. The explosive, designed to simulate a heavy AP mine, consisted of ½ pound of TNT initiated by a small U.S. AP mine. Three explosive charges were laid with the initiator mine’s detonator just above the surface. The tractor, with the roller attached on the front, was pulled over each of the explosive devices. The roller sustained no damage. See Figure 23.

Figure 23: Results of Blast Test Against Roller

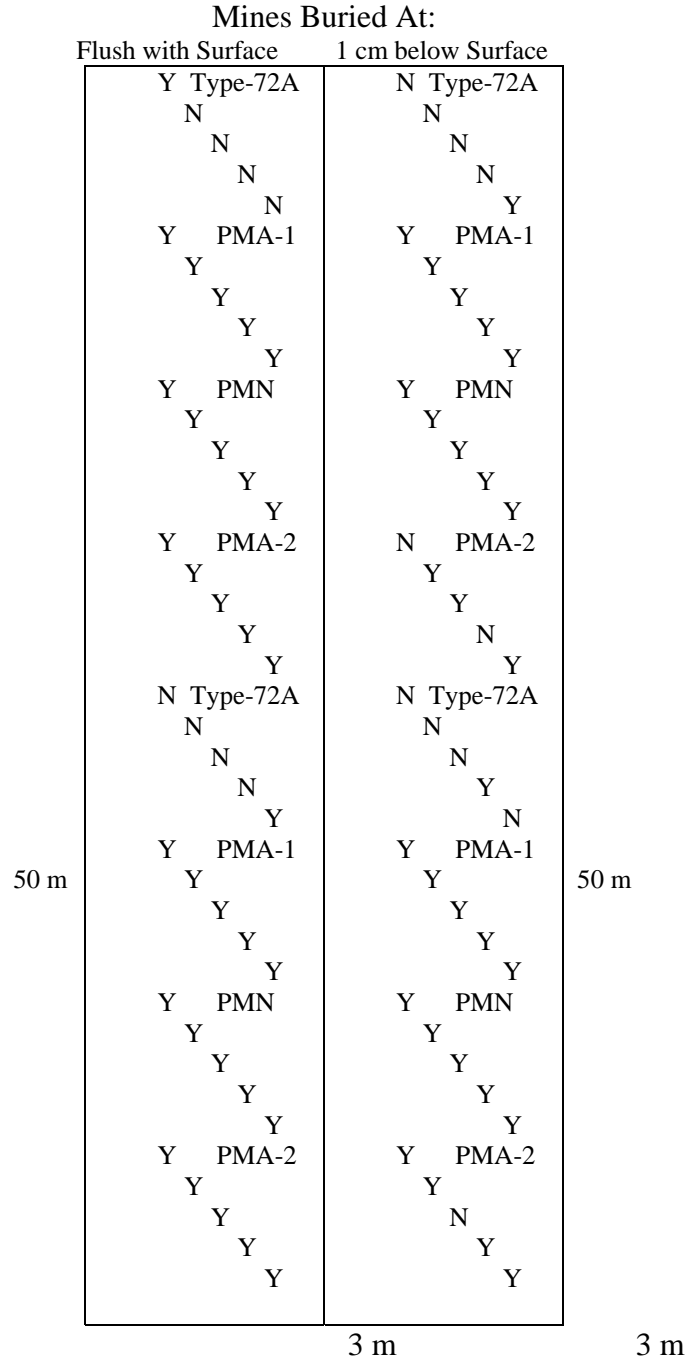
In Lane 1, 80% of the flush-buried mines were detonated. All those not detonated were Type-72A MRMs. In Lane 2, 75% of the mines were detonated. Those not detonated were eight Type-72A and two PMA-2 MRMs.

Figure 24: Test Lane Configuration and Mine Emplacement

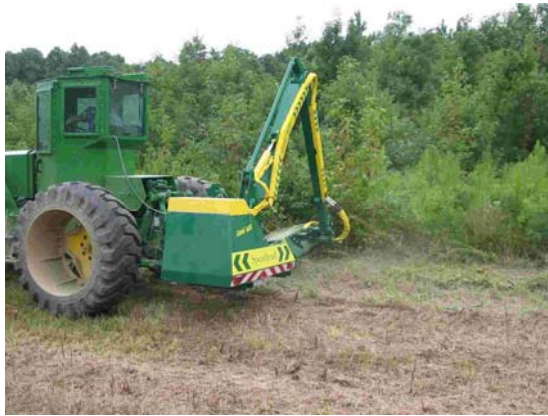
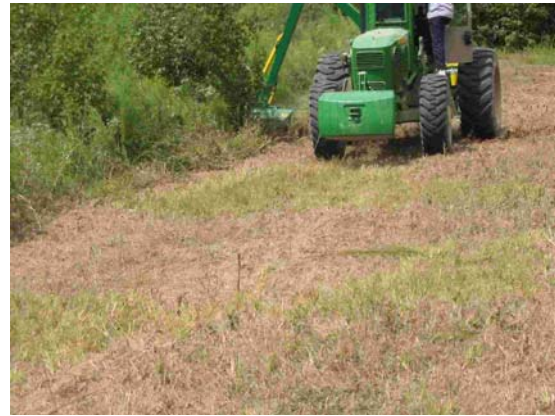
The Hedge Trimmer, designed to be mounted on the rear 3-point hitch of the tractor, is powered by the rear PTO. The PTO drives an on-board hydraulic system that controls the movement of the boom and powers the cutter head. The boom allows the hedge cutter to operate over an intervening guard rail or other similar obstacle and cut the vegetation beyond

the obstacle. The cutter is powerful, quiet, with very minimal vibration, indicating excellent balance of the cutting rotor. The cutting rotor has a double row of cutters with 14 cutters per row. The cutting swath is 1 meter. With the boom fully extended, and with no intervening obstacle, the cutting head is able to reach out 13.33 ft (4 m). The Hedge Cutter had no problem cutting Category 1 and 2 vegetation. On Category 3 vegetation, the cutter was able to cut the vegetation down to ground level only by cutting the vegetation in stages, beginning at the top, and working down. The Hedge Cutter was not designed to be operated in this fashion; however, it can be done, albeit awkwardly. The Hedge Cutter appears to be sufficiently robust to operate for extended periods of time against Categories 1 and 2 vegetation. No trials of area versus time were made. No mechanical problems were encountered.

Figure 25: Brush Cutter Operations

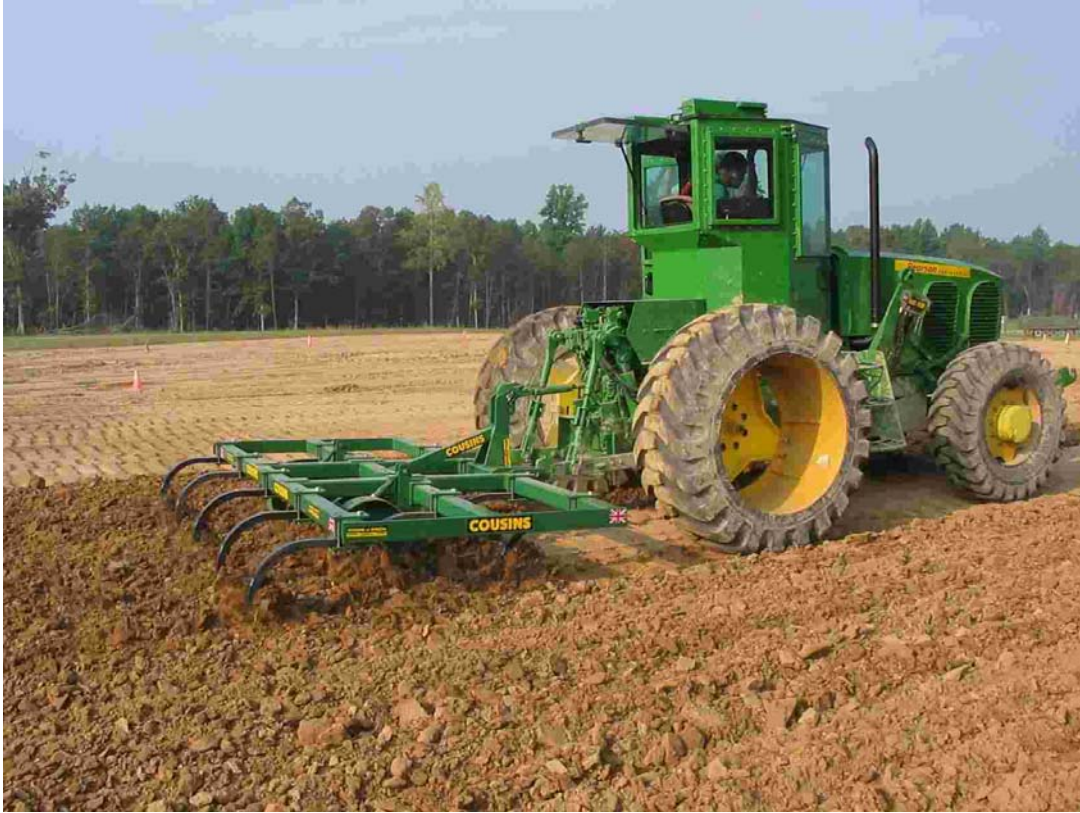
The Spring Tine Cultivator, a commercial farming tool, was mounted on the MCSV with SETCO tires. The test area was hard-packed sandy clay soil. At the start of the test, when the MCSV operator tried to control the tractor throttle and depth of the cultivator manually, the cultivator operating depth varied as the surface of the field rose and fell, and the MCSV was brought to a complete standstill at low tractor speeds by the drag of the cultivator. However, when the tractor was put into Economy Drive (similar to cruise control), the cultivator allowed to ride on the depth-control wheels installed on the cultivator, and the desired tractor speed set, the MCSV fuel-control system and engine computer automatically adjusted the fuel flow to keep the tractor moving as the cultivator load on the tractor varied. When driven using Economy Drive, the tractor was able to cultivate the soil to a depth of 6 inches (15.25 cm) on all three rows of tines. No time trial measurements against area cultivated were made.

Figure 26: Spring Tine Cultivator Demonstration

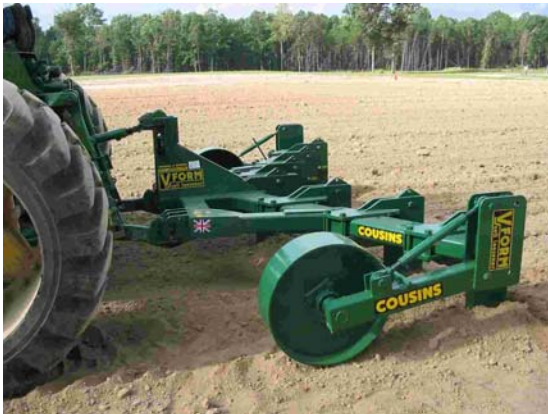
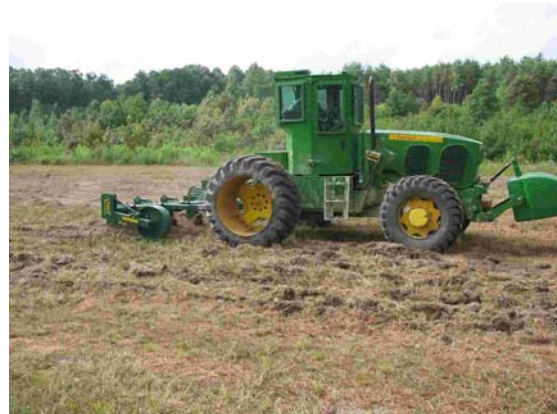
Based on the experience with the Spring Tine Cultivator, the performance test of the Soil Loosener made use of the installed depth-control wheels to control the tool's operating depth, and the Economy Drive system was engaged. Trials were conducted in dry, compacted sandy clay soil with no vegetation and in an area where Category 1 vegetation had been cut with the rotary mower. At both sites, the MCSV had no trouble pulling the Soil Loosener at an operating depth of approximately ½ meter.

Figure 27: Soil Loosener in Packed Clay and Heavy Sod

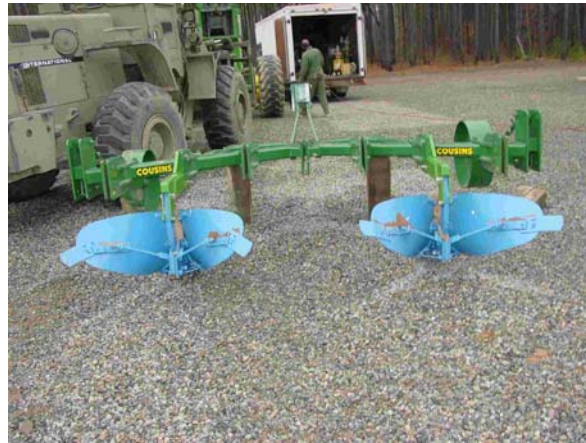
The Bed Formers were installed on the Soil Loosener frame once the Soil Loosener blades were removed. The two Bed Formers are shaped like plows and are so spaced that the distance between their center points is equal to the tire track width of both the MCSV and the Soil Sifter. The Bed Formers, capable of operating up to a depth of 14 inches (35.6 cm), move the broken-up soil (preprocessed by the Soil Loosener) into windrows measuring 7.48 feet (2.28 meters) wide from the center of one trough to the next. SETCO tires can also be mounted on the MCSV without the blast-off mounting hub.

Figure 28: Bed Formers Installed on the Soil Loosener Frame

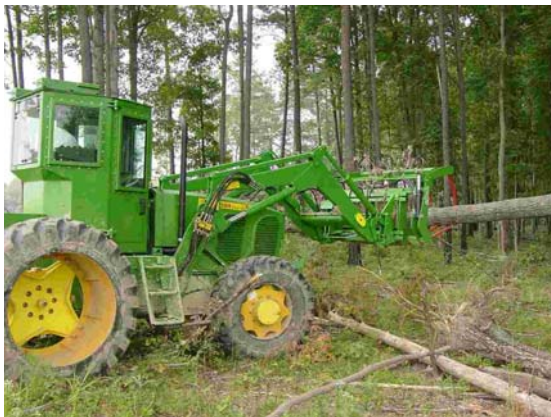
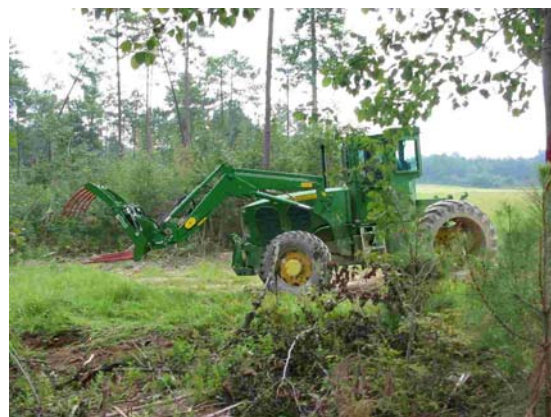
The Grab, designed to pick up cut brush, debris from forestry operations, or any loose material resulting from a vegetation-clearing project, is mounted to the tractor using the Universal Mount. Although operator visibility of the tool is limited when the tool is on the ground, with a minimal amount of experience the operator is able to use the tool with no trouble. As can be seen, lifting capacity, by weight, is sufficient to handle large debris-clearing jobs. No tests, other than the demonstration shown, were conducted.

Figure 29: MCSV with Grab

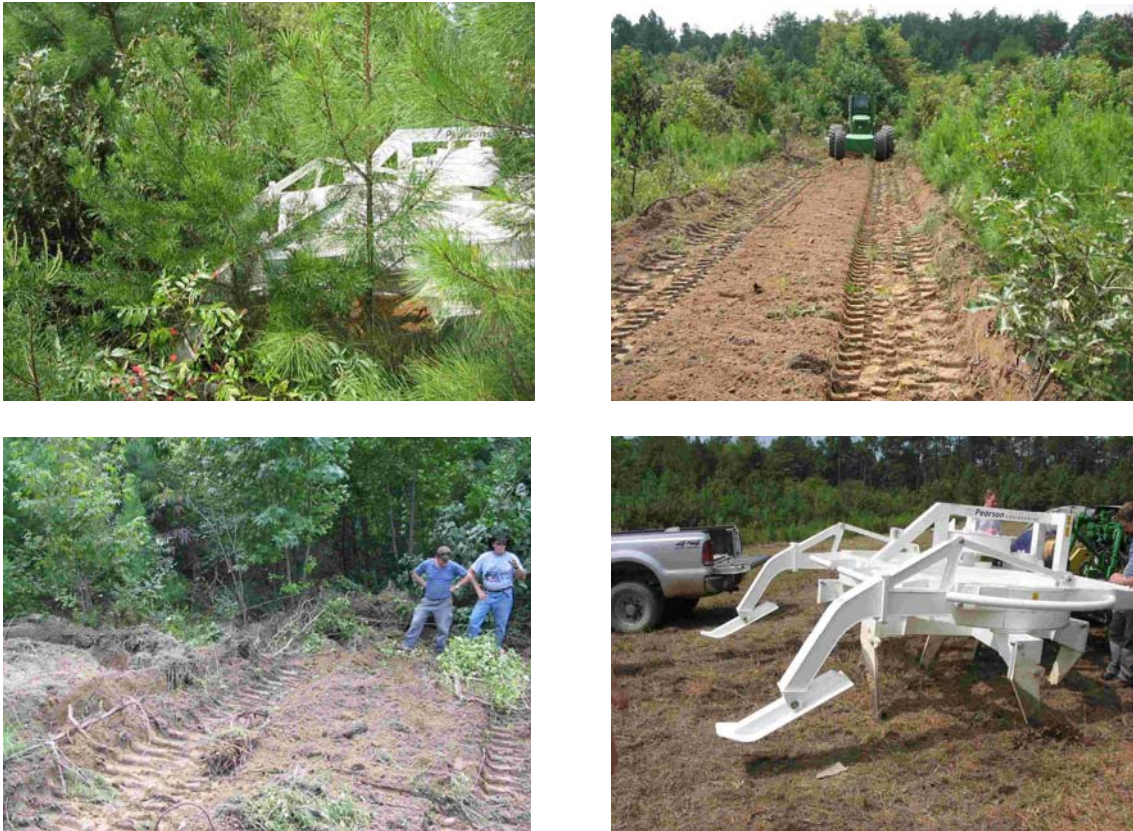
The Rotary Mine Comb, designed and built by Pearson Engineering, Ltd., is an adaptation of an old idea for a garden tiller. The two sets of counter-rotating tillers, canted slightly outward, bring mines to the surface and then slowly, and gently, move the mines to the sides of the tiller and deposits them in windrows. Throughout the demonstration, the Rotary Mine Comb handled all vegetation conditions, ranging from dense Category 1 to very heavy Category 3, with ease. The 40 cm operating depth of the cultivating tines removed not only the above ground vegetation, including 15 to 20 ft (4.6 to 6.1 meter) tall trees up to 3 inches (7.6 cm) in diameter, but also dug up the trees' root systems. This tool, without exception, was the best area-proofing and mine-removal tool tested during the MCSV proof of performance. Pictures showing the Rotary Mine Comb in action and the results of its operation are shown in Figure 30.

Figure 30: Rotary Mine Comb Demonstration

During the performance demonstration in heavy Category 2 and Category 3 vegetation, the operator had trouble steering in a straight line with the mine comb pulling the tractor on a gentle curve to the left. If the ground is not level, the Rotary Mine Comb digs more deeply on the low side. This in turn exerts a pull to that side causing the tractor to

An operational transit problem presented itself and a workable solution was devised. In the full-up position with the Rotary Mine Comb out of the ground and the PTO shaft connected to the Rotary Mine Comb, the Rotary Mine Comb clears the ground by scant inches. When moving from a staging area to a work site over anything other than a flat, smooth surface, the Rotary Mine Comb digs into the ground as the MCSV pitches and sways over the uneven surface. Since the PTO shaft is the limiting link in determining ground clearance in the all-up position, it is recommended that the PTO shaft not be connected until the Rotary Mine Comb is at the work site. This allows additional ground clearance when in the all-up position. When departing a work site, the PTO shaft should be disconnected.

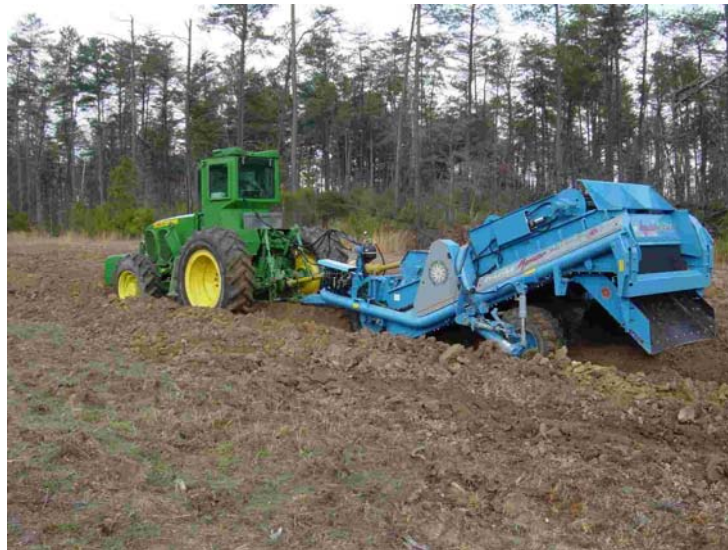
at the rear of the sifter. Experience showed that the sifter was much more efficient when operated at the lower of the PTO speeds (540 rpm vs. 1000 rpm). At a forward speed of 1 mph (1.61 kph), the sifter is capable of sifting 3,033 square yards per hour (2,773 square meters per hour).

There are four drawbacks to using this attachment, one potentially serious, three easily correctable. The serious drawback is that the MCSV would have to drive over a mined area to prepare the soil with the Soil Loosener and Bed Formers prior to using the Mine Sifter. The second drawback involves the rear-facing chute. Because of its width, mines can be deposited in the trough between the sifted windrows and might be covered with a thin layer of soil that slides down the sides of the sifted windrows. This can pose a hazard to deminers who would walk in the troughs looking to recover sifted mines. An easy correction to keep the mines on top of the sifted windrow is to install a choke in the discharge chute, ensuring that the mines are deposited in the center portion of the windrows. The third drawback is that the MCSV operator cannot see what is being deposited by the rear facing discharge chute, and therefore alert waiting deminers of a sifted AP mine. It is thought that an observer using binoculars should be able to spot sifted mines. Finally, SETCO tires with standard hubs, and not the blast-off hubs, have to be used to match the tire track width of the sifter.

Figure 31: Mine Sifter in Operation

Before using the sifter, the soil was broken up by the MCSV pulling the Soil Loosener. After breaking up the soil, the soil-breaking wedges were removed from the Soil Loosener frame, and two bed-forming v-shaped plow implements attached. The area to be sifted was formed into windrows using the bed-forming v-shaped plows. The design and spacing of the plow attachments allow the wheels of the MCSV and the sifter to ride in the troughs between the windrows, sifting one windrow at a time. The sifter can be set to sift to a maximum depth of 14 inches (35.6 cm). The pros and cons of using this attachment are discussed below.

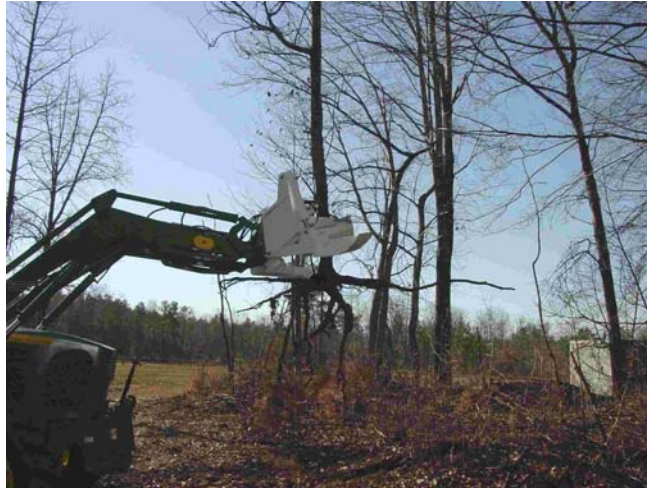
The Tree Picker, also supplied by Pearson Engineering, Ltd., is a hydraulically actuated attachment that mounts to the MCSV using the standard 3-point hitch on the front of the vehicle. The picker is actuated by two electronically controlled hydraulic feed lines off the MCSV's hydraulic system, mounted one on each side of the 3-point hitch. These operate the left and right power outriggers on the picker as well as the central tree-grabbing mechanism. Limited training on and use of, the tree picker occurred during the assessment. However, the demonstration did include the removal of a 12 inch (30.5 cm) diameter tree well in excess of 60 feet tall.

Figure 32: Tree Picker in Operation

Two operational issues were noticed during the demonstration assessment, which included using pneumatic tires on the MCSV. The first is that the pressure placed on the front tires during the tree extraction process and later by the weight of the extracted tree was sufficient to almost totally collapse the front tires. Therefore, it is recommended that the tree picker be used with the SETCO tires installed on the MCSV. The second is that forward moment caused by the weight of the extracted tree made the MCSV very light on its rear tires. Therefore, any extracted tree should be lifted slowly to make sure that the weight of the tree does not cause the rear wheels to lift off of the ground.

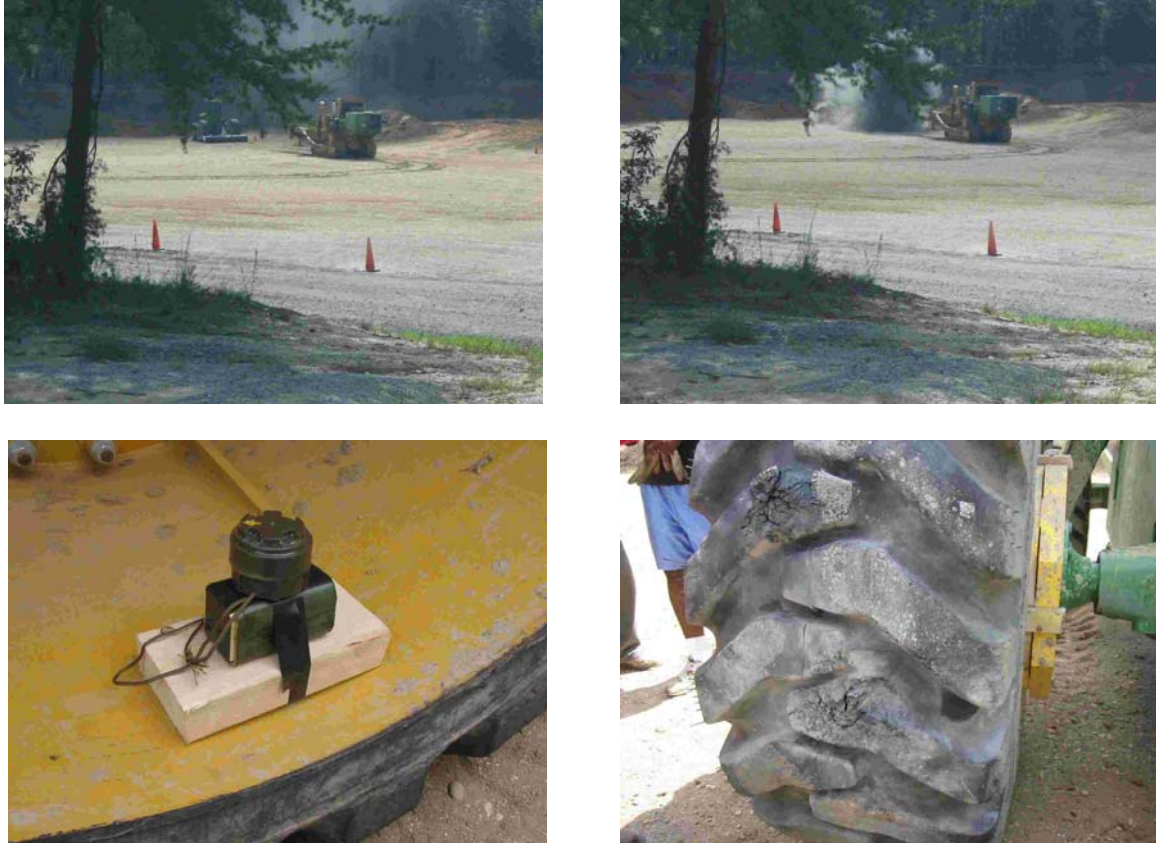
Two blast tests were conducted against the left rear SETCO tire. The two explosive charges used were (1) ¼ pound TNT initiated by a small U.S. AP mine, and (2) ½ pound TNT initiated by a small US AP mine. The explosives were buried with the AP mine pressure plate at ground level. The SETCO tires sustained some surface scuffing and localized charring from the blasts. While there was more surface scuffing caused by the ½ pound explosive charge, neither blast area showed significant damage. Given the size and the surface area of the tires, each tire could probably sustain hundreds of such blasts before consideration might be give to changing them.

Figure 33: Blast Test, SETCO Tires

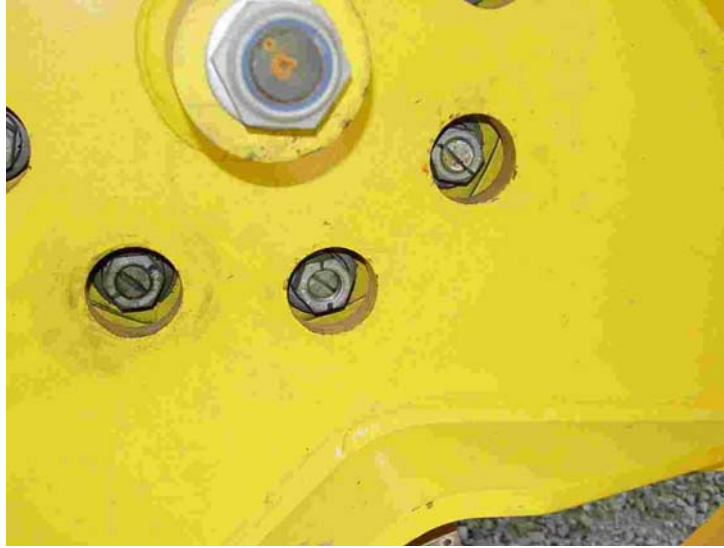
- g. Lapsed time for the repair was 8 hours, with one to three people working at all times.
9. It was noticed during the inspection of the MCSV, after the on- and off-road mobility trials, that the wheel lugs on the rear SETCO tires had worked loose. The lugs nuts were tightened and the trials made with the heavy cultivator. Inspection of the lug nuts showed that they had again become loose, some as many as three and four complete turns of the nut. The nuts were again tightened, using a large breaker bar with a 4-foot extension pipe. The lug bolts were marked and checked three to four times a day for the remainder of the demonstration. There was no further loosening of the lug nuts. See Figure 34. The offset of the black lines on the stud and lug nut indicates a loose lug nut. As can be seen, the bottom lug nut has backed-off at least three full turns.

Figure 34: Loosening Lug Nuts

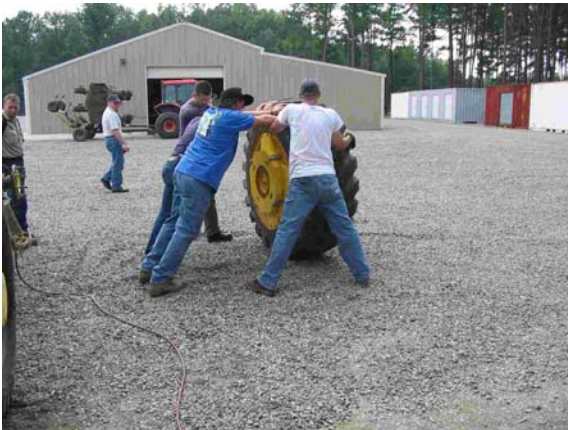
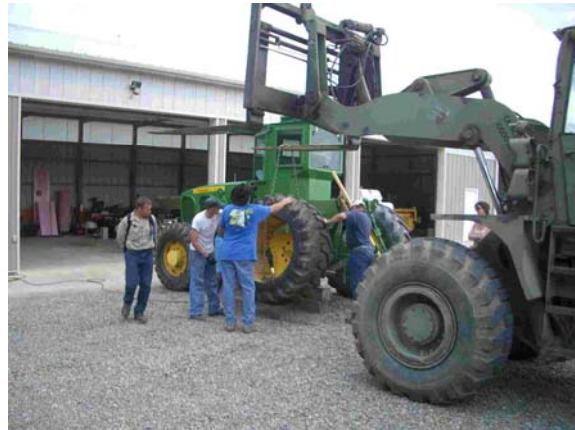
Changing of the rear SETCO tires requires some means of lifting the tires and two to three strong men to position them on the axle. During the proof of performance demonstration, a forklift was used to lift the tire into position. See Figure 35.

Figure 35: Mounting SETCO Rear Tires

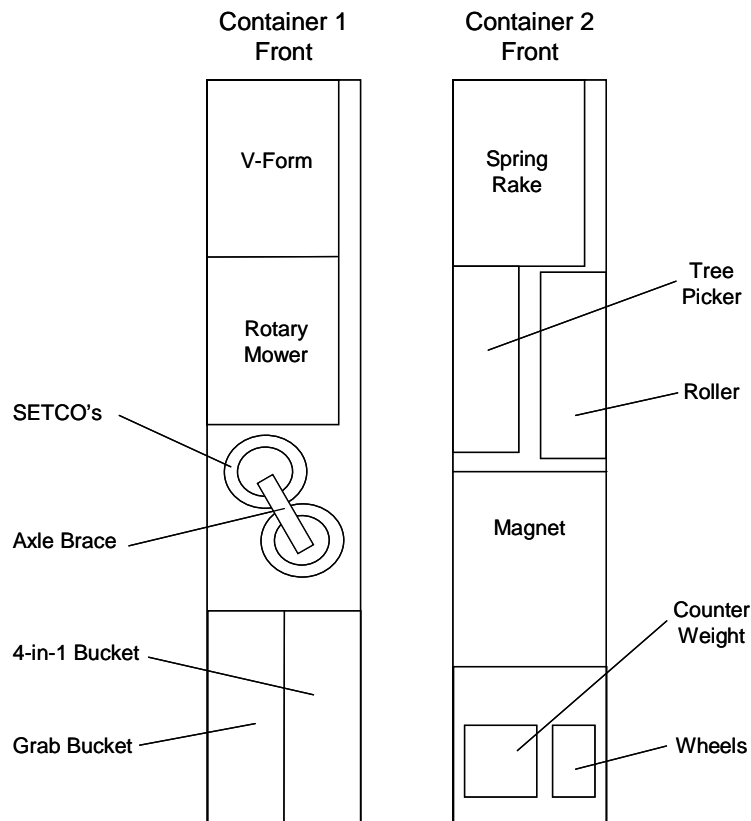
For overseas or long-distance in-country shipment, the MCSV tools and attachments will be loaded into two, 40 foot long CONEX containers according to the loading plan shown in Figure 36. The tractor will be driven into or onto a ship, flatbed rail car, or flatbed trailer and chained in place for shipment.

Figure 36: MCSV Load Plan: Two 40-foot Containers
