Test and Evaluation Report For DOK-ING MV 10

DOK-ING MV 10 Test and Evaluation
May 2008

A test of the DOK-ING MV 10 was performed in Sweden by SWEDEC in May 2008. Performance and survivability tests were done according to the European Committee for Standardisation (CEN) Workshop Agreement "CEN Workshop Agreement 15044; Test and Evaluation of Demining Machines", available at the international Test and Evaluation Website (www.itep.ws).

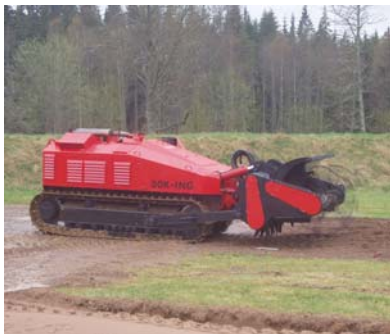
Figure 1. MV 10

The DOK-ING MV 10 medium double tool combined system (hereinafter MV 10) is a remotely controlled tracked mechanical mine clearance machine, operated within visual line-of-sight by the operator.

A number of tools can be attached to the MV 10 including a combined flail and tiller, a double flail, a roller and a blade. During these tests the MV 10 was equipped with a combined flail and tiller.

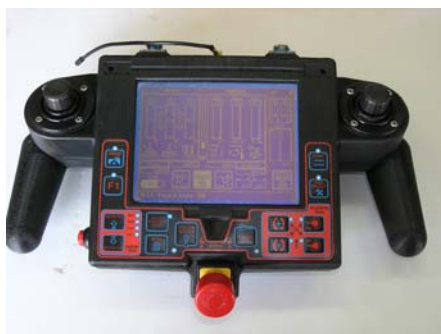
Figure 4. Remote Control

The operator controls the machine from a man-portable transmitter unit using visual observation of the machine.

The remote control for the MV 10 was a new version (see figure 4).

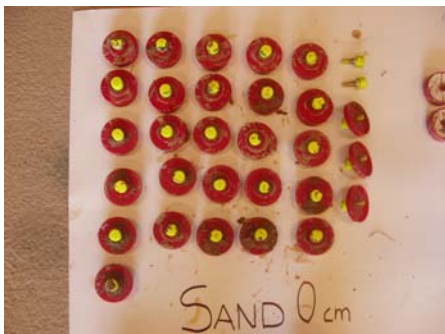
Figure 1, Sand 0 cm first drive

After each test in the series, the test lanes were searched as described above, and the materials of interest were assembled and inspected. These materials included fuzes, fuze components, intact mine targets, and mine bodies with most of or the entire (inert) main charge intact. The photos in figures 1-8 show the collected debris.

The first test done in sand, which is shown in the annex, had low resultant of triggered mines. The operator drove very fast and couldn't control the depth setting. The number of detonations was 17 during this test.

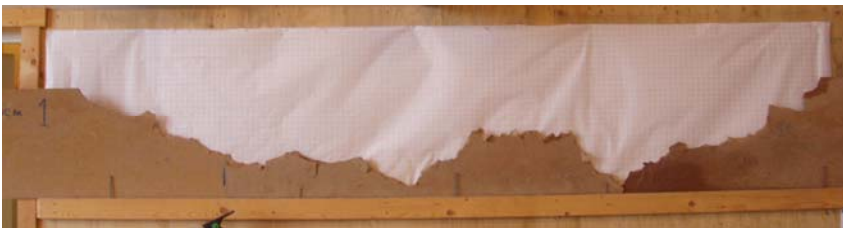
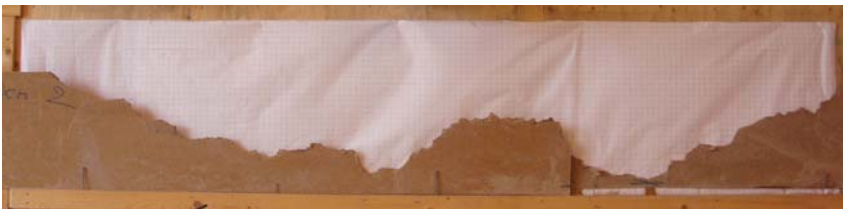
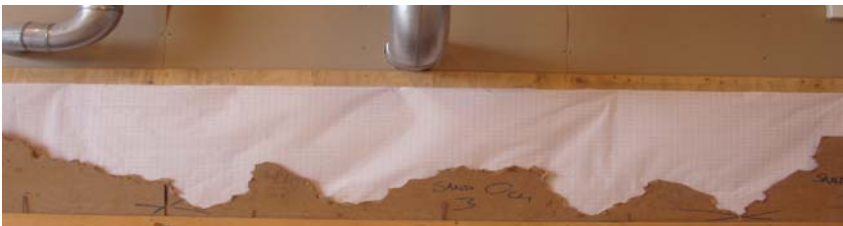
During the first test (sand 0 cm), the machine manufacturer chose an inexperienced operator. He drove very fast (the velocity can be found in the annex) and couldn't control the depth. This can be seen on the witness boards above.

First run resulted in big skip zones in the witness board this because of to high clearing speed. The time for run one 1.09 min/ 25 m. The second run was slower and the penetration was 25-30 cm on the first witness board and 40 cm on the second and third. The time for second run was 4.33/ min/ 25 m.

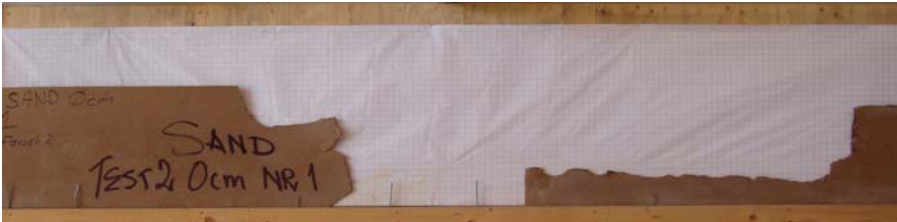
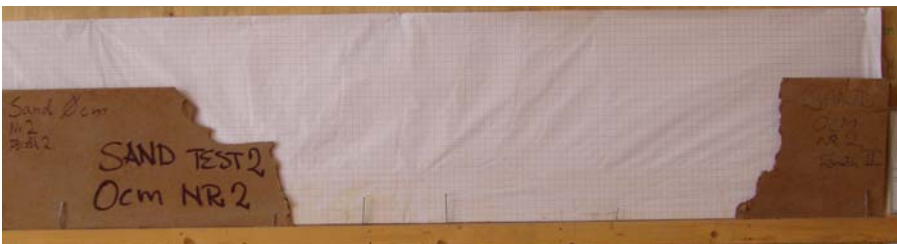
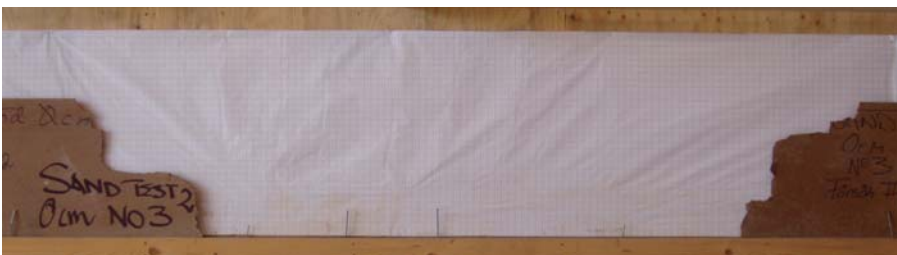
During this test (the second for sand 0 cm) the result was much better. The clearance depth was over 40 cm on profile 2 and 3 though (the fibreboard is 40 cm).

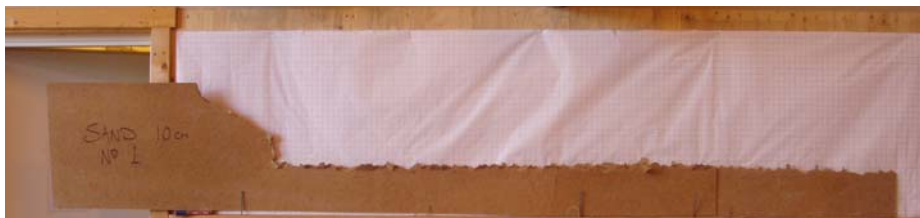
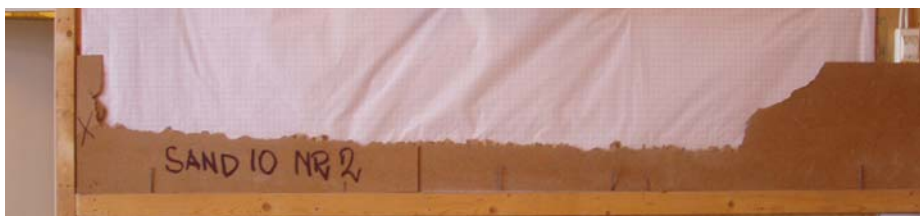
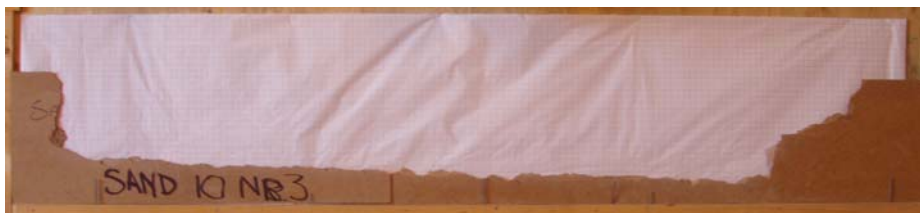
Clearance depth about 25 cm.

The depth of penetration on all three witness boards was 25 cm. The time was 4.21 min/ 25 m.

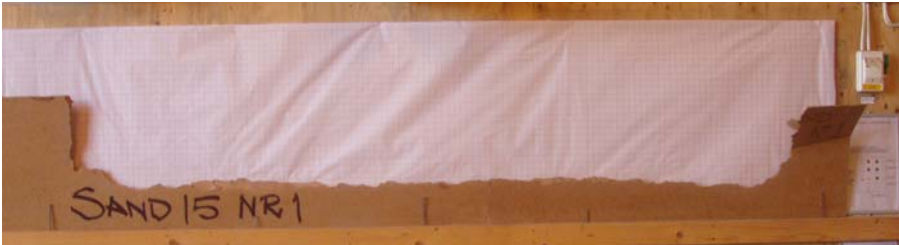
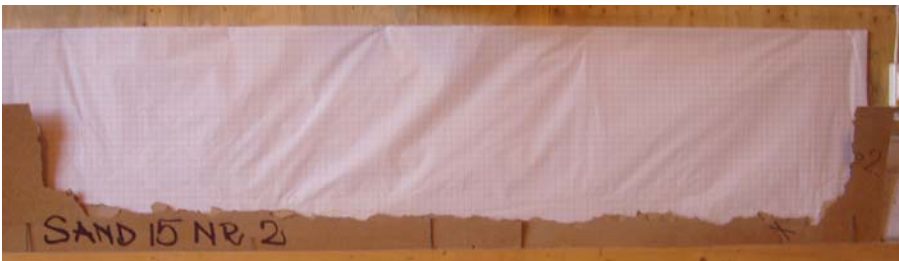
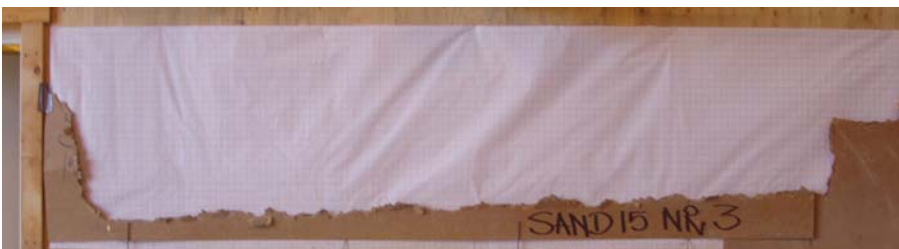
The clearance depth about 25-30 cm.

The depth of penetration on all three witness boards was 30 cm. The time was 2.24/, min/ 25 m.

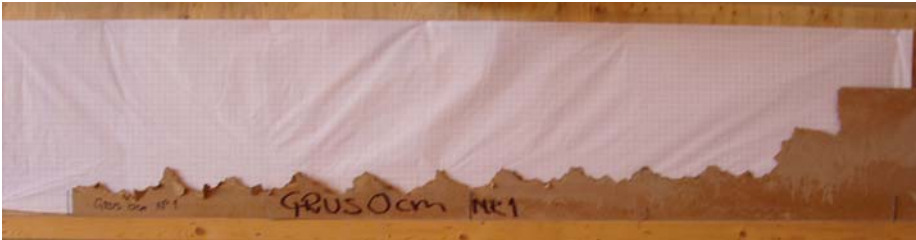
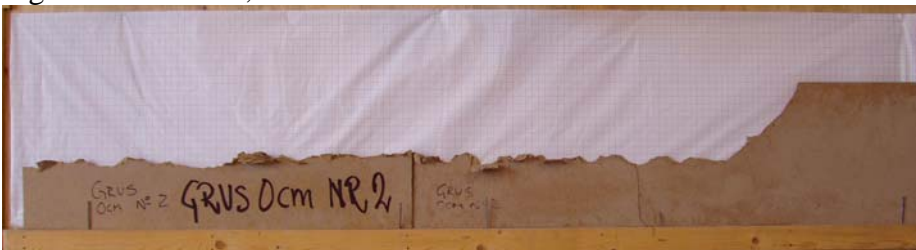
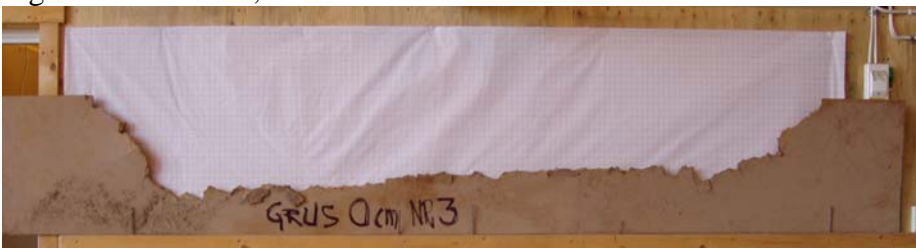
Clearance depth about 25-30 cm

The depth of penetration on the first witness board was 30 cm and showed some small skip zones. The small skip zones is because of the speed. On the second and third witness board the depth was 25 cm. The time was 2.24 min/ 25 m.

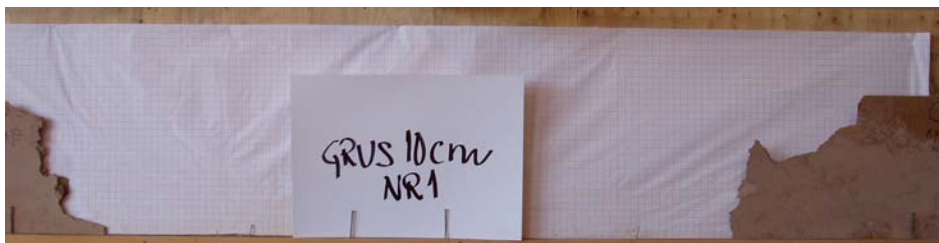
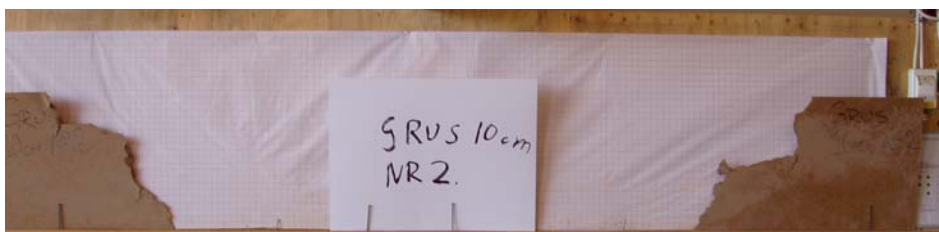
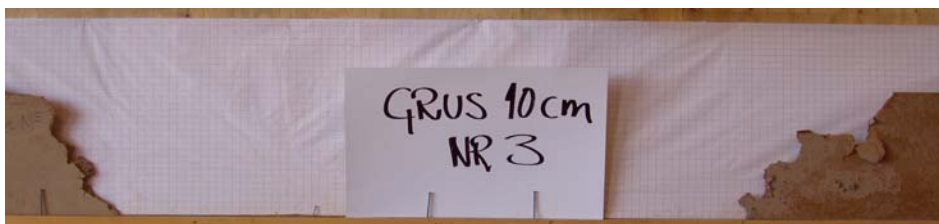
Clearance depth deeper than 40 cm!

The depth of penetration on all three witness boards was over 40 cm. The time was 6.17 min/ 25 m.

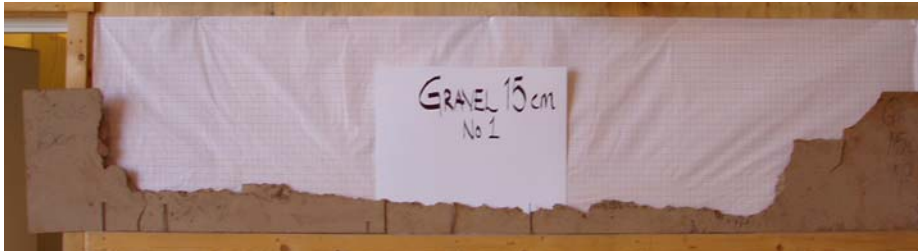
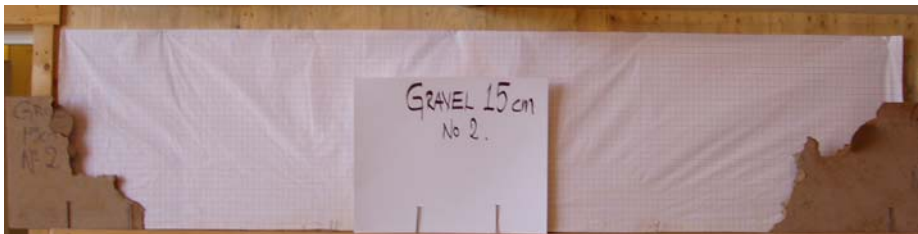
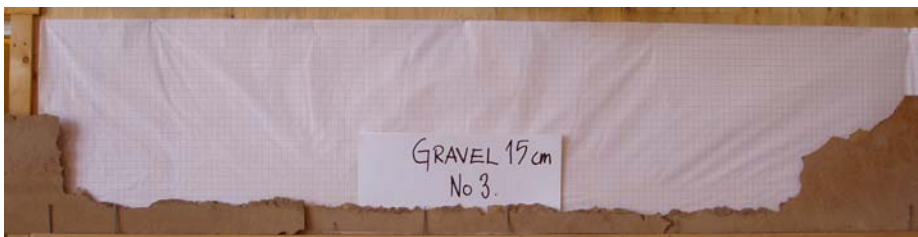
Clearance depth; board 1 25-30 cm, board 2 over 40 cm and board 3 about 25-30 cm.

The depth of penetration on first witness boards was 30 cm. Second witness board over 40 cm and the third witness board 35 cm. The time was 4.50 min/ 25 m.

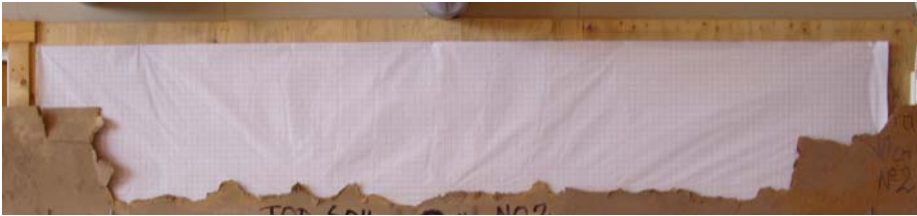
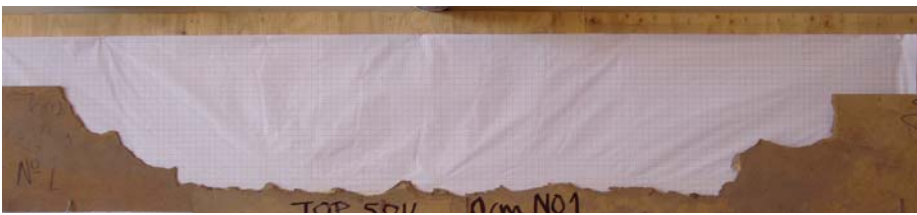
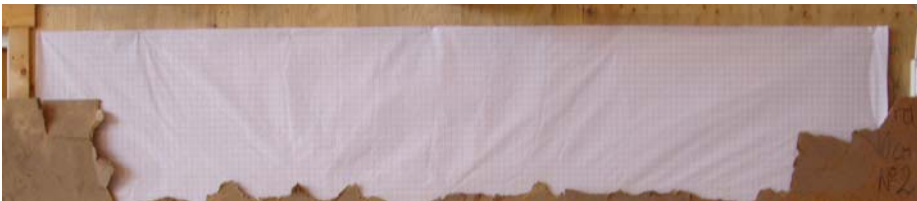
Clearance depth about 30-35 on all boards.

The depth of penetration on all witness boards was 35 cm. The time was 4.59 min/ 25 m.

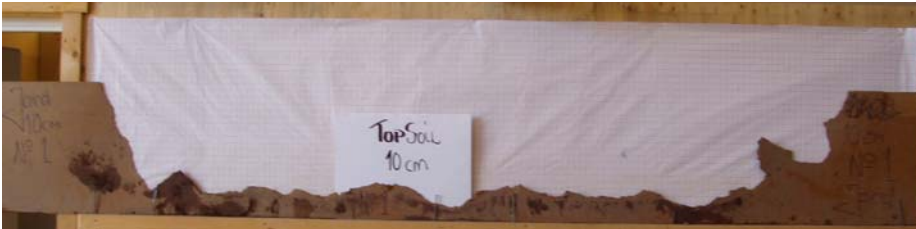
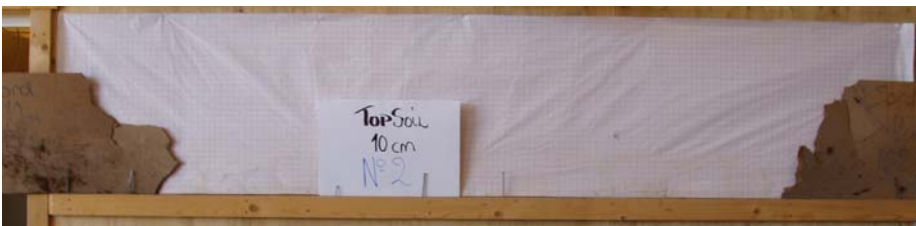
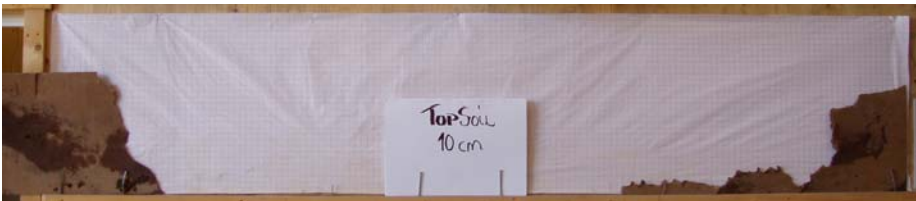
Clearance depth by board 1 about 30 cm, board 2-3 over 40 cm.

The depth of penetration on first witness board 35 cm, second and third witness boards over 40 cm. The time was 4.32 min/ 25 m

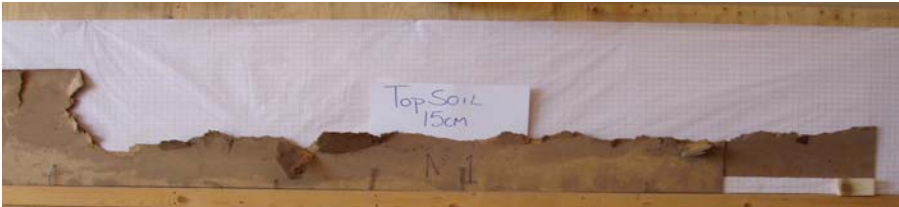
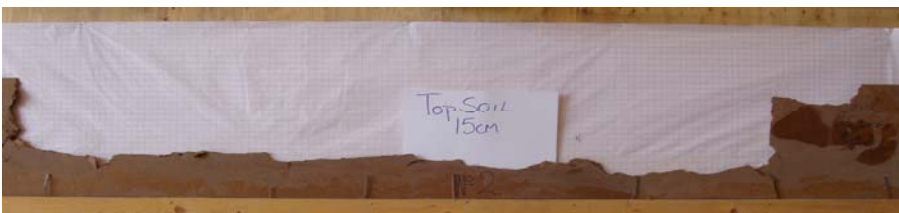
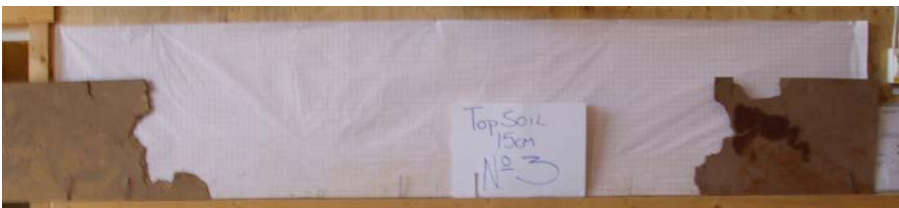
Clearance depth; board 1 20-25 cm, board 2 about 25 cm and board 3 over 40 cm.

The depth of penetration on the first witness board 25 cm, second witness board over 30 cm and the third witness board over 40 cm. The time was 6.20 min/ 25 m

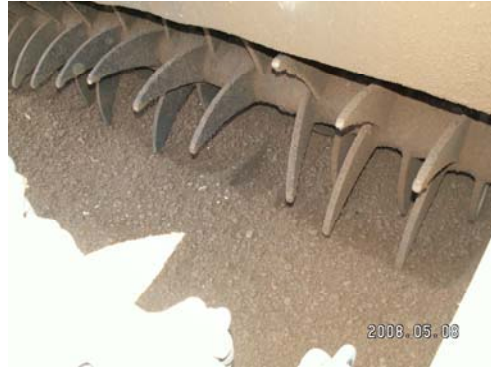
Figure 40, Tiller after AT mine

The 8 kg detonations only had a small effect on the machine. During the try only two chains with tools were destroyed and the tiller had some minor damage as one bend tiller tooth. The machine had no problem to continue to work after these tests. The time to fit new tools will take about twenty minutes. The Video and figures are stored at SWEDEC.

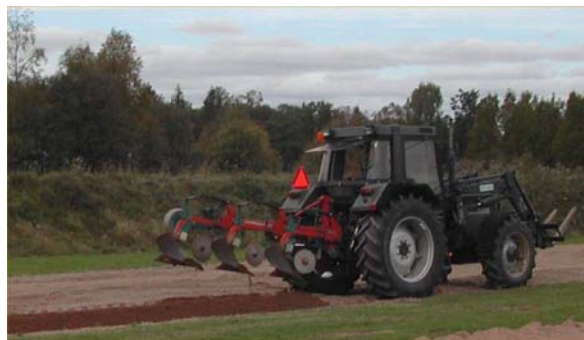
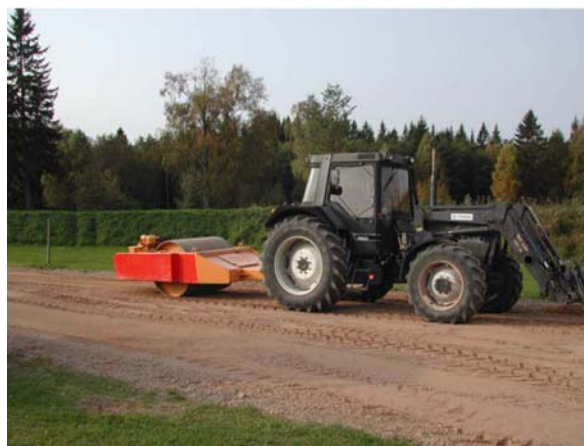
Figure A-1. Soil Preparation – Loosening and compacting the soil

The test facilities at Norra Kulla, near Eksjö, have been used to test various types of equipment in recent years. The site has three soil environments specifically for performance tests. Parallel lanes 5 m wide and 100 m long provide compacted sand, compacted gravel and compacted topsoil. The sand and gravel lanes are easily replicated almost anywhere. As the characteristics of topsoil may vary from one location to the next, data from the topsoil lane may not be quite as repeatable. The soil in each test lane is prepared as follows. Prior to a test the soil is loosened with ordinary agricultural or construction equipment, and then compacted using the vibratory compacter as shown in **Figure A-1**. The soil compaction and moisture content are monitored until the compaction reaches a defined level for that soil type. Compaction and moisture content are measured using the CPN International model MC-3 Portaprobe.

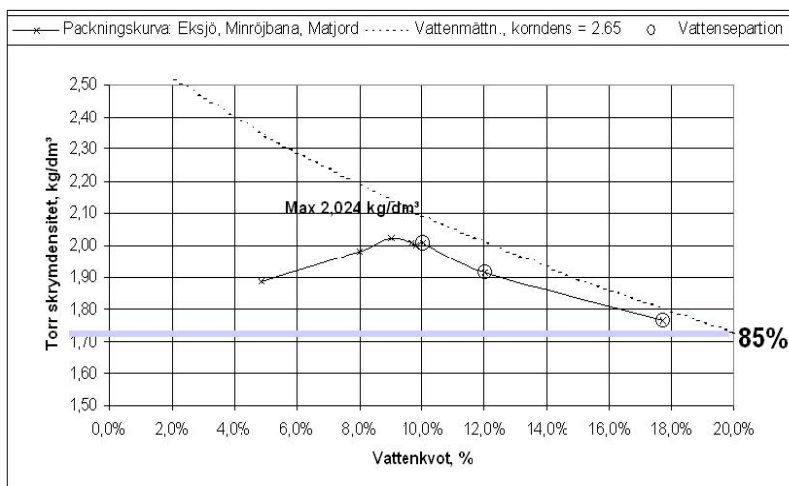
Figure A 2

An example of a soil analysis for the topsoil is shown in Figure A-2. In this Swedish language chart, the horizontal axis refers to the moisture content (by weight), while the vertical axis shows the density, with a maximum occurring at 2.024 kg/dm³. A 95% compaction level (approximately 1.9 kg/dm³) can only be achieved with soil moisture contents between 6% and 12%; this might restrict testing if the moisture content were out of range on a given day. By comparison, compacting the topsoil to approximately 1.7 kg/dm³ results in the soil reaching 85% of its theoretical maximum compaction. For the topsoil this is a useful target since it can be achieved without undue difficulty, and also because it is achievable over a wide range of moisture contents up to 18% or greater. Similar analyses were done to select the compaction levels for the sand and gravel areas. Target compaction levels for the three soils were:

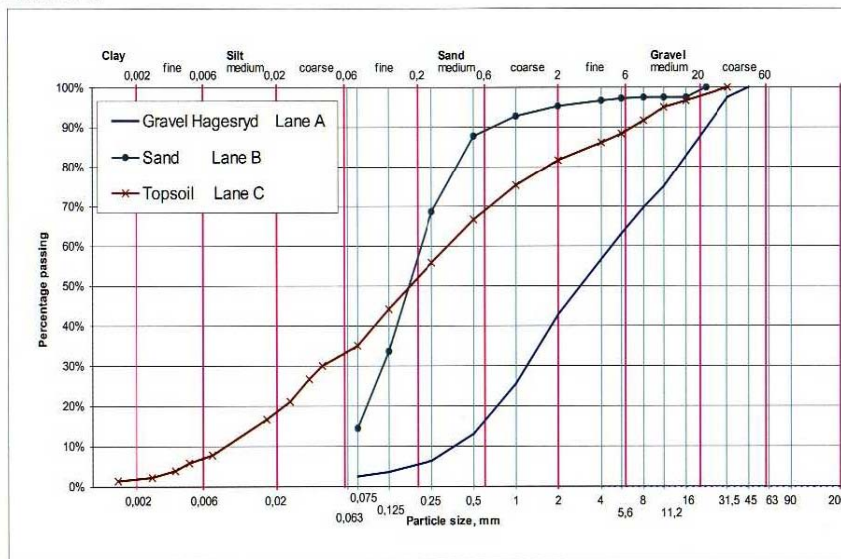
Figure A 2

Samples from the sand, gravel and topsoil areas were analyzed to determine particle size distribution, with Figure A-4 showing the results.

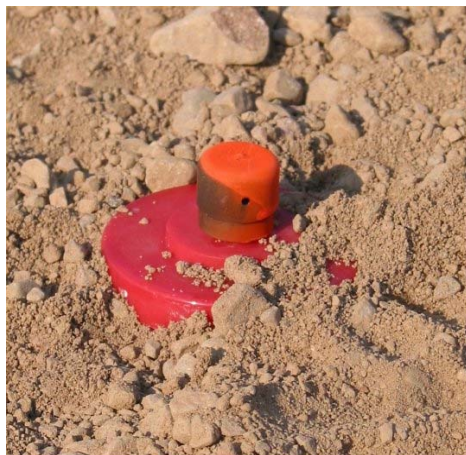
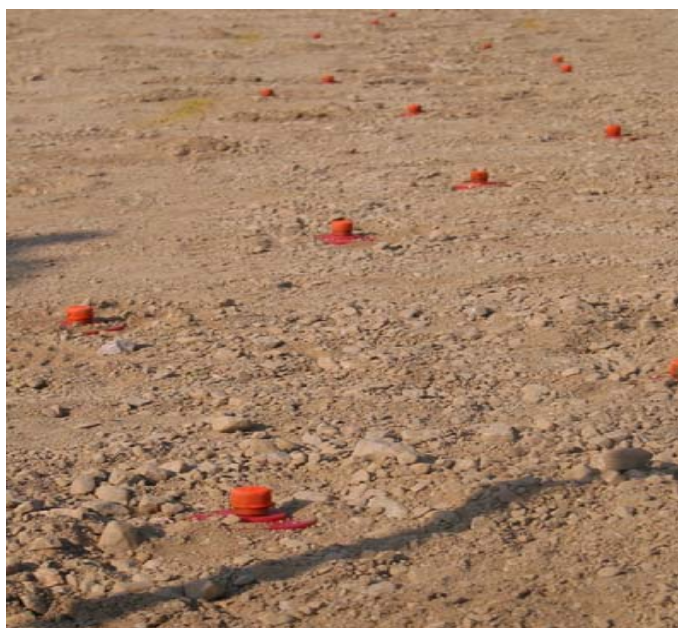
The test targets used in this trial were the standard SWEDEC mine surrogates shown in **Figure A-3** and **Figure A-4**. The targets make use of live fuzes from the m/49 anti-personnel mine installed in inert, plaster-filled plastic bodies. These targets closely replicate many typical small antipersonnel land mines, which a machine might be expected to encounter.

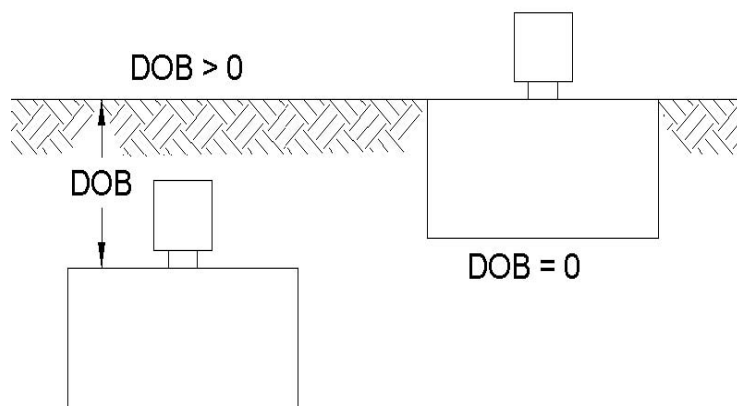
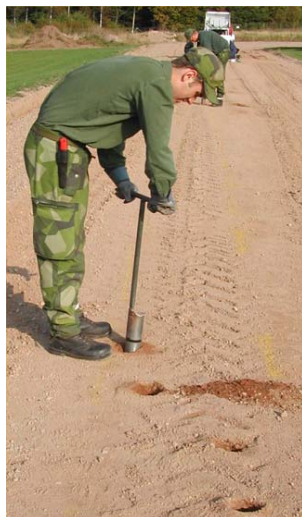
In all cases, the mines are buried as shown in **Figure A-6**. The depth of burial (DOB) is measured from the top surface of the mine (not the top surface of the fuze), to the ground surface. Hence, a burial depth of 0 cm is illustrated in **Figure A-5**, above. To minimize soil disturbance, the tool shown in **Figure A-6** was used to pull out a soil core just slightly larger than the mine body. The live fuzes are installed moments prior to the beginning of the test.

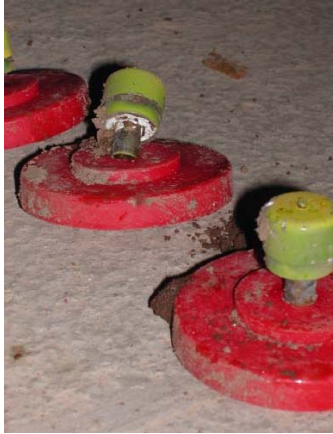
Figure A 7

- Damaged, non-functional - Targets in this condition have not been triggered, but have been broken apart to the point where they can no longer function. This may be as simple as having removed an intact, functional fuze from an intact mine body or it may be a complete mechanical shredding of all components of the mine and fuze. Examples are seen in Figure A-7-8, in which the top row shows intact functional targets missed by a machine. The second row shows fuzes separated from their mine bodies and fuzes still attached to the upper parts of the mine bodies but separated from what would, in a real mine, be the main explosive charge. The bottom row shows the lower bodies of targets which were broken apart without triggering the fuze and where the bulk of the plaster (the main charge in a real mine) remains intact.

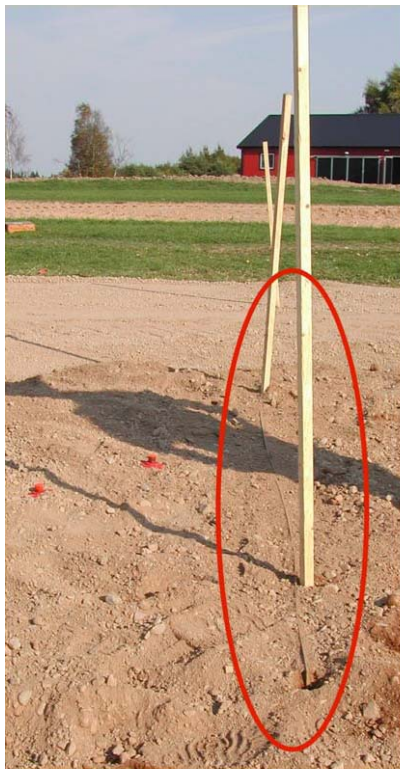
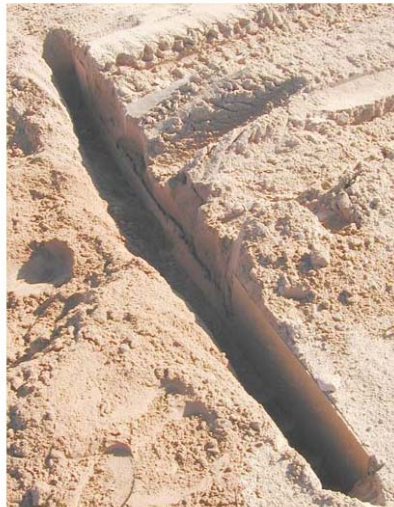
Figure A 9

Along with the mine targets, witness boards are installed at three locations across each lane. At the start, middle and end of each test area, 3mm thick, 400 mm tall oil hardened (water resistant) fibreboards are installed across the full width of the flail head. Buried flush with the surface as shown in Figure A-9, the boards act as witness panels to record the depth of penetration of the tiller/flail hammers. This technique does not record the force with which the hammers strike, but it does give a clear, unambiguous indication of depth of penetration. Figure A-13 also show a typical example of the witness boards after a test when some of the neighbouring soil has been removed to expose the boards.

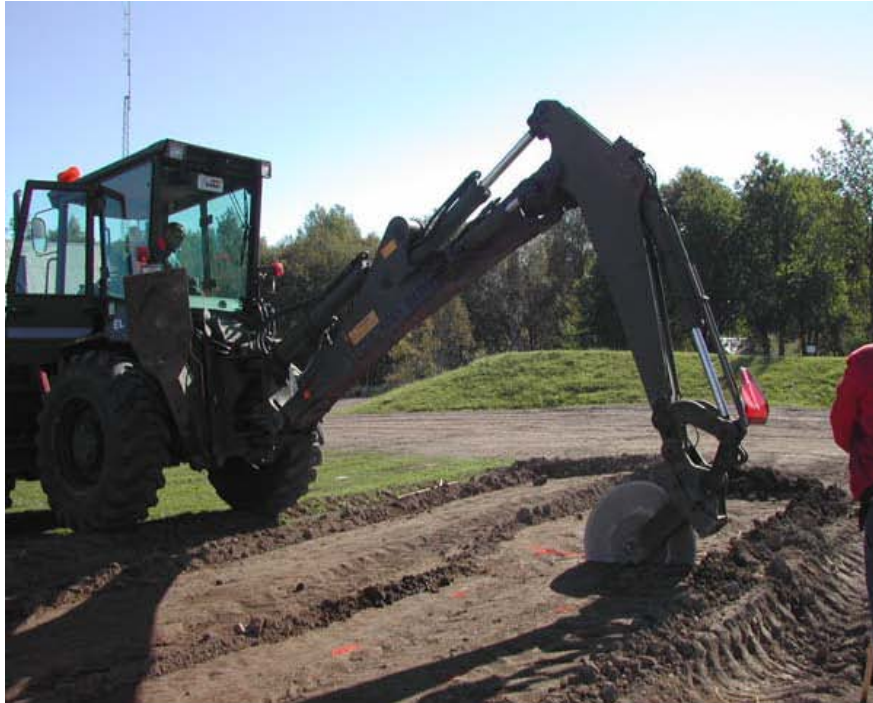
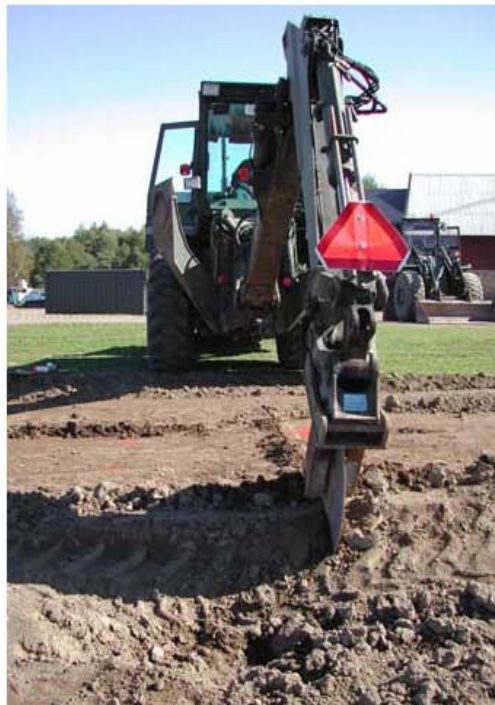
Figure A 10

A simple 'pizza cutter' tool was devised to make installation of the witness boards quick and easy without excessive disturbance of the surrounding soil. This tool, shown in Figure A-10, works very well in sand, topsoil and gravel.
