THE MgM ROTAR SYSTEM, A NEW PATH IN HUMANITARIAN DEMINING

EVALUATION AND TEST REPORT

Written by Håvard Bach

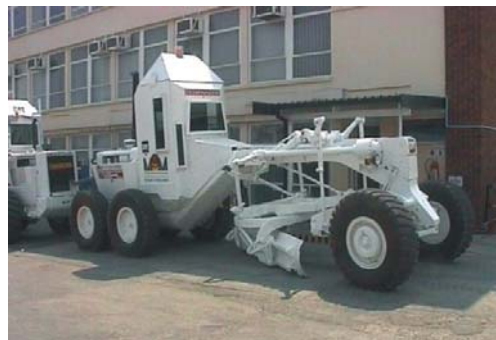
The new MgM grader. The mine protected cabin is similar to the cabin on the MgM ROTAR

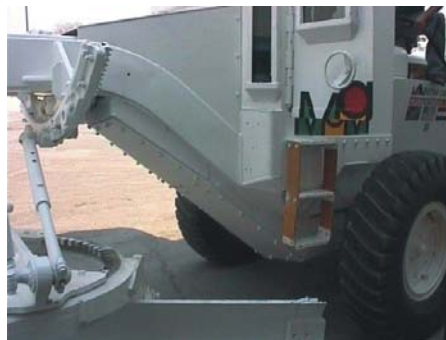
All vital areas have been protected with armoured plates.

The ROTAR consists of an armoured front loader with a rotating sifter bucket mounted to the front end. The front loader is a refurbished and armoured Caterpillar 916. The cabin is mine proof and all vital areas have been protected with armoured plates. Like all other front loaders the Caterpillar 916 is hinged at the middle which makes the machine easy to manoeuvre in restricted areas. Anti-tank mines would probably inflict serious damage to the machine. The ROTAR is therefore only intended to be used in areas where no anti-tank mines are suspected.

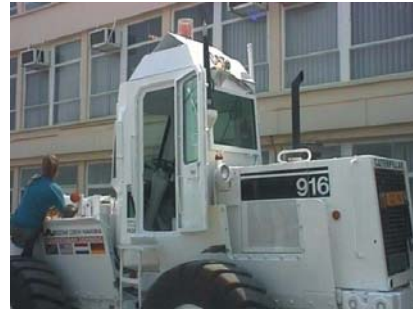
*Armoured plates can be seen on the sides of the machine.
The black antenna socket is for HF communication*

The cabin is made from 6 mm ballistic steel plates with bullet/fragmentation proof windows on all fire sides. Because of the armouring and sealing, it has been necessary to install an air condition inside the cabin. The cabin is also fitted with HF, VHF and HF PGS radio communication equipment.

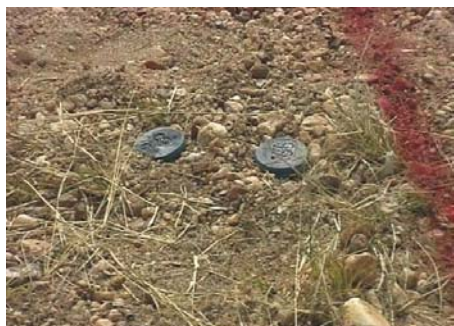
The 50 meter long and 1 meter wide test field after marking and placement of 100 dummy mines (test one)

The first test was undertaken on flattish land with soft sandy soil with a high density of small rocks. The soil had been prepared mechanically by someone else (not MgM) before the test which made the consistence very loose. A 1 x 50 metre straight lane was prepared and marked and 100 AP mines where surface laid inside this lane. The distance between each mine was approximately 50 cm. The mines, which had been numbered from 1 to 100, were laid in a numbered order, meaning that mines with low numbers would be cleared first while mines with high numbers would be cleared last.

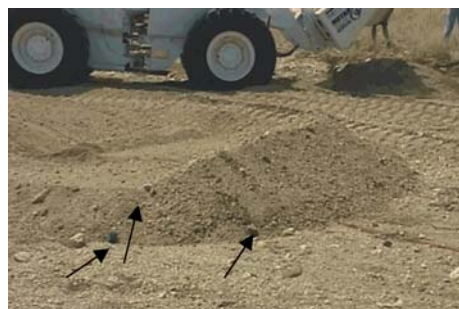
Mines can be seen in the front of the berm almost two meters to the side of the original test line.

When the ROTAR excavated, soil was pushed to both sides of the bucket meaning that mines that have been pushed out of the suspected area could easily be pushed back into the cleared area. The MgM ROTAR tried to deal with this problem by re-clearing the cleared area with the newly created berm. Theoretically mines could then be pushed further into already cleared areas. The only way to be sure that no mines had escaped was to lift all the soil out of the area and sift it. Due to the sandy and loose surface, much of the sand actually ran out of the sifter and back onto the same
