SWEDISH EOD AND DEMINING  
CENTRE

### **Test and Evaluation Report For FREELAND 3000**

**FREELAND 3000 Test and Evaluation  
August 2008**

**Abstract**

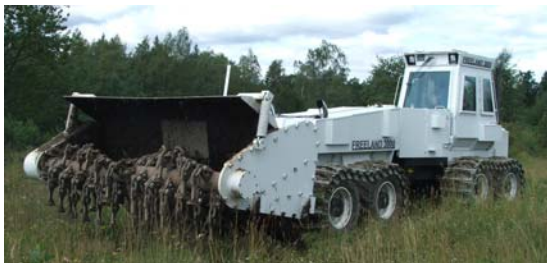
Figure 1. Freeland 3000

The FREELAND 3000 ground clearing flail is operated from the cabin on the machine. The Freeland 3000 is built on an ROTTNE F9 and the engine for the flail is an DUETZ double turbo. The manufacturer Complete Demining AB had built Freeland 3000.

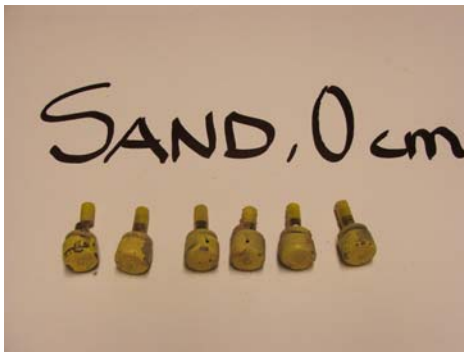
Figure 1, Sand 0 cm

After each test in the series, the test lanes were searched as described above, and the materials of interest were assembled and inspected. These materials included fuzes, fuze components, intact mine targets, and mine bodies with most of or the entire (inert) main charge intact. The photos in figures 1-3 show the collected debris.

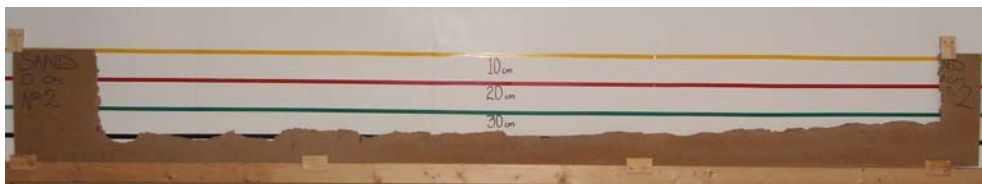
Figure 5. Sand 2, 0 cm.

Sand witness board: mine DOB surface 0 cm

The first witness board had a penetration to 20cm, the left side of the witness board had not the same depth it could depend on that the board had been bend. The second and third board had a penetration to a depth of 25-30 cm.

Fourteen of the witnessboards are showing an inclination from the right to the left. This could depend on that the flail aggregate not is in balance, it could deepen on the weight on one side of the aggregate. This problem is necessary to analyse.

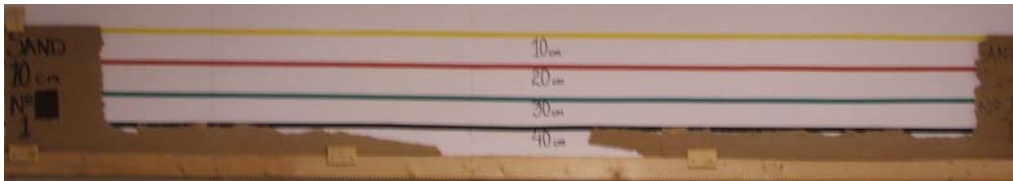
Figure 7. Sand 1,10 cm

Sand witness board: mine DOB surface 10 cm

The first witness board had a penetration down to 30 cm.

The second board showed penetration down to 25 cm and the third board down to 20 cm.

The distant between the first board and the third board is 25 m and the difference in depth is up to 10 cm.

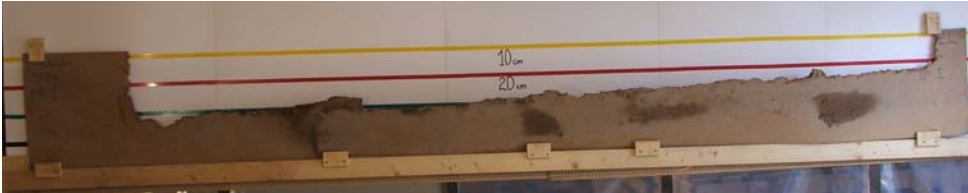
Figure 13. Gravel 1, 0 cm

Gravel witness board: mine DOB surface 0 cm.

The first board had a penetration down to 20 cm but it is a different in depth from the right to the left side up to 10 cm.

The second board and the third board showed a penetration down to 20 cm but it is a different from the right to the left side on both boards up to 5 cm.

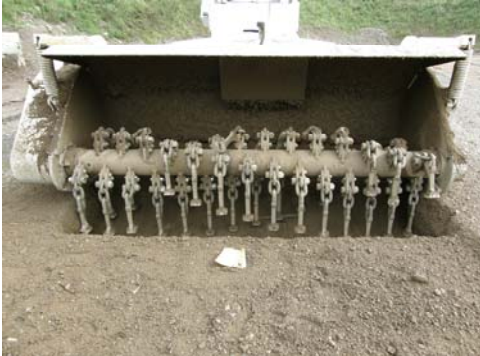
Figure 39: Placed AT mine m/41-47 in front of flail.

Following preparation of the test lane and installation of the mines as described above, the machine was prepared for a test run. The machine was positioned about 8 metres in front of the start of the test lane to allow the driver to get the machine operating in a consistent stable manner prior to the start of the lane. Then the mine was placed just in front of the flail. The camera was started and all personnel went into the safe house.

The machine was left in run with engine and flail.

The mine was triggered remotely.

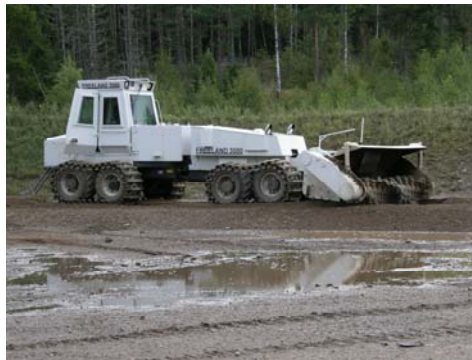
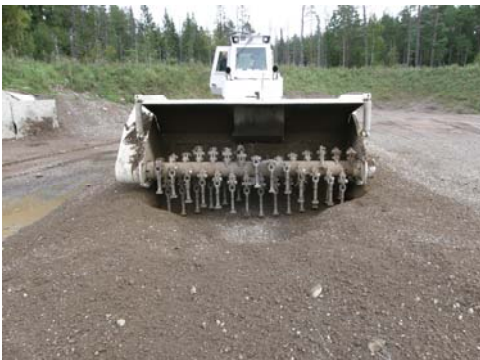
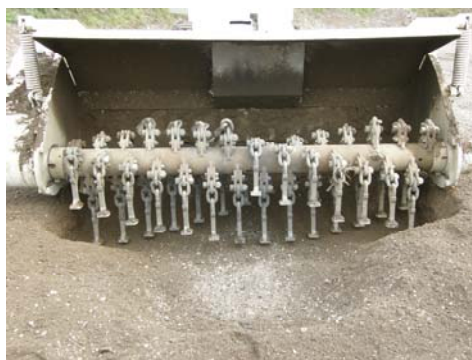
Figure 42, After detonation

The machine suffered no damage from the mine. No tools were missing. The machine could operate again after five minutes.

The 8 kg detonations had no effect on the machine. The machine had no problem to continue to work after these tests.

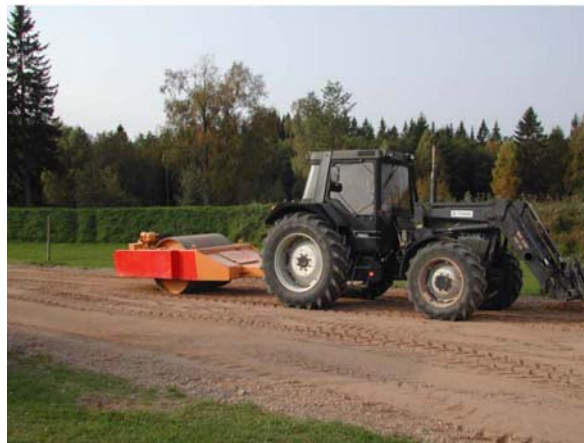
The test facilities at Norra Kulla, near Eksjö, have been used to test various types of equipment in recent years. The site has three soil environments specifically for performance tests. Parallel lanes 5 m wide and 100 m long provide compacted sand, compacted gravel and compacted topsoil. The sand and gravel lanes are easily replicated almost anywhere. As the characteristics of topsoil may vary from one location to the next, data from the topsoil lane may not be quite as repeatable. The soil in each test lane is prepared as follows. Prior to a test the soil is loosened with ordinary agricultural or construction equipment, and then compacted using the vibratory compacter as shown in **Figure A-1**. The soil compaction and moisture content are monitored until the compaction reaches a defined level for that soil type. Compaction and moisture content are measured using the CPN International model MC-3 Portable.

*Figure A-1. Soil Preparation – Loosening and compacting the soil*

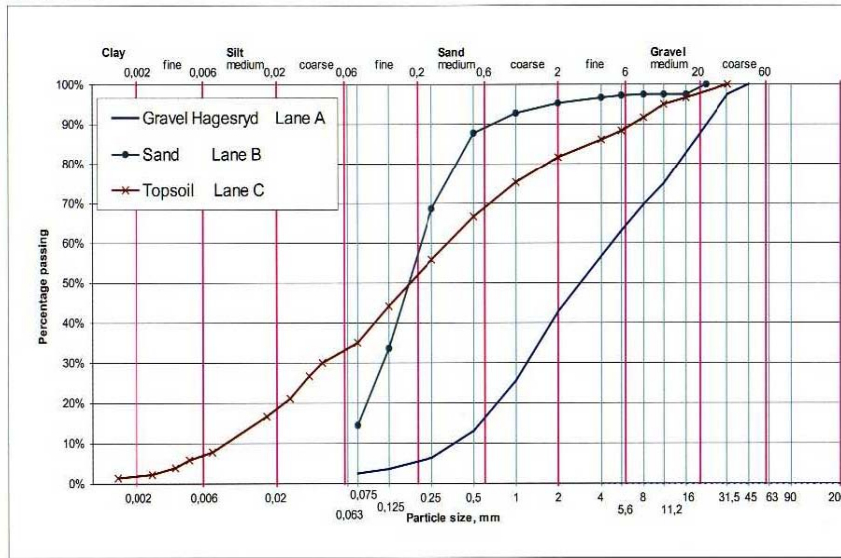
Lane A-C

Samples from the sand, gravel and topsoil areas were analyzed to determine particle size distribution, with Figure A-4 showing the results.

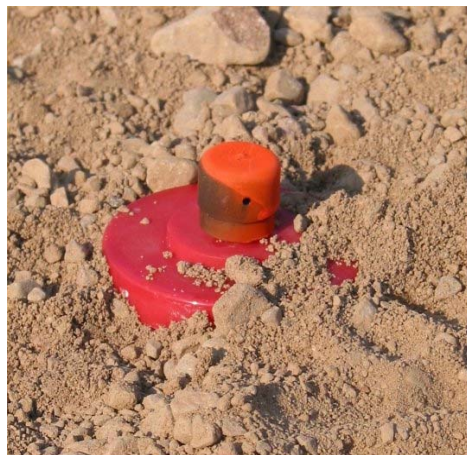
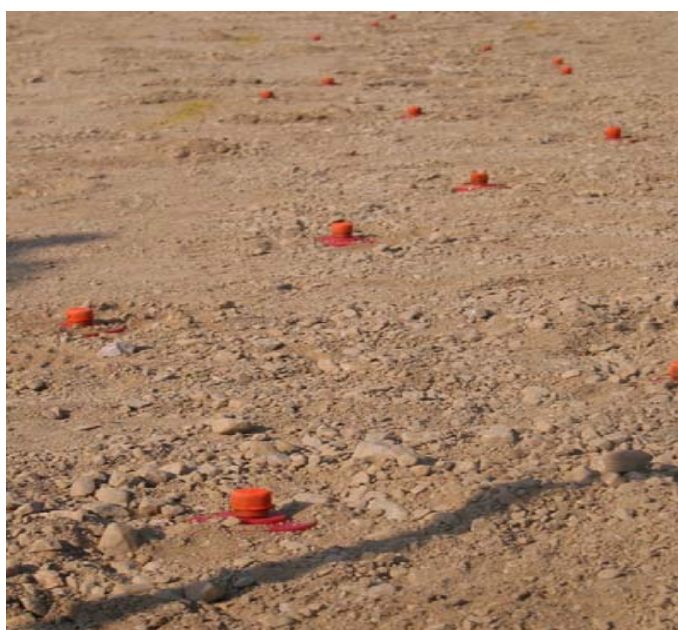
The test targets used in this trial were the standard SWEDEC mine surrogates shown in **Figure A-5** and **Figure A-6**. The targets make use of live fuzes from the m/49 anti-personnel mine installed in inert, plaster-filled plastic bodies. These targets closely replicate many typical small antipersonnel land mines, which a machine might be expected to encounter.

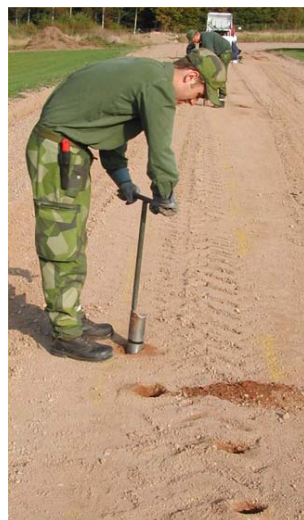
Figure 7-8

In all cases, the mines are buried as shown in **Figure A-7**. The depth of burial (DOB) is measured from the top surface of the mine (not the top surface of the fuze), to the ground surface. Hence, a burial depth of 0 cm is illustrated in **Figure A-5**, above. To minimize soil disturbance, the tool shown in **Figure A-8** was used to pull out a soil core just slightly larger than the mine body. The live fuzes are installed moments prior to the beginning of the test.

DOB – Subsurface    DOB – Surf

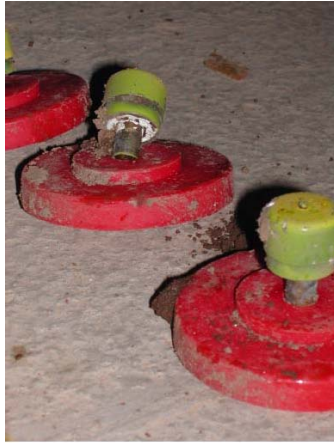
- Damaged, non-functional - Targets in this condition have not been triggered, but have been broken apart to the point where they can no longer function. This may be as simple as having removed an intact, functional fuze from an intact mine body or it may be a complete mechanical shredding of all components of the mine and fuze. Figure A-10 shows three example of this condition. From left to right, they include (i) a broken fuze torn from the main charge, (ii) an intact fuze torn from the main charge, and (iii) an intact main charge without a fuze. While not explicitly required, data was also recorded to indicate non-triggered fuzes found separated from their respective mine bodies after each trial. Examples are seen in Figure A-11, in which the top row shows intact functional targets missed by a machine. The second row shows fuzes separated from their mine bodies and fuzes still attached to the upper parts of the mine bodies but separated from what would, in a real mine, be the main explosive charge. The bottom row shows the lower bodies of targets which were broken apart without triggering the fuze and where the bulk of the plaster (the main charge in a real mine) remains intact.

*Figure A-10. Level of damage – Damaged, non-functional*

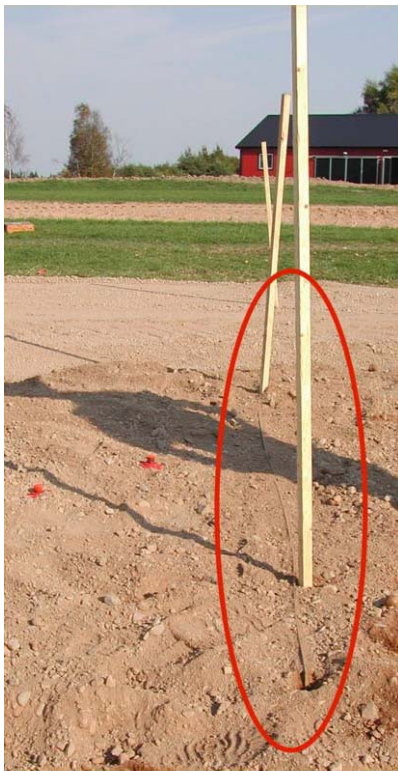
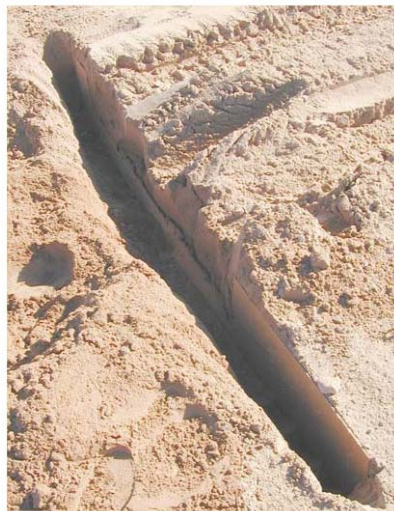
**Figure A-13. Witness Panels**

Along with the mine targets, witness boards are installed at three locations across each lane. At the start, middle and end of each test area, 3mm thick, 400 mm tall oil hardened (water resistant) fibreboards are installed across the full width of the flail head. Buried flush with the surface as shown in Figure A-13, the boards act as witness panels to record the depth of penetration of the tiller/flail hammers. This technique does not record the force with which the hammers strike, but it does give a clear, unambiguous indication of depth of penetration. Figure A-13 also show a typical example of the witness boards after a test when some of the neighbouring soil has been removed to expose the boards.

Ready For Test

After Test

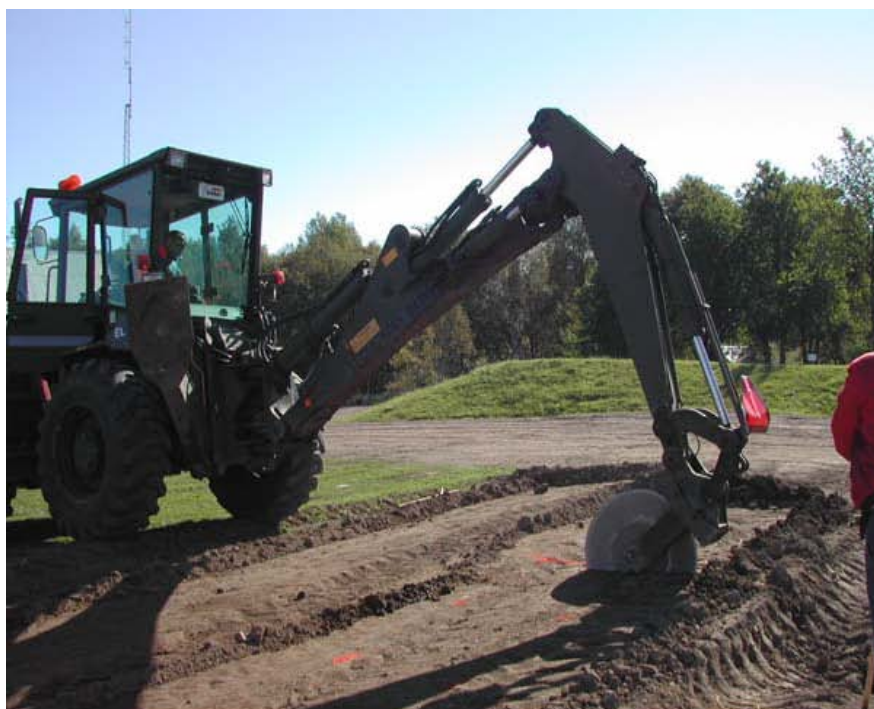
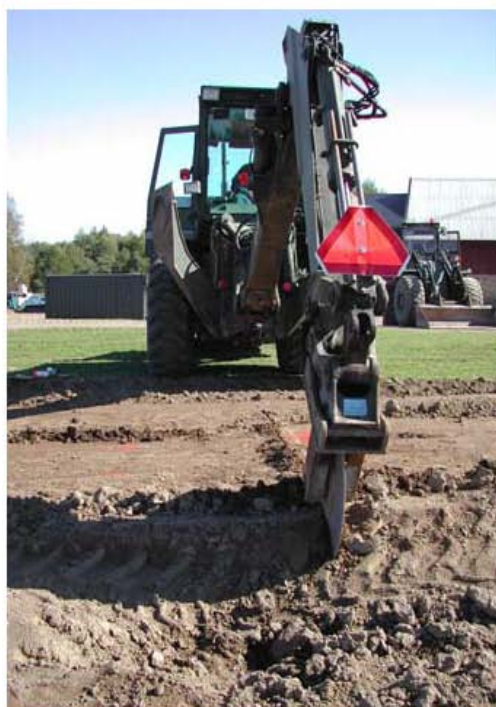
A simple 'pizza cutter' tool was devised to make installation of the witness boards quick and easy without excessive disturbance of the surrounding soil. This tool, shown in Figure A-14, works very well in sand, topsoil and gravel.

**Figure A-14. 'Pizza Cutter' used to install witness panels**
