TEST AND EVALUATION

VOLVO L90 ARMOURED FRONT END LOADER **& ALLU SCH 4-25 CRUSHING AND SCREENING BUCKET**

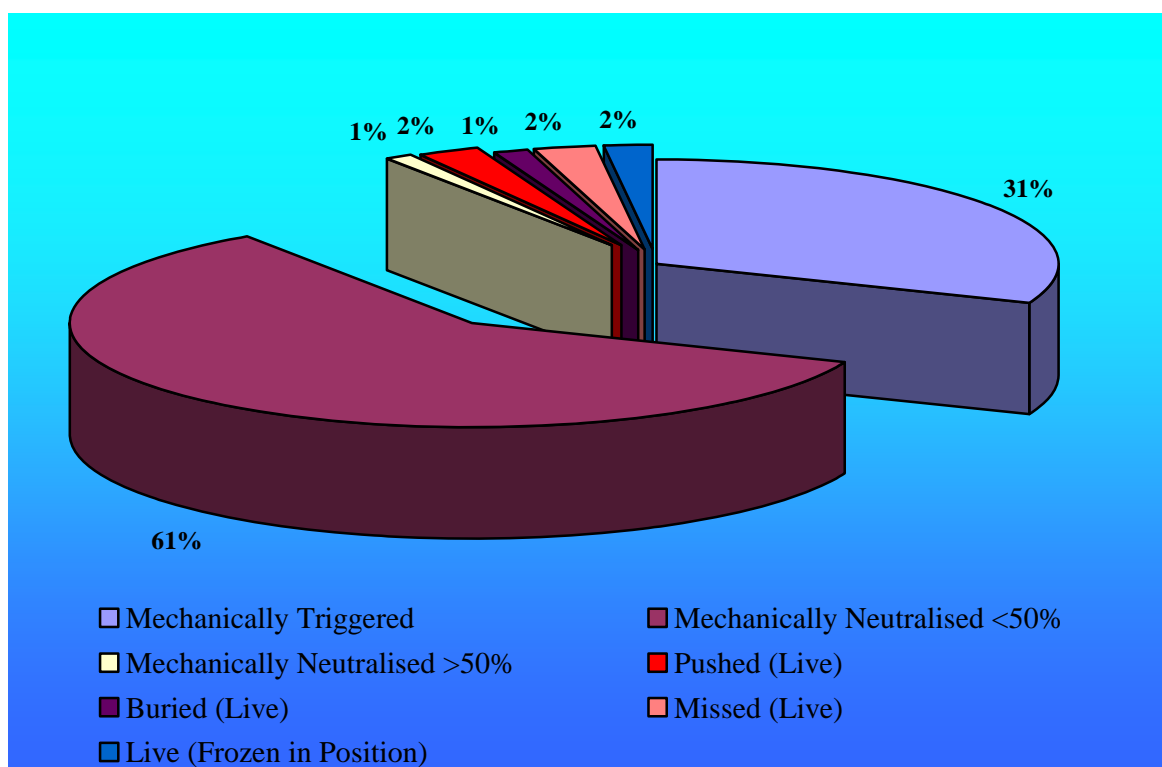
Overall Statistical Summary of Soil Processing of Contaminated Land – AP MINES

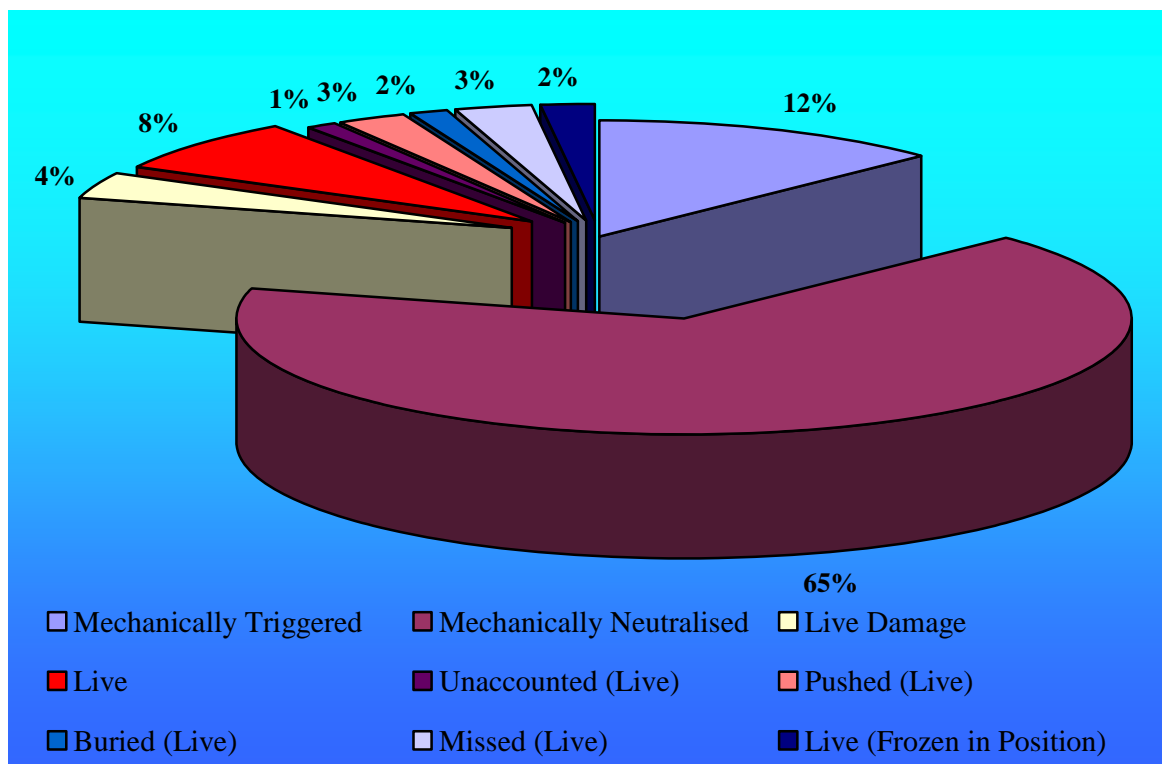
Overall Statistical Summary of Soil Processing of Contaminated Land - FUSES

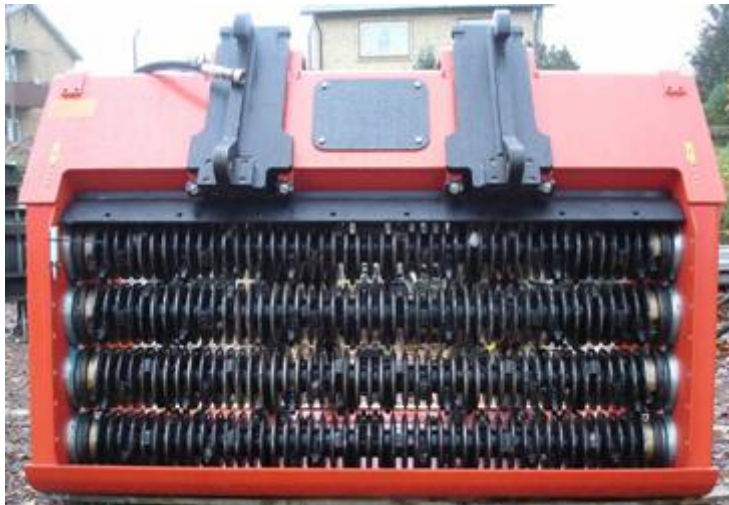
In contrast to previous variants, the ALLU SCH 4-25 bucket employs a specially designed drum configuration, where the spacing interval has been considerably reduced to a set size of 23mm x 48mm. This was based on recommendations made to the manufacturer, explaining some of the likely difficulties experienced when working landmine and UXO contaminated areas.

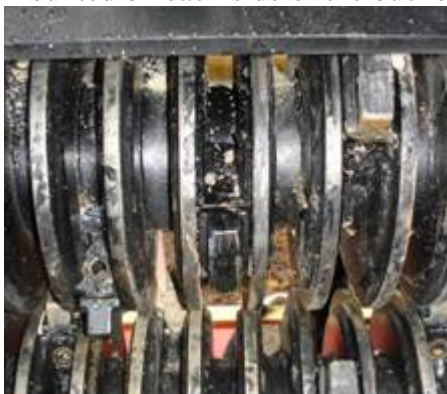
The screening set size is based on a unique drum design, where hardened discs are placed on a solid steel shaft, at intervals of 35mm. Blades and blade holders are then welded into position between each set of discs. The combination of disc spacing and blade position prevent any object greater than the set size of 28mm x 48mm passing through.

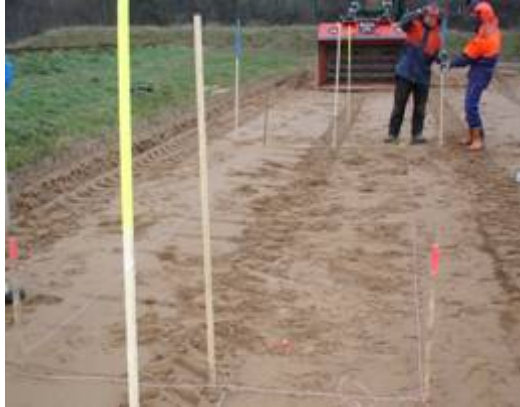
Completion of lane setup for Serial 1B Sand

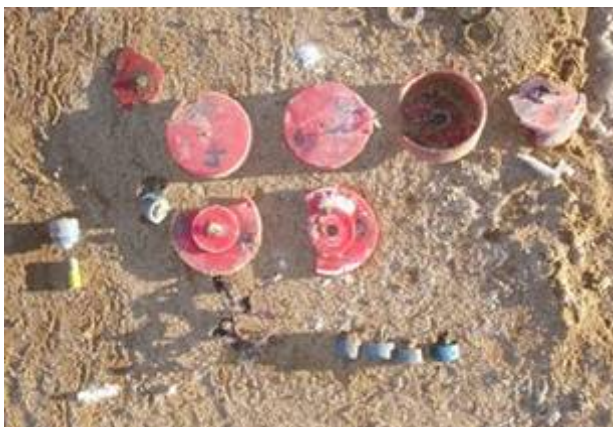
An example of surrogate AP mines after processing through the bucket. All targets have either been triggered or mechanically neutralised. Fuse states can also be identified.

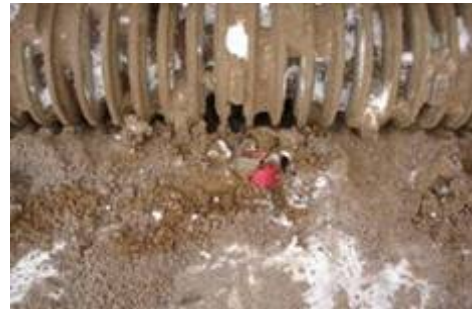
When excluding extreme weather conditions, the only other possible cause identified for “resting” mines was the counter blade, where mines are shifted through the action of the rotating drum. Items which are caught in this area of the drum may be held there through the sharp angles. As no further cases of “resting” mines were found, this particular idea could not be credited or discredited.

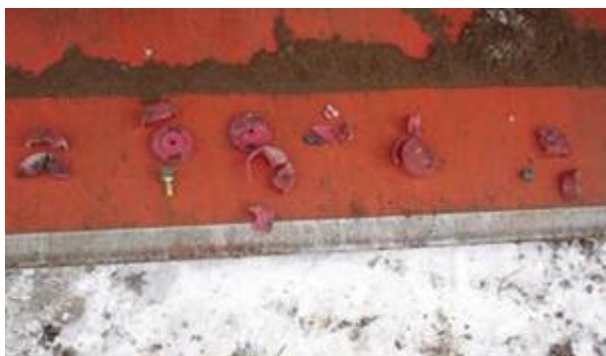
Photo of surrogate mine results from Stage 1 Function Test Serial 4/D Gravel

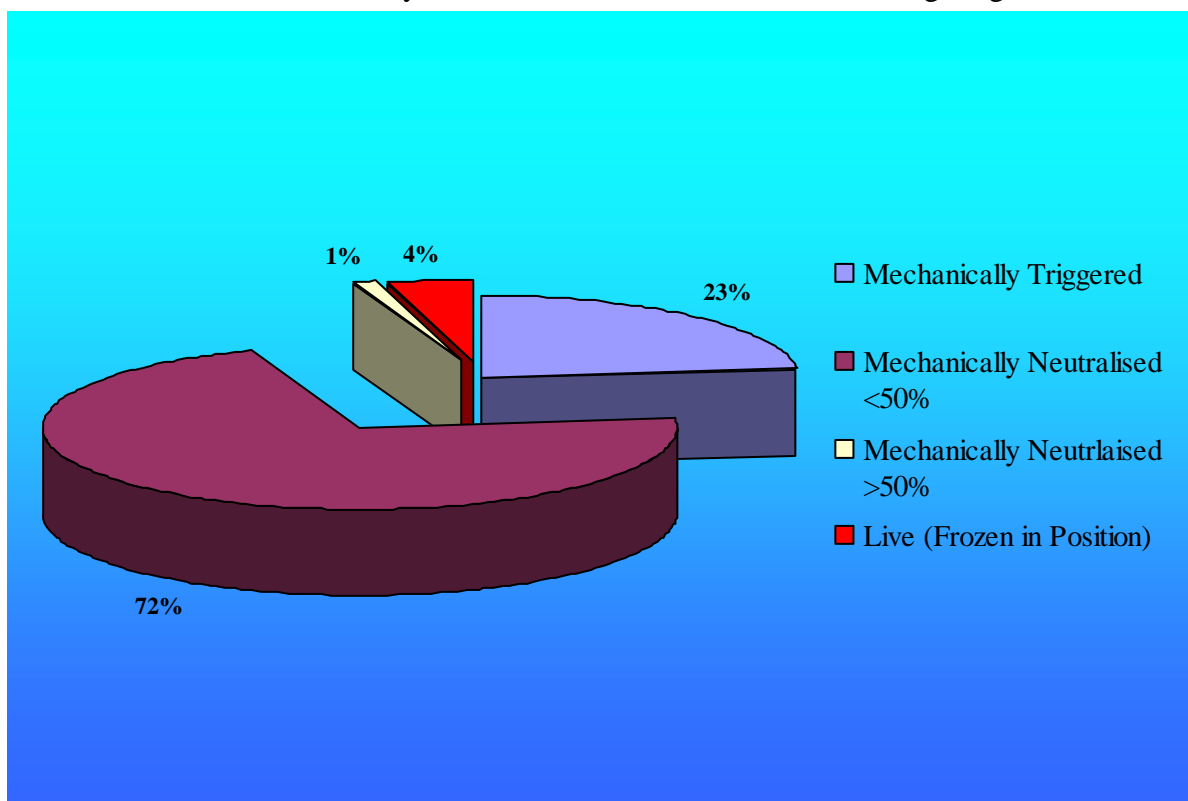
Although the residual threat of fuses remains, the action of the bucket lowers the risk factor dramatically. Demining staff can be confident in the fact that complete, intact anti personnel blast mines will not be found in processed soil.

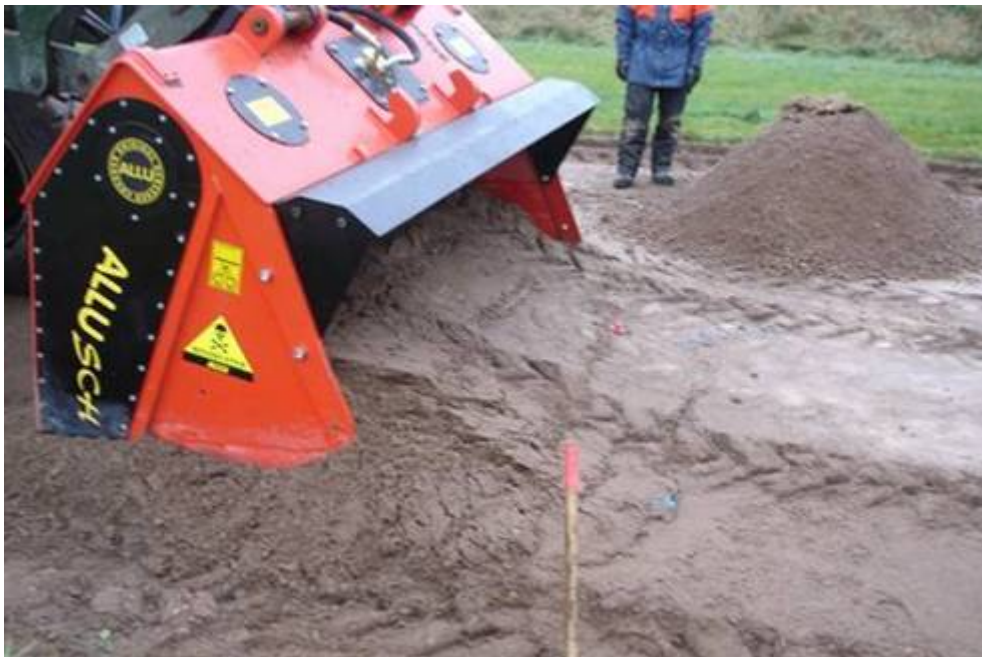
View of lane excavation nearing completion

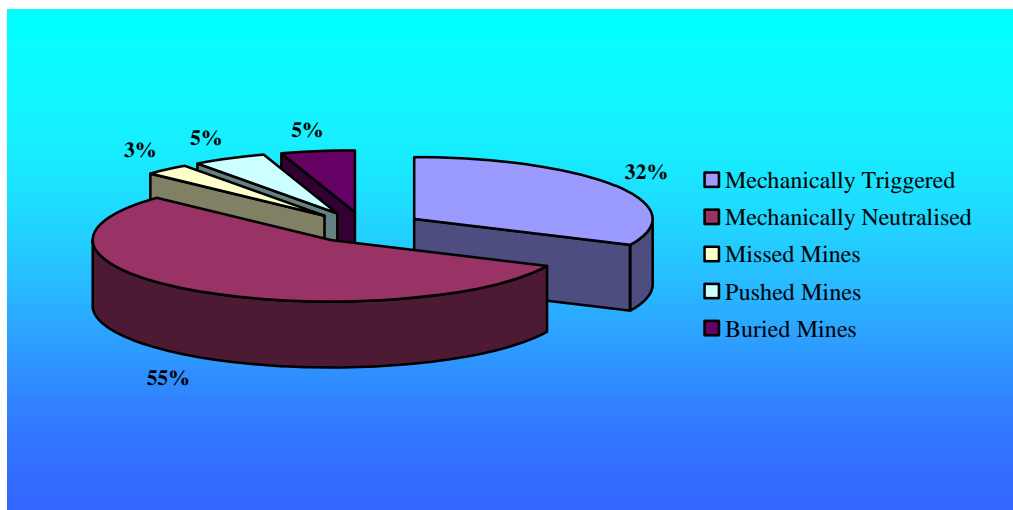
Various test targets during Stage 2 testing were recorded as either missed, buried or pushed during excavation evaluations (refer to above graph). These cases are related to performance data and details on these test targets are described in section 6.1 ALLU SCH 4-25 Performance Results.

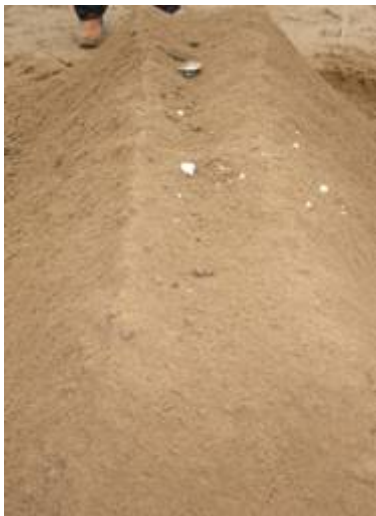
Although a very low number of targets were used, the overall results were extremely positive, with the bucket achieving 83% in activating the mines. The remaining two items were mechanically neutralised during processing.

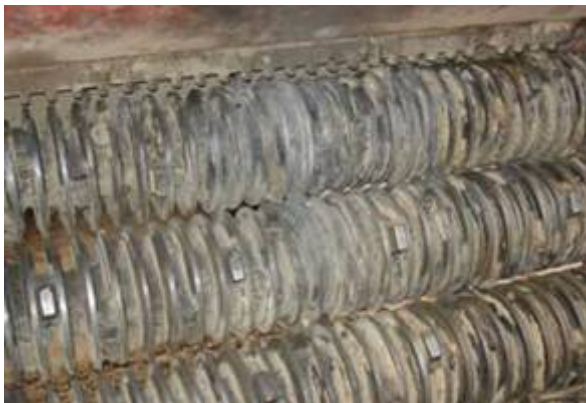
This photo shows the detonation of an M49 on the top drum. Damage to the drum was negligible. A gouge in the bucket frame was noted, yet evidence of cracked or chipped discs could be found. It was assumed that the metal washer fitted to the mine as a safe guard was the cause.

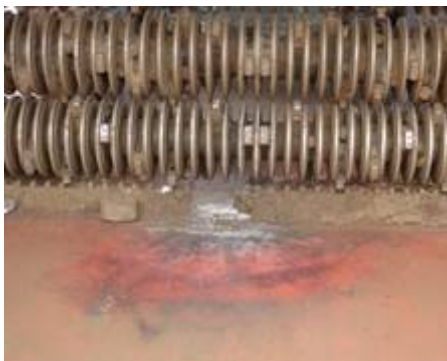
Photo of Serial 2A – M49

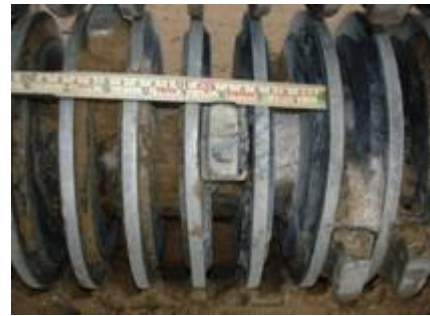
The drums have proven to be manufactured in such a way to withstand multiple blasts, sustaining very minor damage overall. The slight separation of the discs during serial 1C highlighted the possibility that a mine could end up sideways, wedged between discs. The fact that it detonated is positive and underlines the reliability of the drum crushing action.

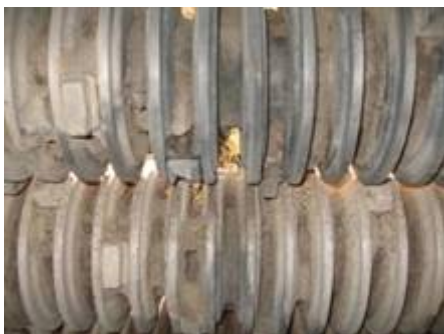
Damage from the blast directly on the discs was minimal, causing slight deformation of the disc edges and cracking a hardened blade.

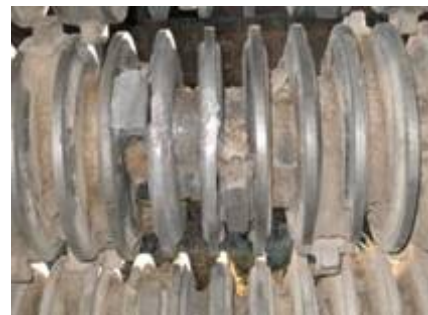
Serial 1A complied directly with previous test conducted during Stage 3 Phase 1, where the damage from a detonation directly on the drum centre caused minor deformation to the discs and fractured a blade

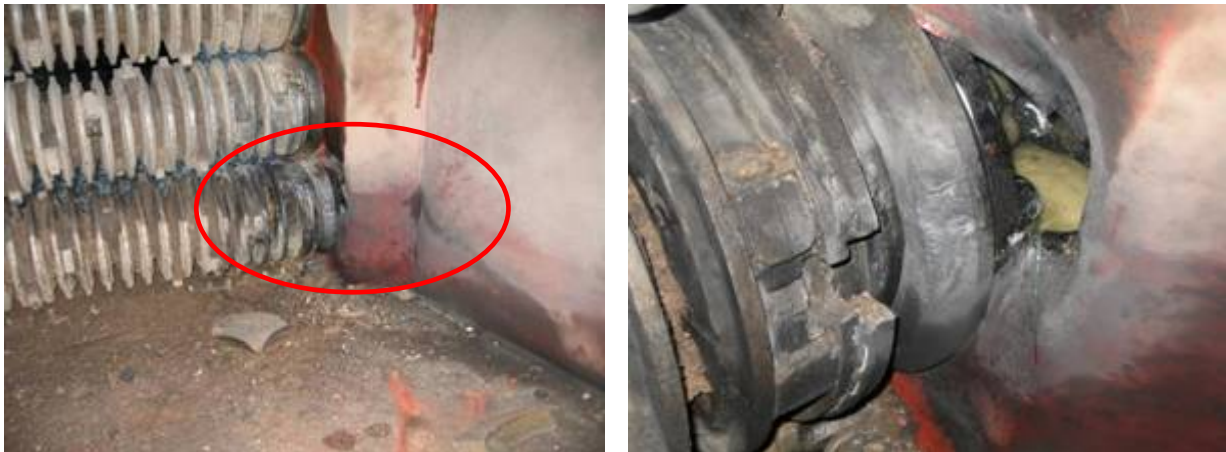
The blast physically cut through the housing wall, exposing the inner chain drive mechanism and lubricant.

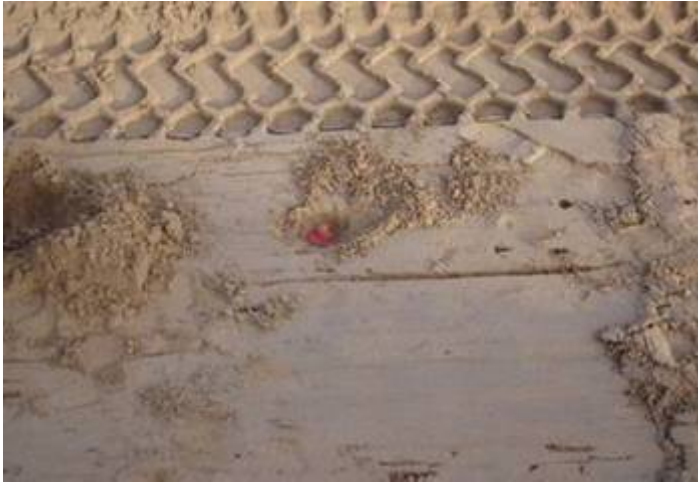
Photo of missed mine #1 from serial 1/A. Located during the follow up phase using detector.

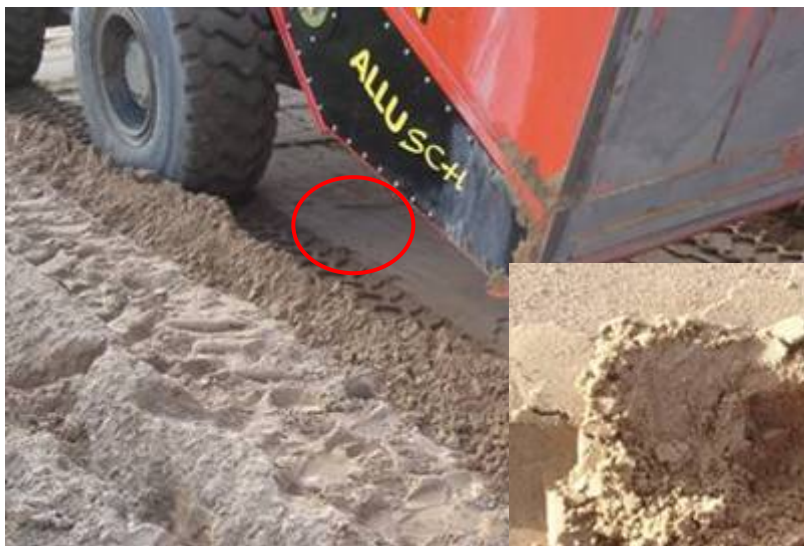
The potential risk of missed mines is clearly visible here.

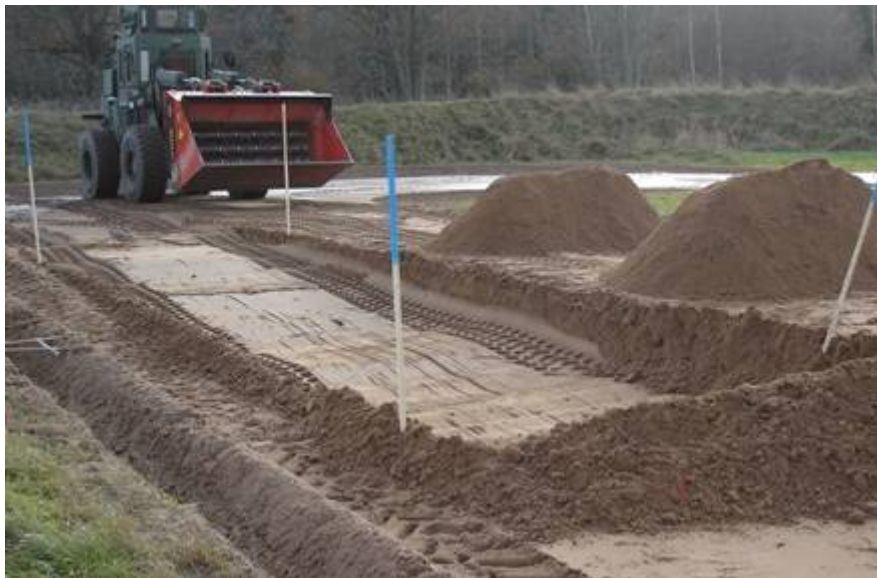
Stage 2 Phase 1 Serial 1A

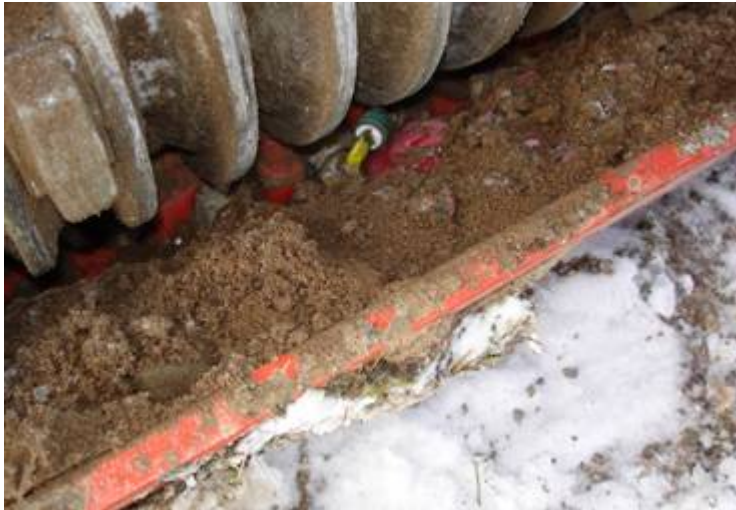
Fuse located on the rear skirt behind the bottom drum.

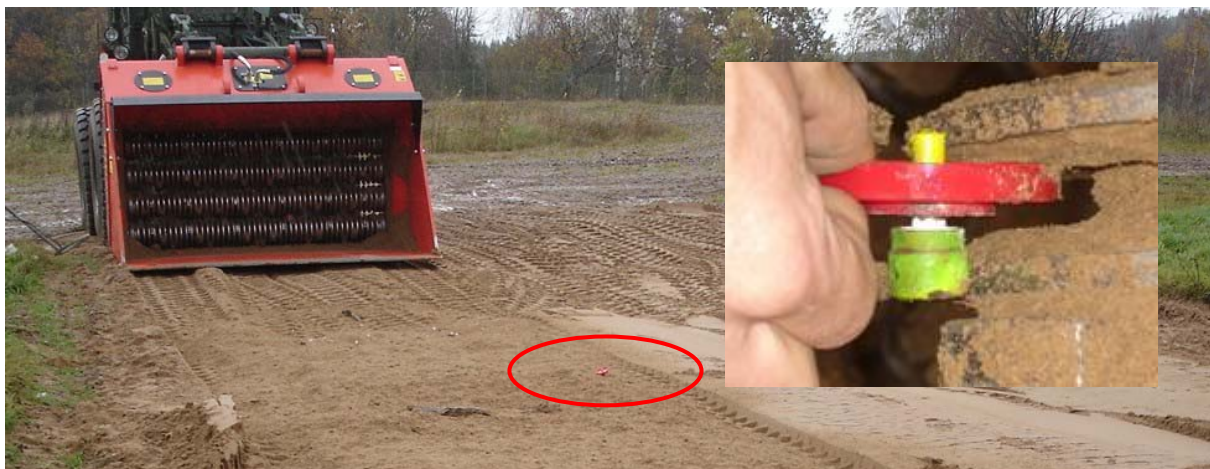
View of thrown fused top plate. The insert shows that a complete Top Plate, with fuse, cannot pass through the drums without receiving some form of damage from the rotating blades

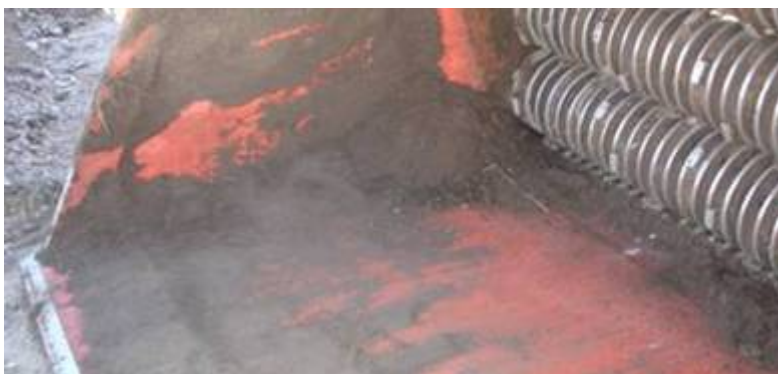
Built up Top Soil in bucket corners and along sharp angles.
