Göran Danielsson, SWEDEC

## Flail Hammer Head Test and Evaluation

2005

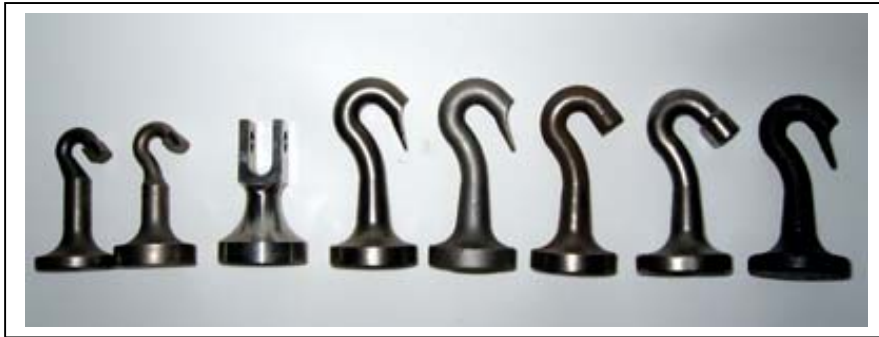
Several designs and materials of hammer heads were tested during 2005. Figure 1 shows the tested tools. During the first test period in April the Mark I hammers were tested. The material in the cast iron was too brittle, so most of the tested hammers were lost during the first hour of flailing. The cast iron hammers (Mark II-III) in the second period were produced in a different cast iron alloy.

*Figure 1: Selection of tested hammer heads during 2005 developed by the project group*

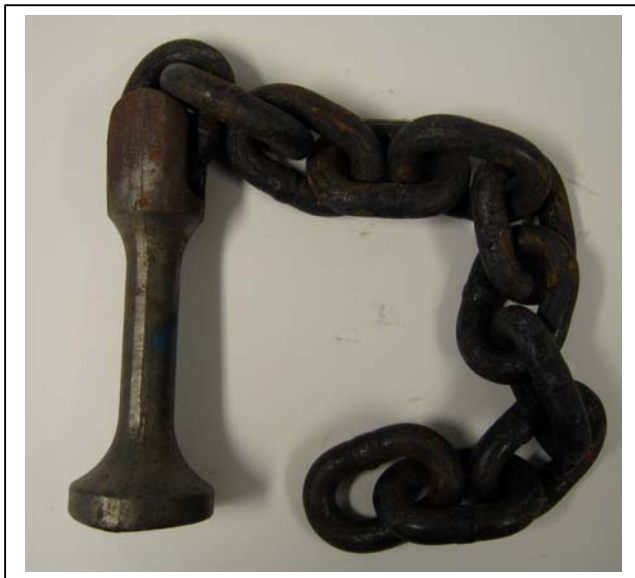
Scanjack AB was also invited to the first test period. They came up with a wrought iron tool riveted together with a chain (Figure 2). The test result of the Scanjack tool are presented in a Scanjack AB report.

*Figure 2: Wrought iron tool manufactured by Scanjack AB*

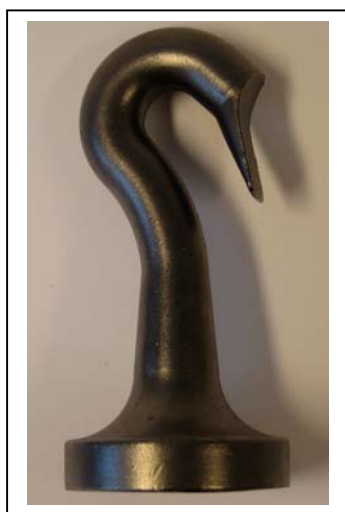
*Figure 5: Mark I of Sprain Tool  
Wear plate Ø 65 mm, thickness 15 mm  
Weight: 884 grams  
Material: Cast Iron*

The Sprain Tool have a loop and a lip that will be battered to stay with the chain. Two different materials were tested on the sprain tool. The lip on the cast iron tool was very brittle and broke quite frequently when it was attached to the chain. In comparison between cast iron, Sprain and Super Tool, more Super Tools were lost. The Sprain Tools have also good qualities when it comes to weight distribution. The major part of the material used sits at the far end (wear plate) of the tool. The design of the loop increases the contact point between the chain and the tool which will decrease the wear on the attachment point compared with the original hammer (pin). The chain can be used over and over again until it is worn out if the lip is cut on the hammer and a new one is assembled.

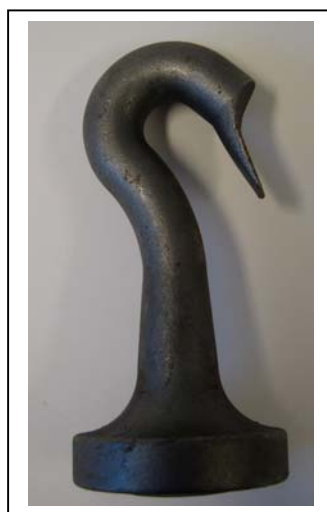
*Figure 6: Mark II of Sprain Tool  
Wear plate Ø 65 mm, thickness 15 mm  
Weight: 935 grams  
Material: Cast Iron*

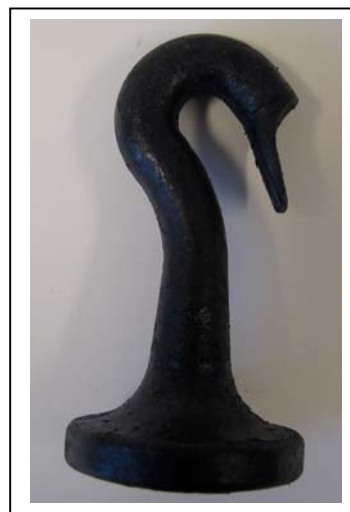
*Figure 7: Mark III of Sprain Tool  
Wear plate Ø 73 mm, thickness 15 mm  
Weight: 1040 grams  
Material: Wrought Iron*

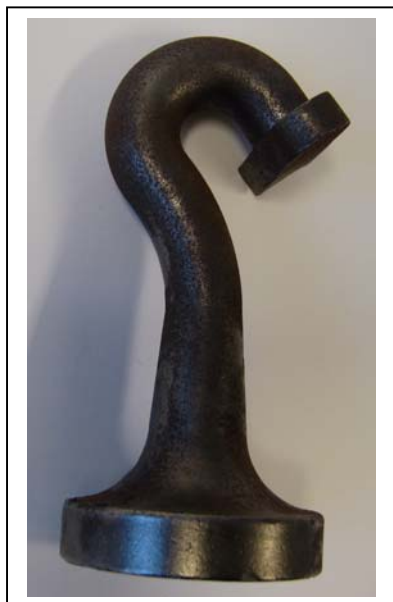
Figure 9:  
Mark I of Super Tool  
Wear plate  $\varnothing$  65 mm,  
thickness 15 mm  
Weight: 910 grams  
Material: Cast Iron

The Super Tool has a hook in mechanism that is very fast and simple to use when it comes to assembling. After some hours when the attachment and the chain starts to wear out some of the Super Tools were lost. They seemed to hook out because the increased clearance. The design of the hammer increases the contact point between the chain and the tool which will decrease the wear on the attachment point compared with the original hammer (pin). The chain can be used over and over again until it is worn out. New hammers can easily be assembled. No wrought iron Super Tools have been tested during the test.

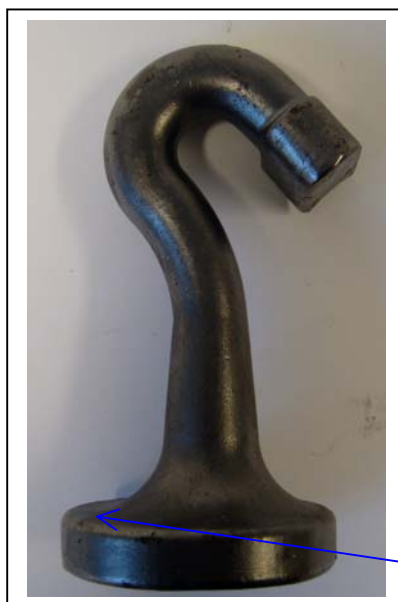
Figure 10:  
Mark II of Super Tool  
Wear plate  $\varnothing$  : Asymmetric  
thickness 15 mm  
Weight: 1000 grams  
Material: Cast Iron

Asymmetric wear plate.  
6 mm added in  
direction of attack

The cast iron Super-Tool tested in Nov/Dec also had an asymmetric wear plate with an increased diameter in the direction of attack. The reason for that was to increase the life time of the hammer.

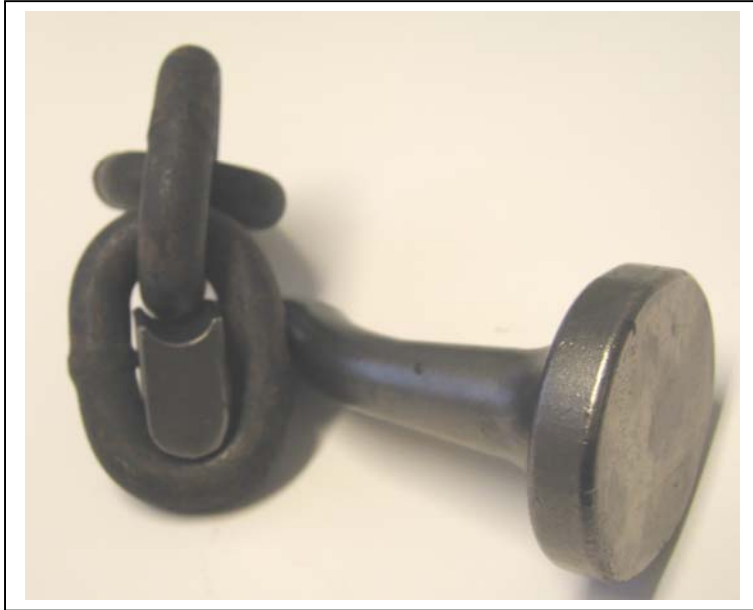
*Figure 11: Chain attachment for the Super Tool*

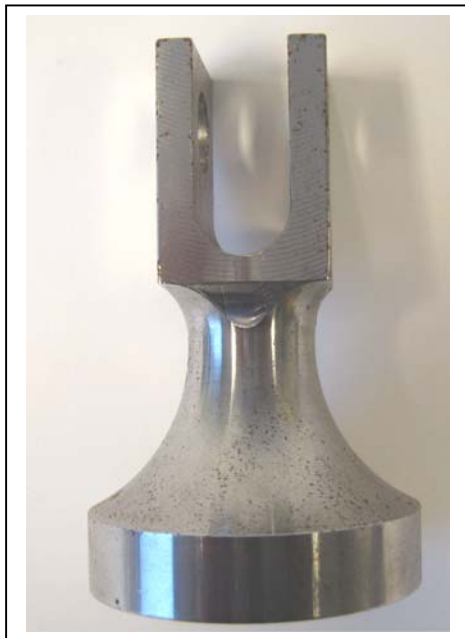
*Figure 12: Short Tool  
Wear plate Ø 65 mm, thickness 15 mm  
Weight: 890 grams  
Material: Steel, machined, not heat treated*

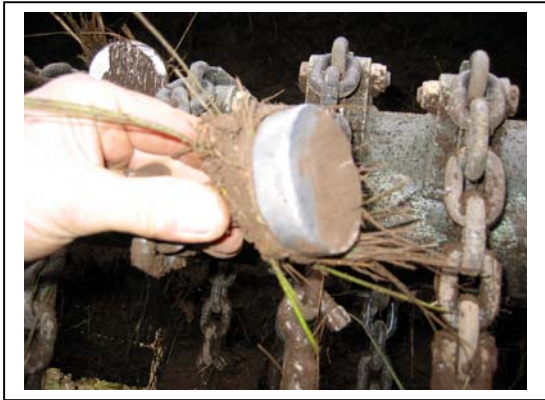
| <b>Test protocol Clearing Tools<br/>TMR</b> | | |
|--|---|---|
| <p><i>Figure 91: 5 min flailing</i></p> <p><i>Figure 20: Reference tool</i></p> | | |

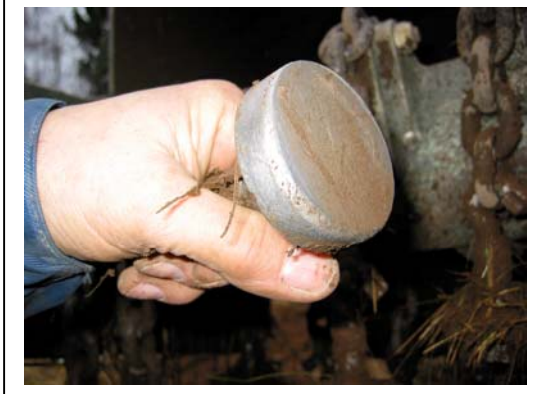
| <b>Test protocol Clearing Tools<br/>TMR</b> | | |
|--|---|---|
| <p><i>Figure 21: After 10 min flailing</i></p> <p><i>Figure 22: Reference tool</i></p> | | |

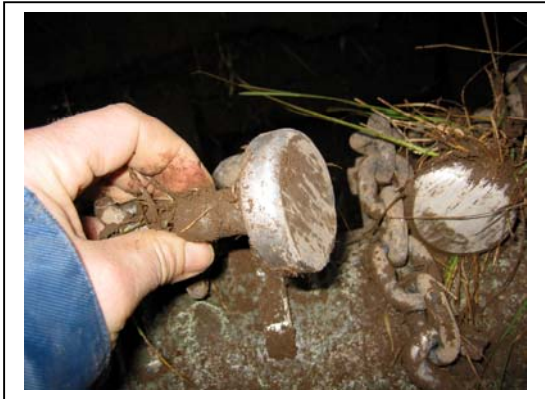
| <b>Test protocol Clearing Tools<br/>TMR</b> | | |
|---|--|---|
| <i>Figure 23: 15 min flailing</i> | <i>Figure 24: Reference tool</i> | |

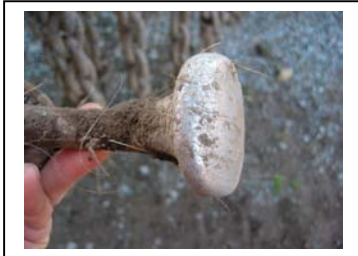
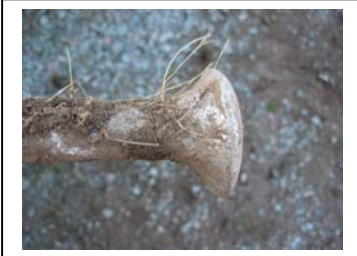
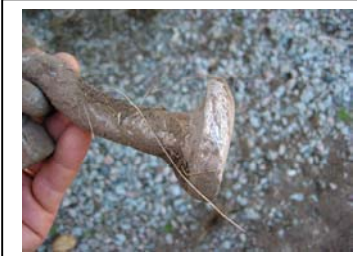
| <b>Test protocol Clearing Tools<br/>DMR</b> | | |
|---|--|---|
| <i>Figure 70: Sprain tool,<br/>cast iron</i> | <i>Figure 71: Reference tool</i> | <i>Figure 72: Super tool, cast<br/>iron</i> |

| <b>Test protocol Clearing Tools<br/>DMR</b> | | |
|---|--|---|
| <p>Photos taken after total time of 155 min flailing in meadowland.</p> <p>Rear flail: A total of 11 super tools and 1 sprain tool were missing<br/>Front flail: A total of 4 super tools and 4 sprain tools were missing</p> <p>Front flail speed/pressure: 7/180-200 bar<br/>Rear flail speed/pressure: 6/180-200 bar<br/>Depth meter: ~ 20 cm<br/>M2 engine rev: 1800 rpm<br/>M1 engine rev: 1300 rpm<br/>Clearing speed: ~300 m/h</p> | | |

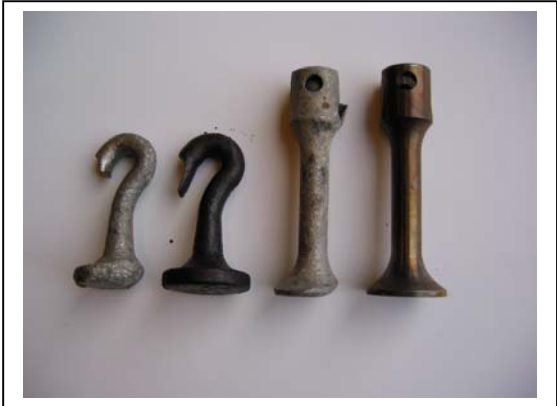
| <b>Test protocol Clearing Tools<br/>DMR</b> | | |
|--|---|---|
| <p><i>Figure 88: Comparison<br/>between new and worn tools<br/>used in the test</i></p> | | |

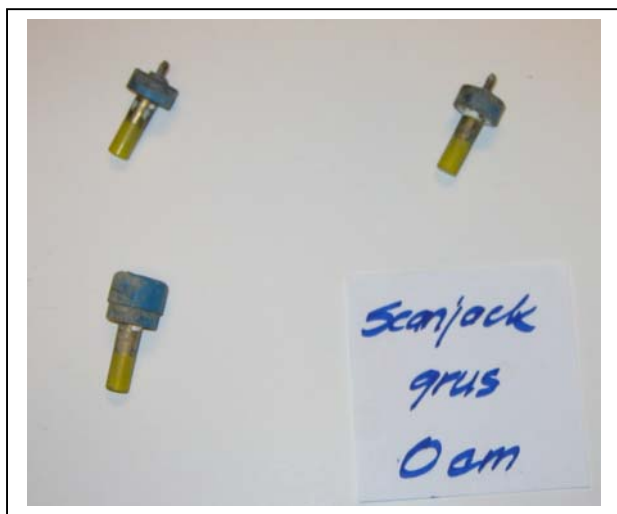
Single fuses AP blast 3 of which 2 were damaged  
 Single fuses AP : of which were damaged

Figure 89: Debris of interest Gravel 0 cm

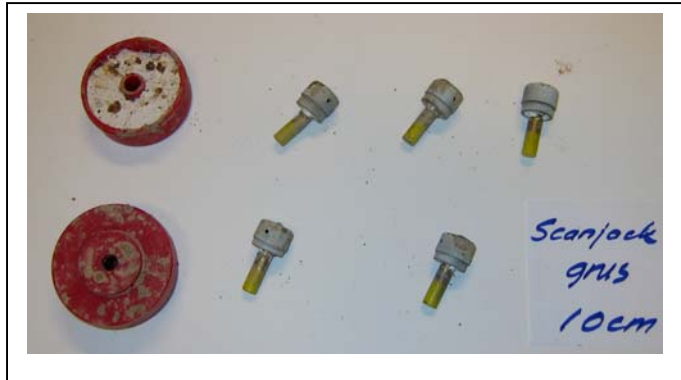
Single fuses AP blast 5 of which 3 were damaged  
Single fuses AP : of which were damaged

*Figure 90: Debris of interest Gravel 10 cm*

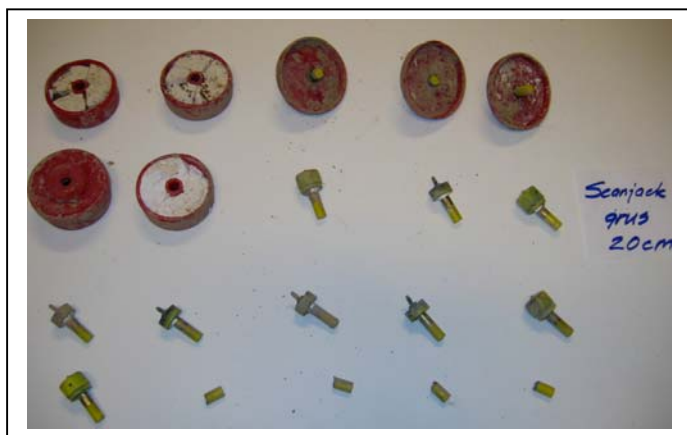
Triggered targets were found buried deep in the ground. The detonations were probably not heard. All reasonable action has been taken to find the fuses. No live targets (mine +fuse) is left in the ground.

Single fuses AP blast 16 of which 16 were damaged  
Single fuses AP : of which were damaged

Figure 91: Debris of Interest, Gravel 20 cm

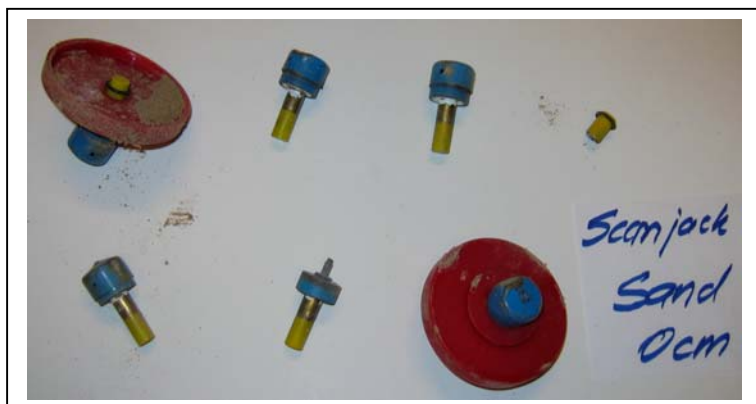
Single fuses AP blast: 7 of which 6 were damaged  
Single fuses AP : of which were damaged

*Figure 92: Debris of Interest, Sand 0 cm*

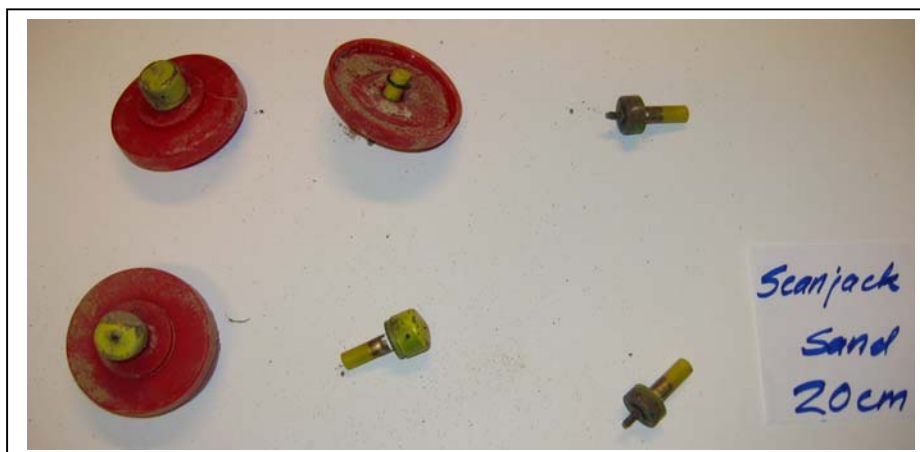
Triggered targets were found buried deep in the ground. The detonation were probably not heard. All reasonable action has been taken to find the fuses. No live targets (mine +fuse) is left in the ground.

Single fuses AP blast 5 of which 4 were damaged  
Single fuses AP : of which were damaged

Figure 94: Debris of Interest, Sand 20 cm
