## Machine Demonstration Analysis and Preliminary Results

Geoff Coley<sup>36</sup>

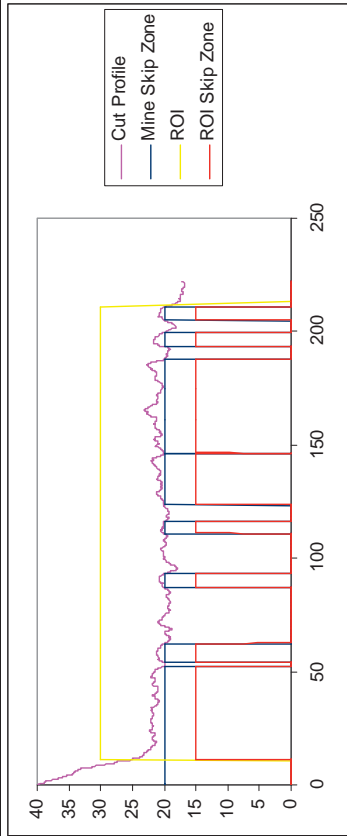
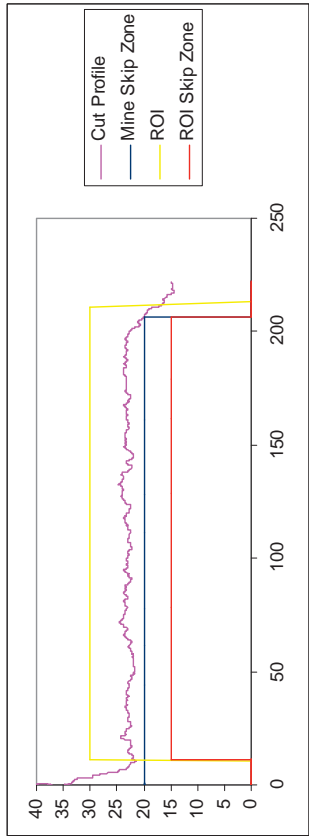
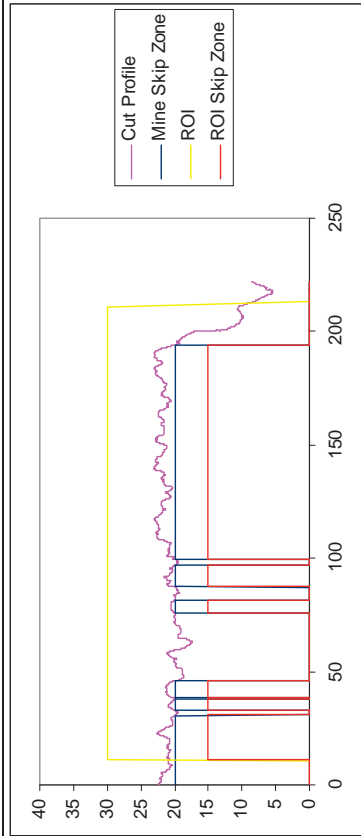
Appendix 1 – Bozena-4

- Dead crawl all the way through – appeared to have consistent speed control. Some evidence of soil wave suggesting that machine may have been under manual depth control.

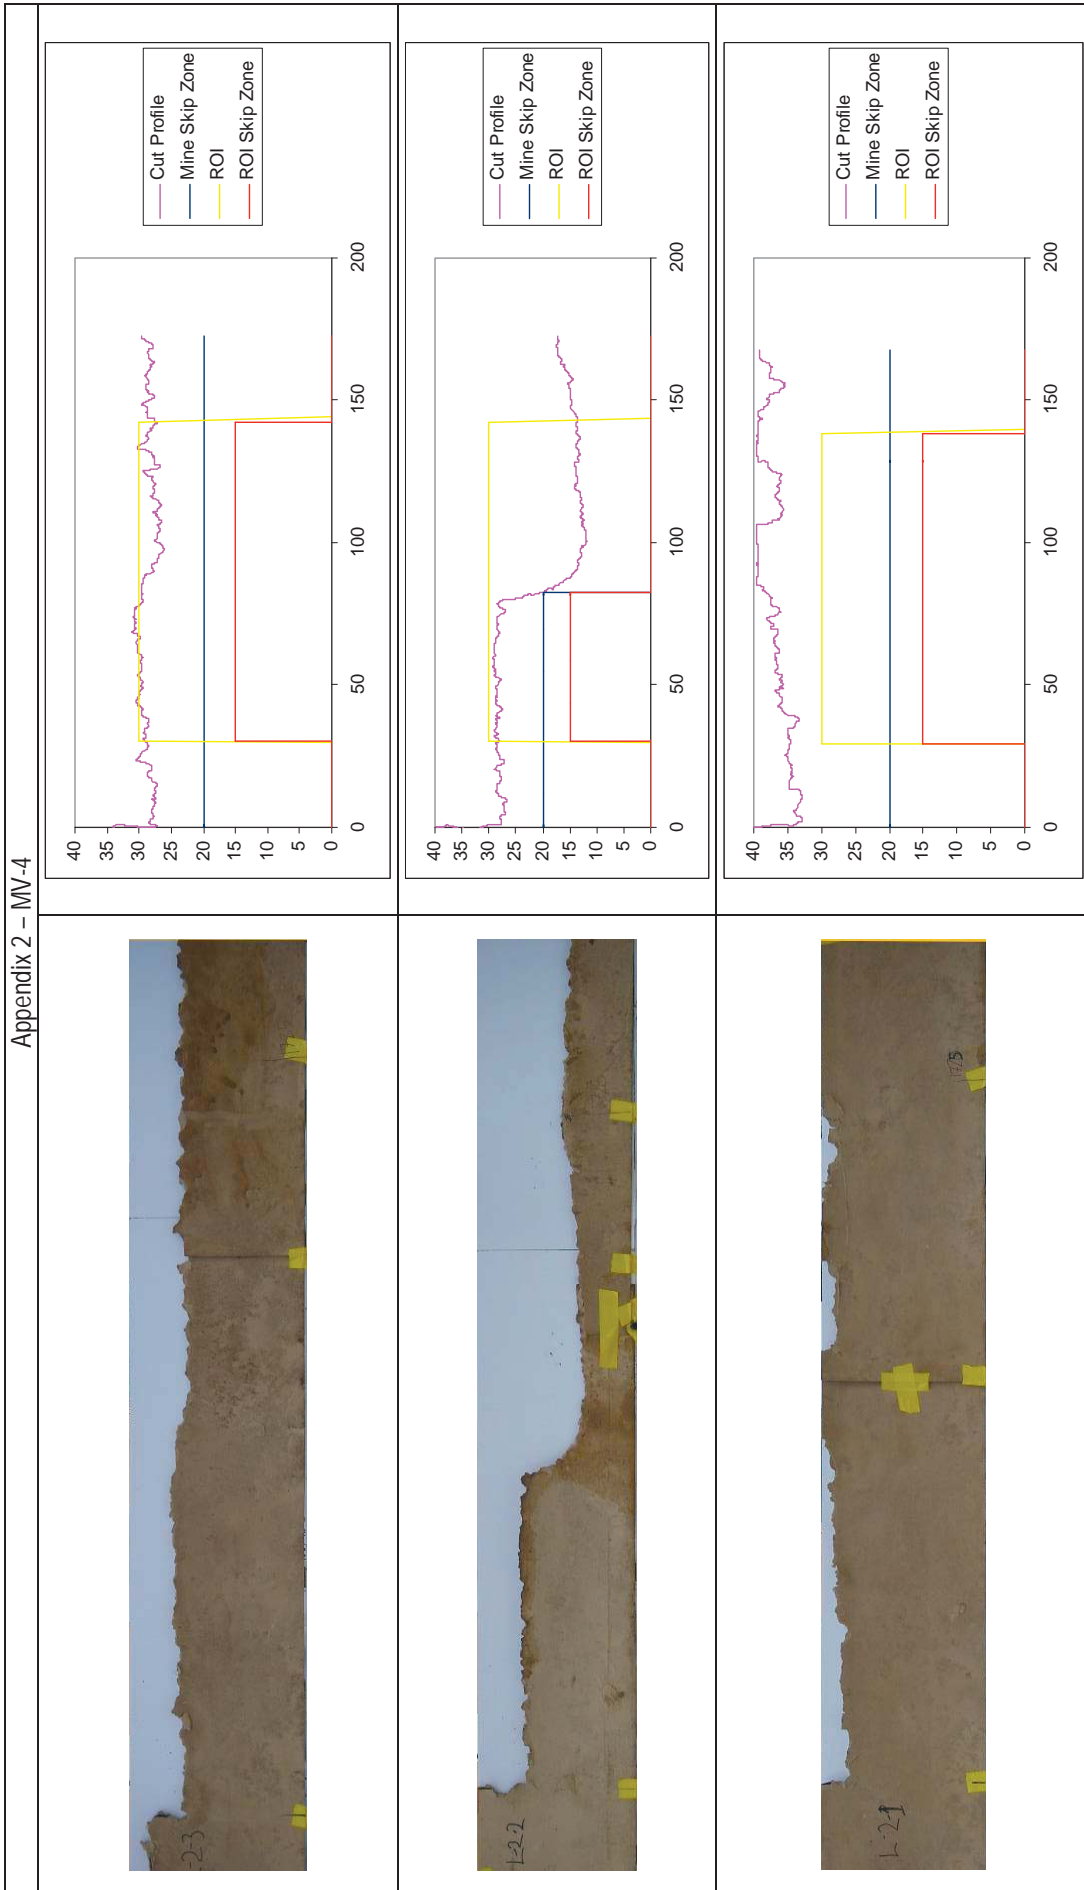
Appendix 2 – MV-4

- Out of the gate very fast but slowed to a crawl, possibly stopping right at strip 2. Very erratic speed control – stop/start movement in some places. Erratic depth control throughout – flail head completely clear of the ground near strip 4. Appeared to stop near 4<sup>th</sup> strip. Quit working altogether part of the way back. Claimed equipment malfunction.

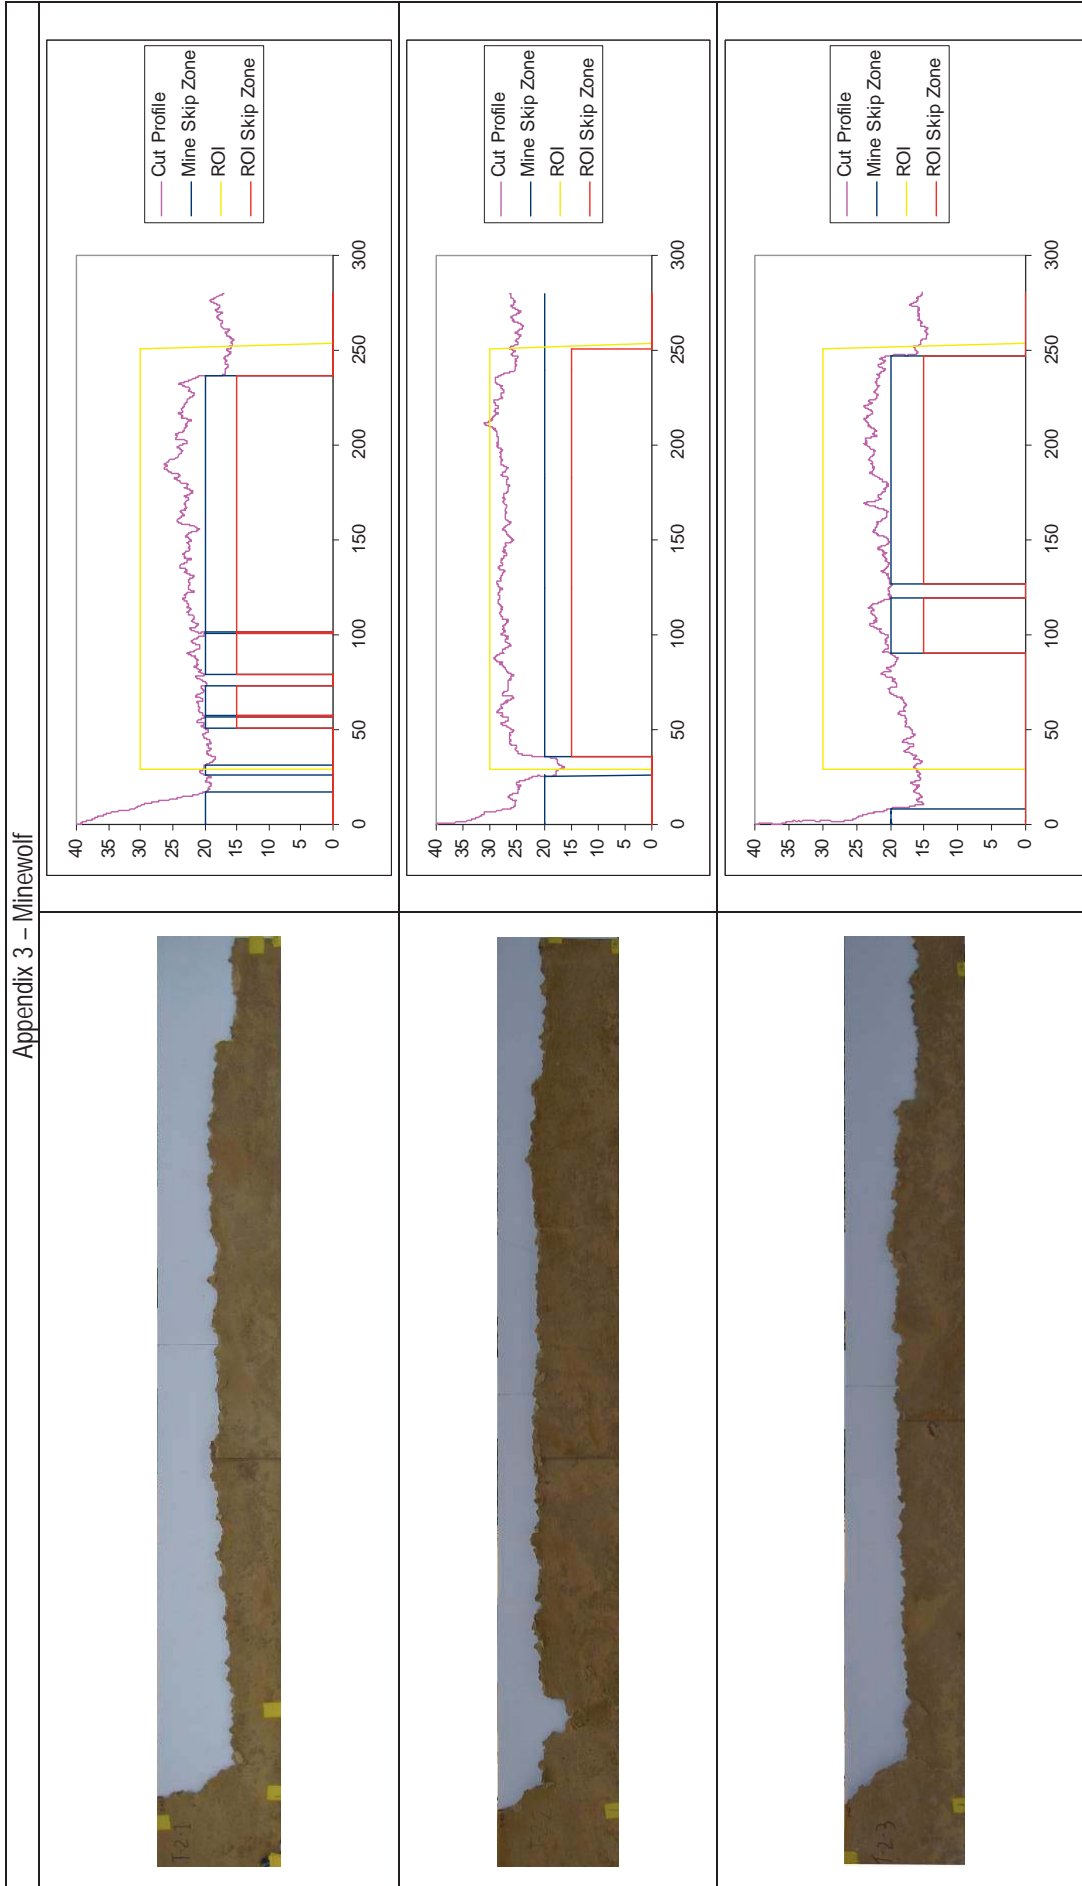
Appendix 3 – Minewolf

- Operated very fast and with erratic depth control. Very little dust cloud as soil is sliced, not pulverized. Throws a lot of debris under/behind machine. Speed consistent throughout. Tiller head porpoised its way through the test – operator control or a lag in the feedback?

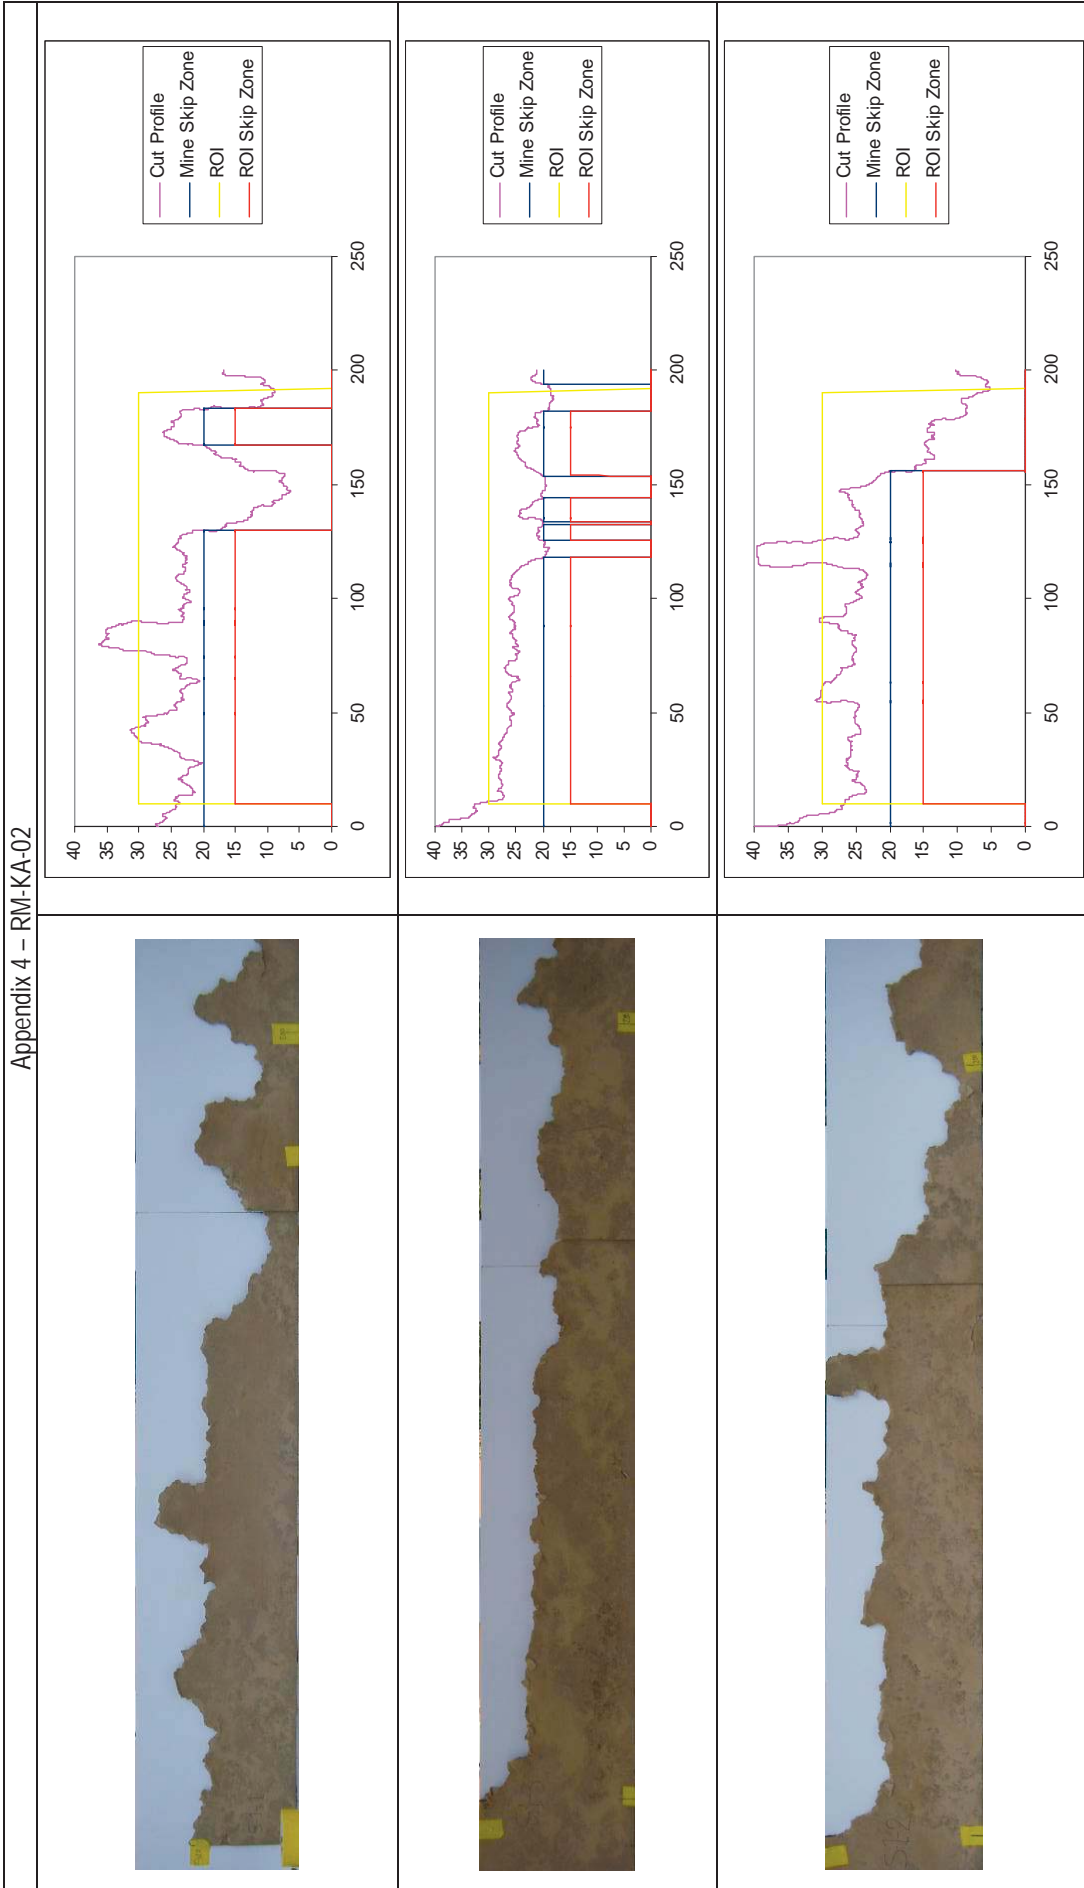
Appendix 4 – RM-KA-02

- RC operator wandered well into the test lane following the machine (far closer than the 50m requirement) until called back by official. (Was first machine to run so requirement may not have been clear to the operator.) Was forced to stop once on the return run because the visibility of the operator was obscured by a cloud of dust created by the operation of the Samson machine.

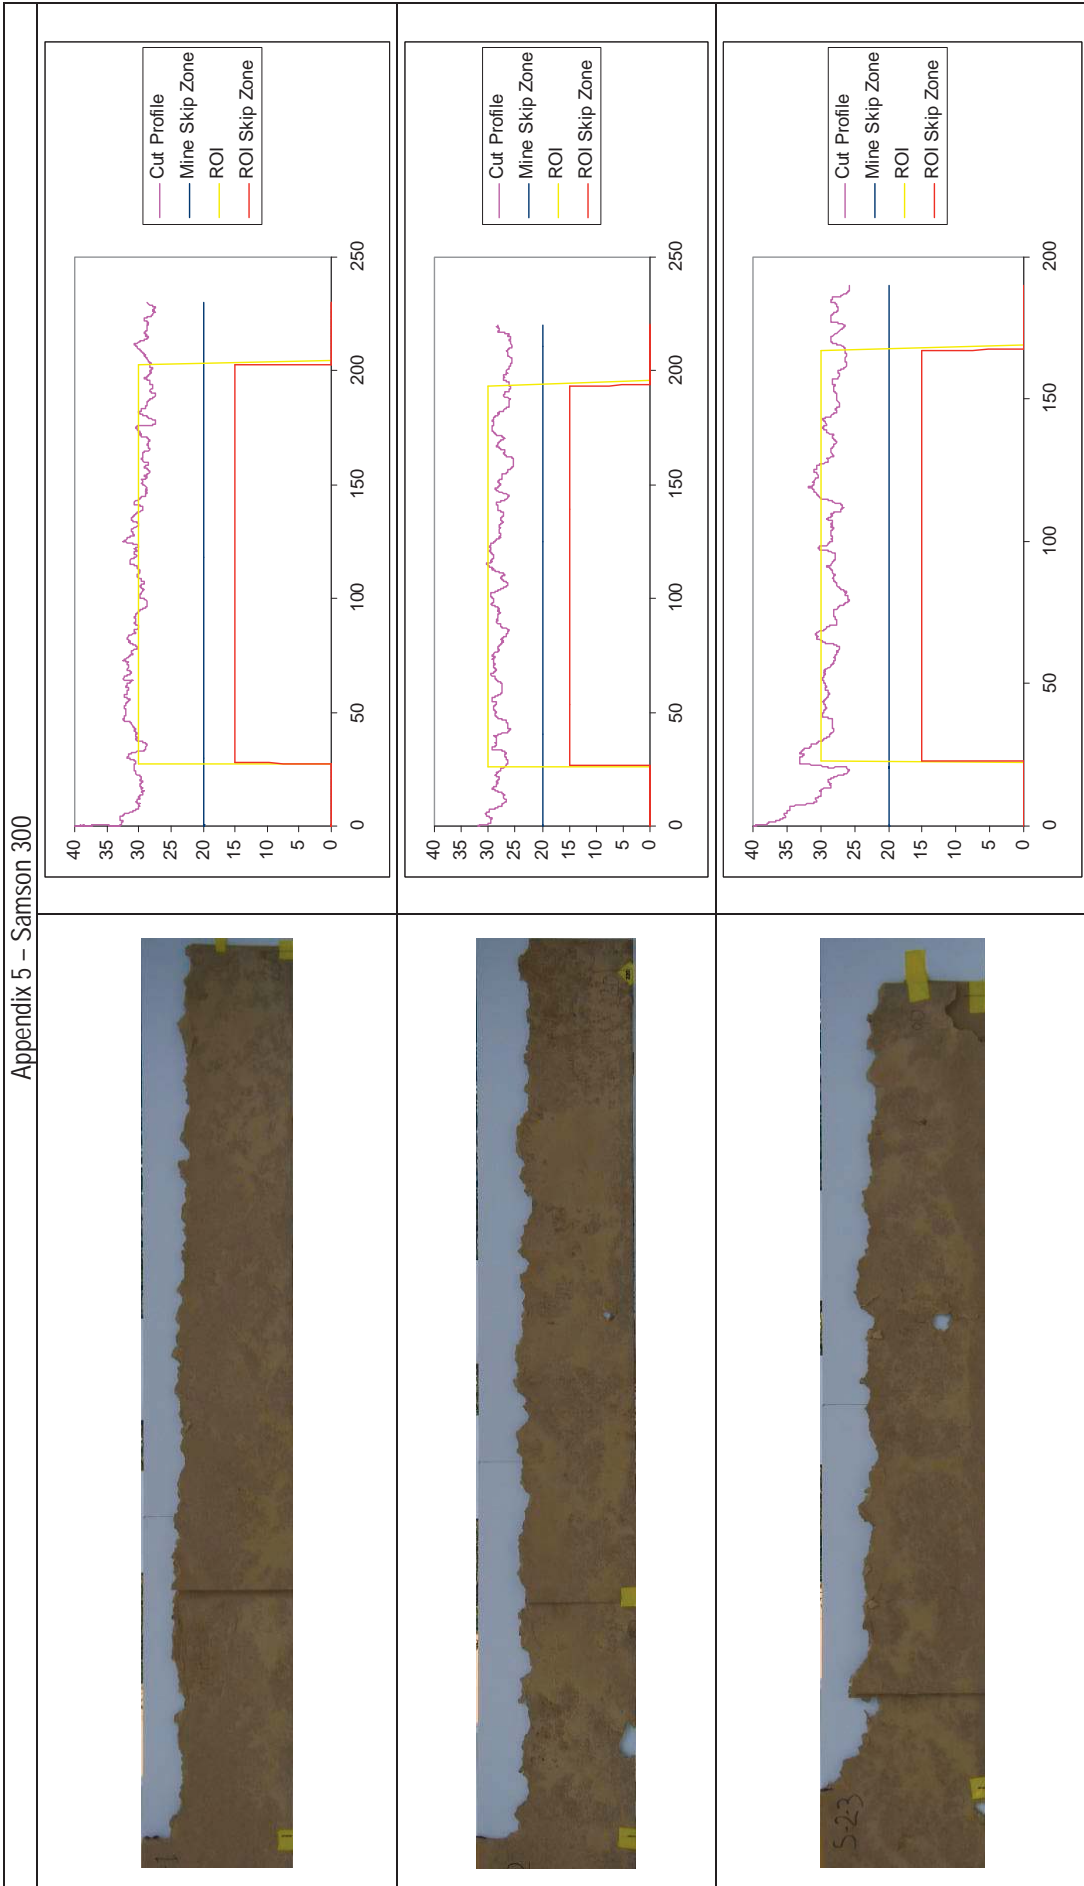
Appendix 5 – Samson 300

- Driver stopped briefly on return trip 3-4 times – probably a visibility issue. Huge dust cloud (partly caused by lack of shroud, partly because the machine worked to a shallow depth where the ground was dry). Apparently misunderstood requirement and thought depth of interest was only 15cm instead of 20cm.

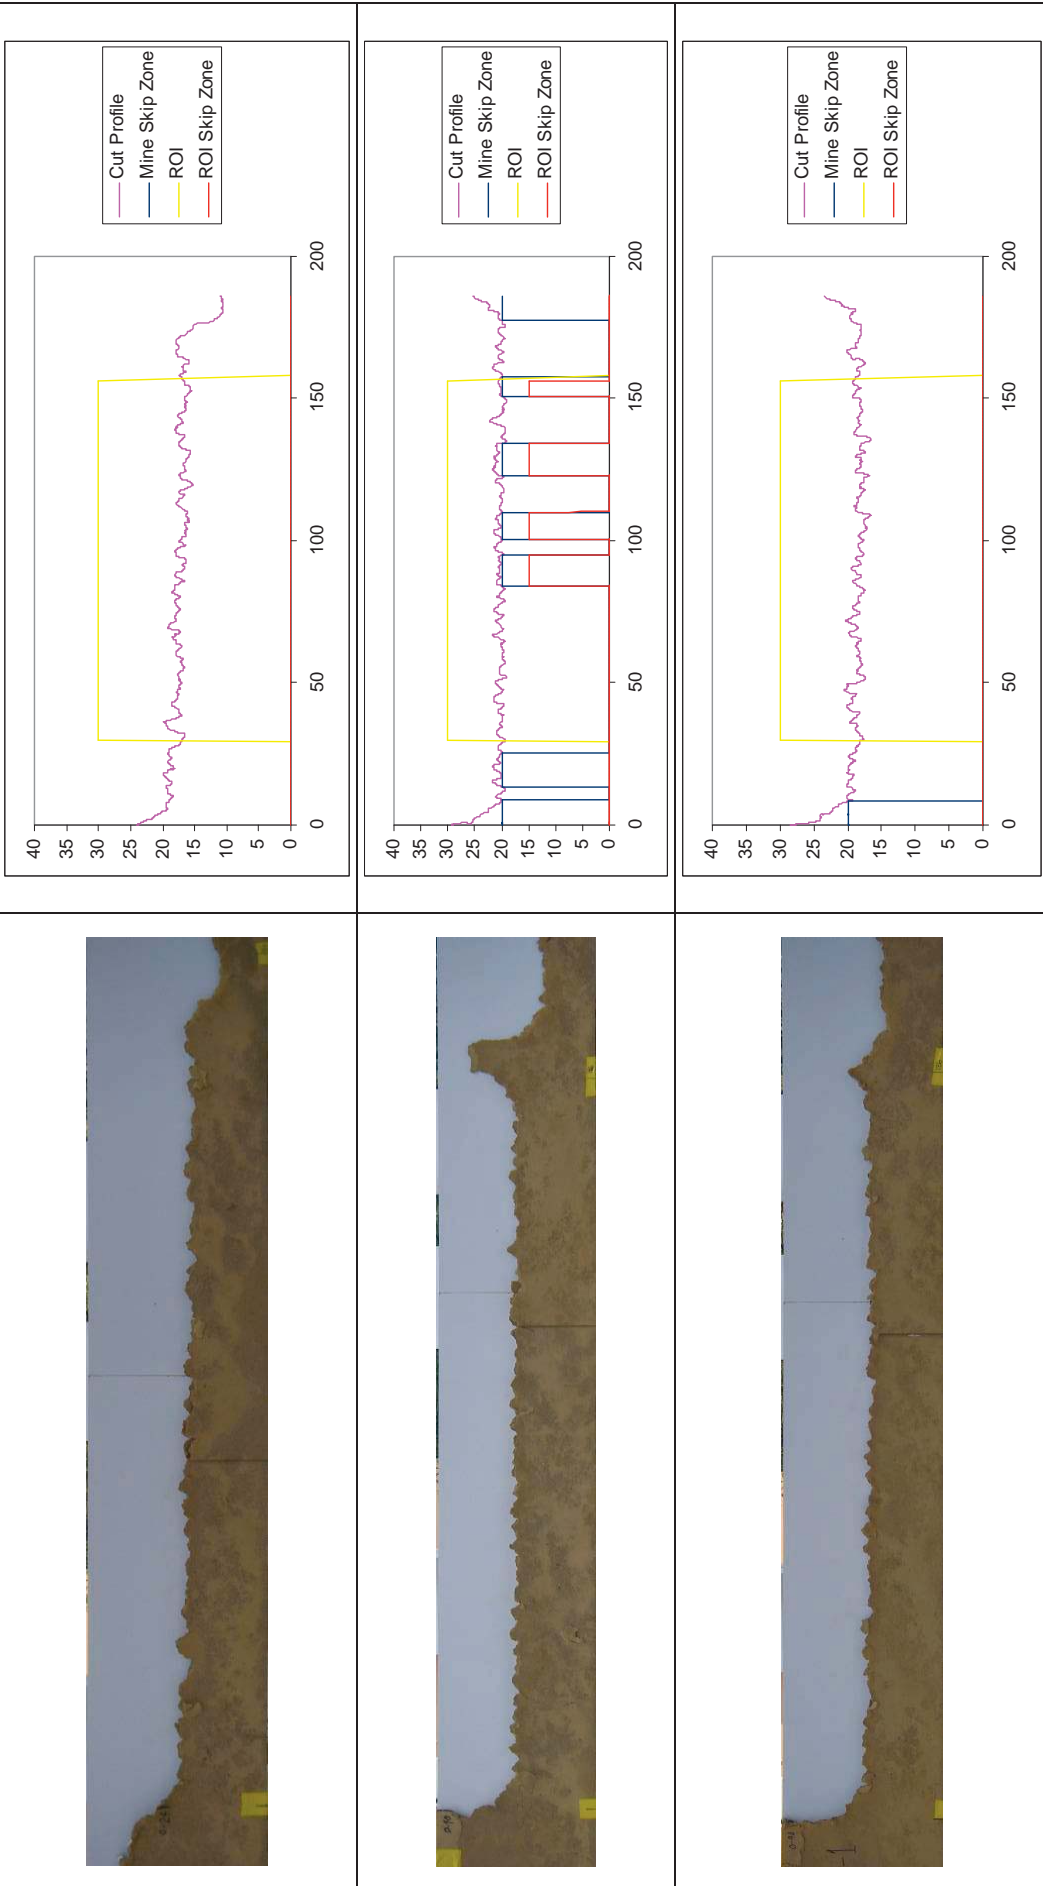
Appendix 6 – Mini-Minewolf

- Very little dust as soil is sliced, not pulverized. Soil only thrown a short distance ahead. From fibreboards, 30cm overlap not really achieved. Obviously a driver error issue not a machine performance issue.

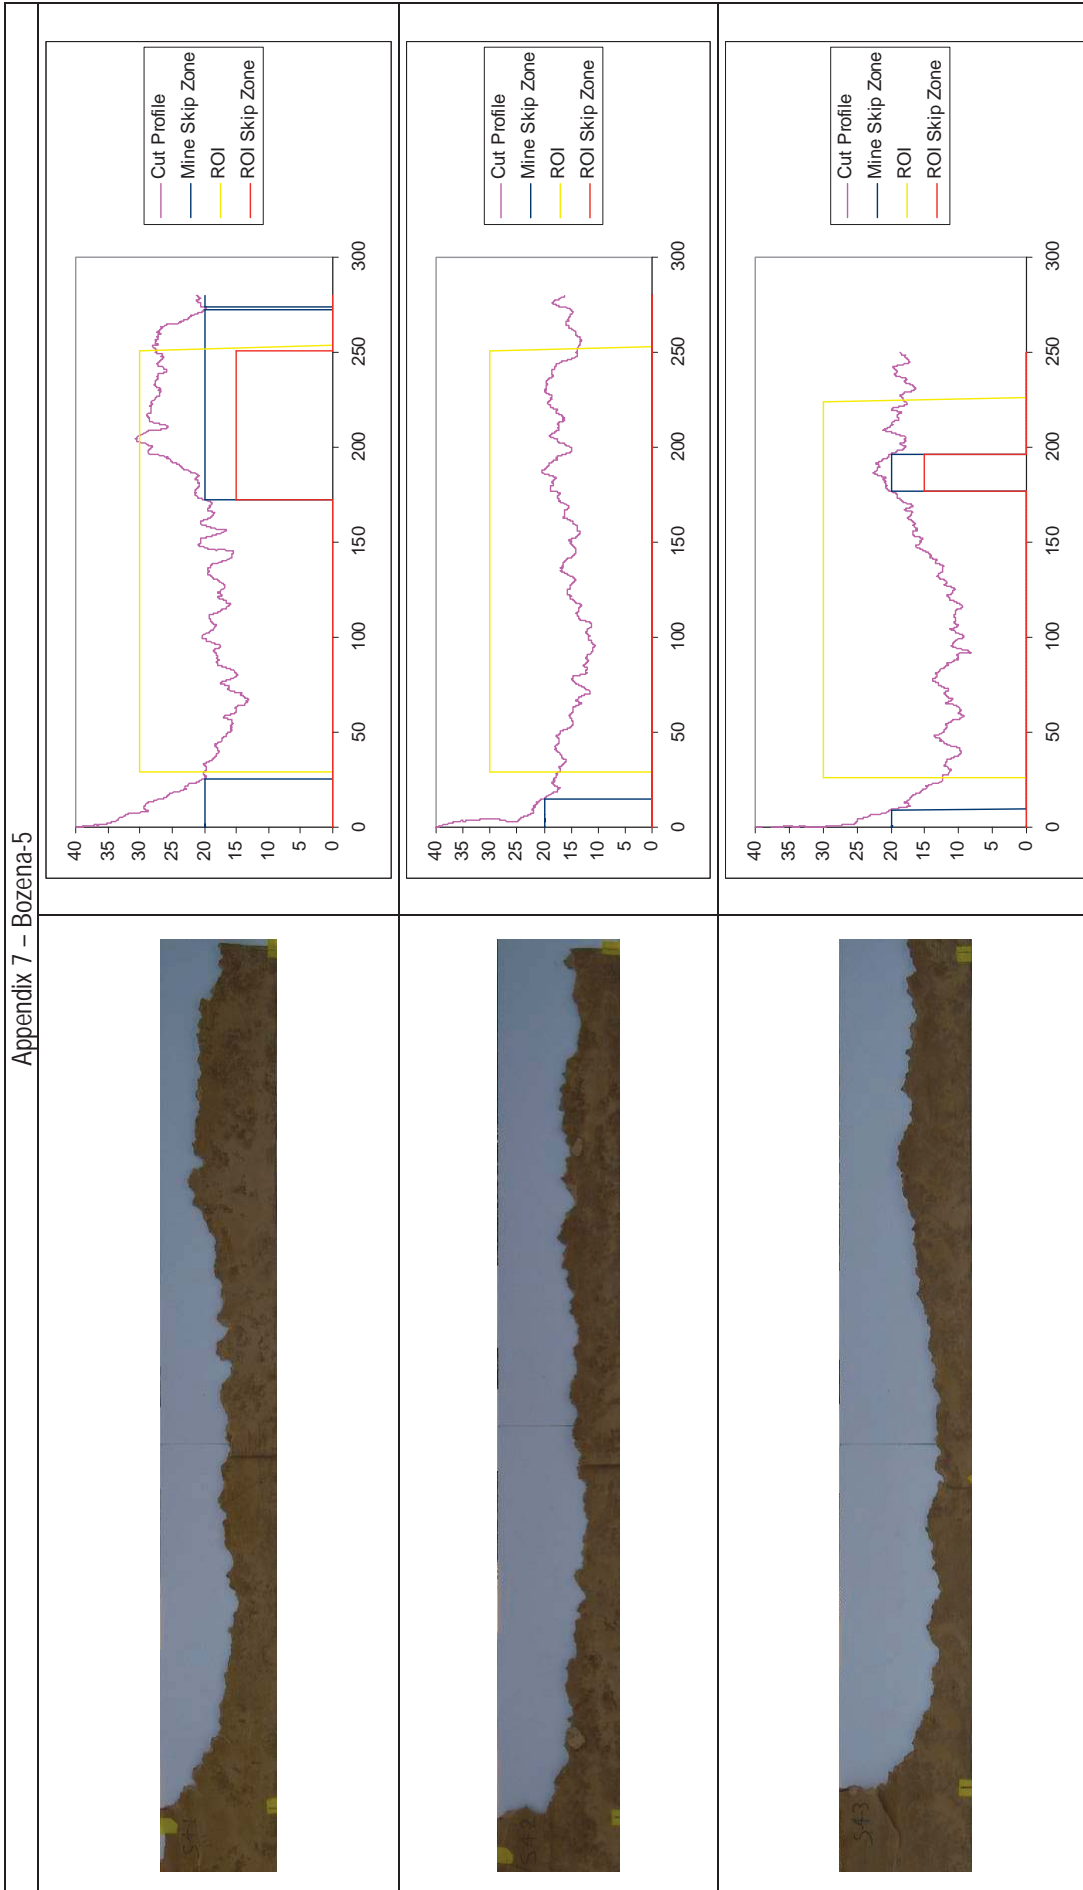
Appendix 7 – Bozena-5

- Consistent speed control.

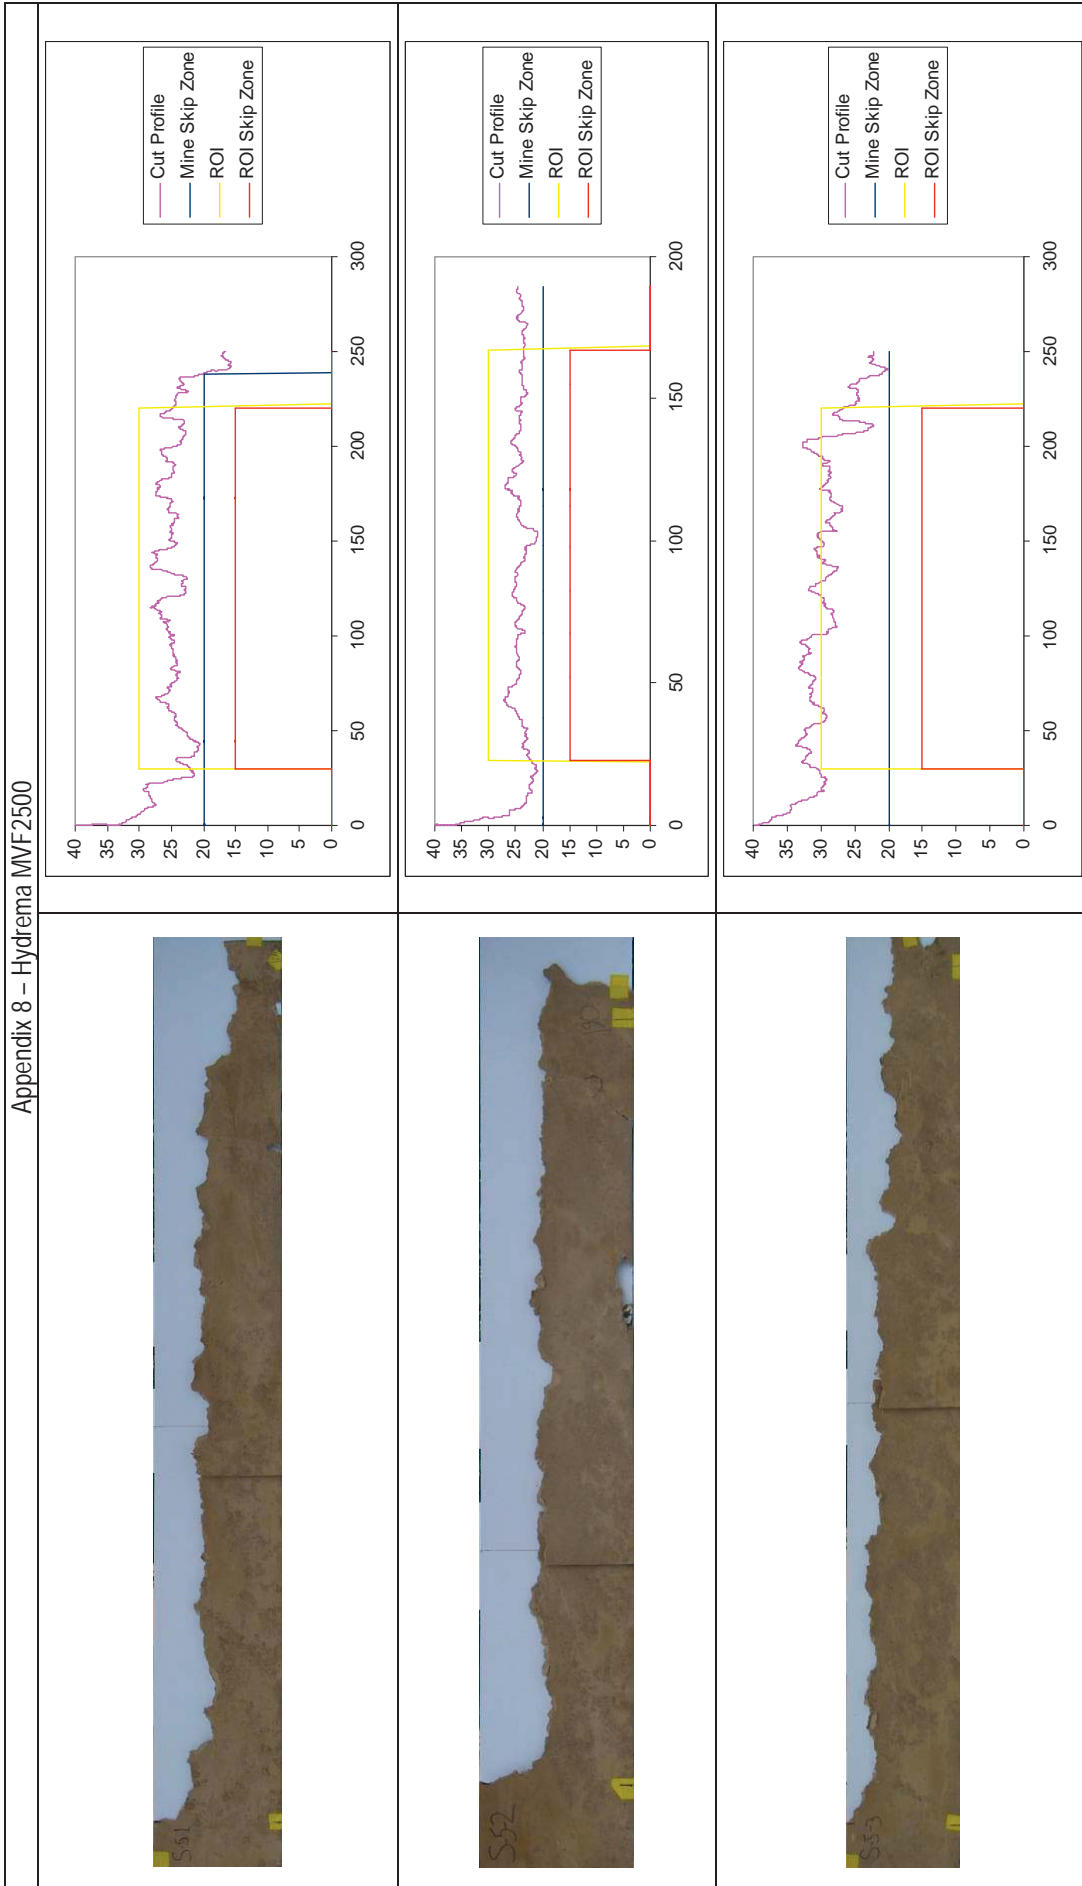
Appendix 8 – Hydrema MVF2500

- Exact PE(20cm) and MED values may be slightly off since the middle fibreboard was hit so far across the board that only 190cm of the cut could be captured. The difference should be minor.
- Great variations in speed. Slowed visibly near board/decoy strips 1 and 2. Flail head stalled near strip 5. Machine stopped moving while trying to restart flail engine. Lots of smoke on restart of the flail engine. Happened again near strip 6. Slowed several times on return trip.

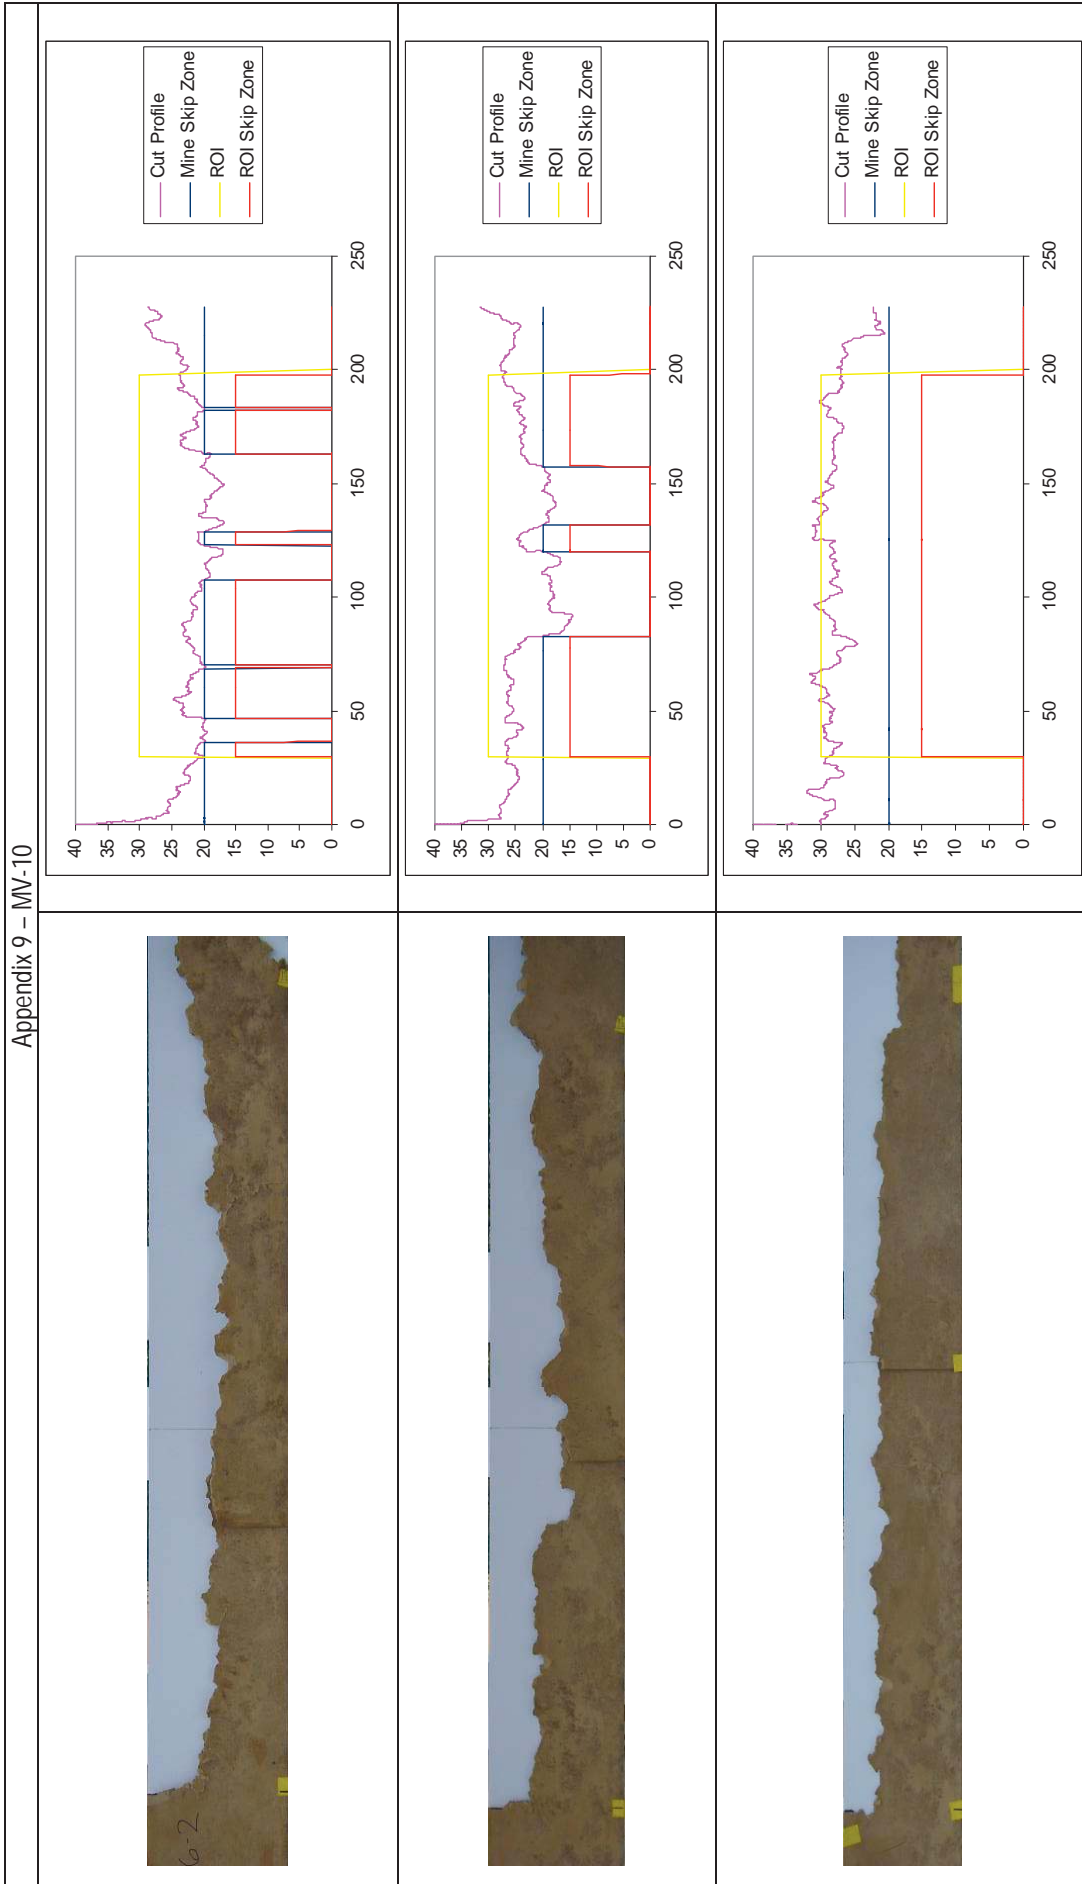
Appendix 9 – MV-10

- Head was lifted a couple times between the first and second fibreboard/decoy strips. Reasonably consistent speed throughout run but may have been a little slower on the return trip.
