Performance test of Demining machines performed by SWEDEC (Swedish EOD and Demining Centre).

The following report on performance test of demining machines are from tests performed by SWEDEC (Swedish EOD and Demining Centre), an independent body within the Swedish Armed Forces.

BOFORS MINEGUZZLER

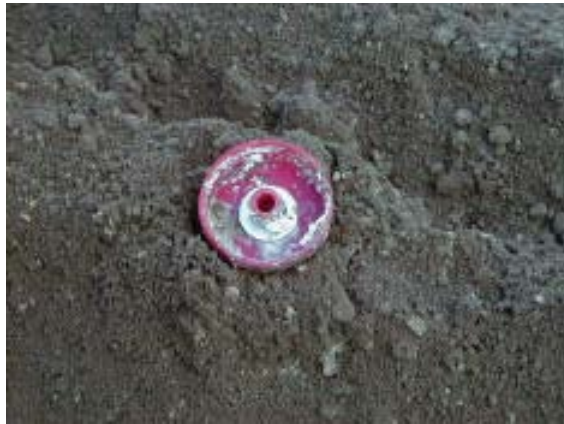
Example of destroyed mine

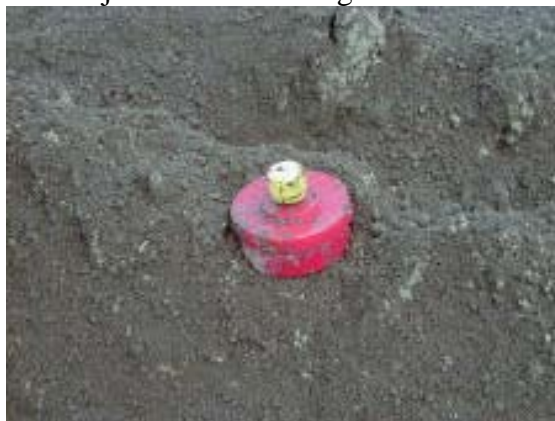
Example of unaffected mine

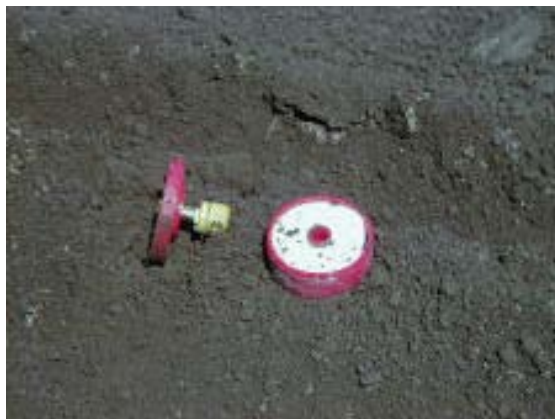
Example of separated mine

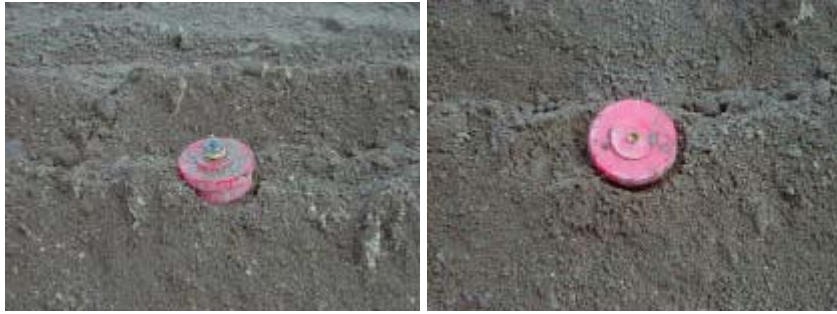
Example of damaged mines

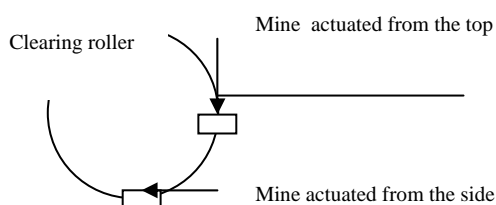
Damaged mines are related to the depth of displacement.

The sketch shows the theoretics, which explains why the number of damaged mines increases with increased laid depth

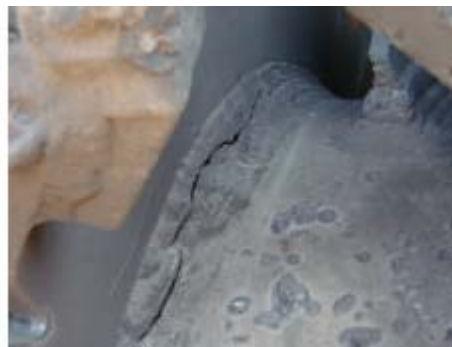
The picture shows formation of cracks in attachments of clearing arm

- 4 nos. of tooth holders missing
- 12 nos. of bits missing
- 1 no. of shark fin missing
- 1 no. of shark fin destroyed
- Formation of cracks in weld seam for clearing arms

The machine is considered to be in operative condition after some deposit welding is carried out on the roller. Estimated repair time: approx. 4 hours. Alternatively it is possible to replace damaged rollers with UE (spare unit). This is not yet tested.

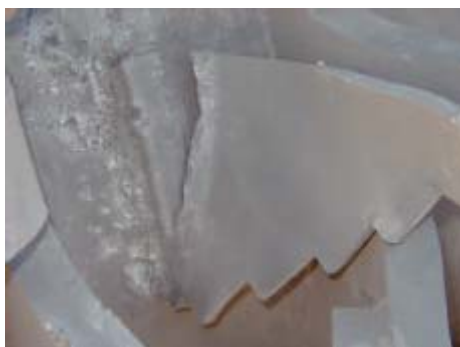
The picture shows destroyed shark fin

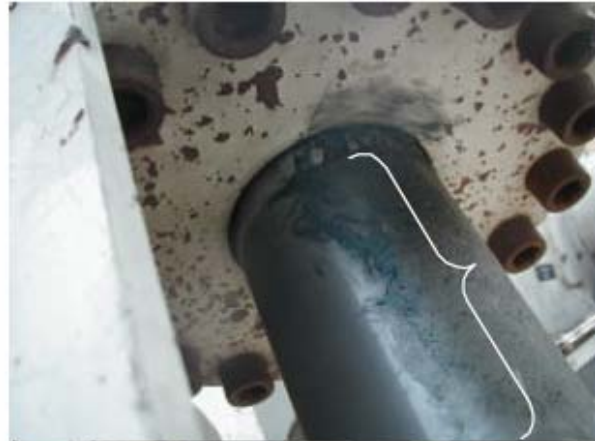
*The picture shows vertical shock absorber
Clamp =motion reserve*

The machine was experienced as very robust. One of the disadvantages is still its weight. Presumably the machine can be optimised for weight, as certain parts on it are considered as oversized. After the blasting test 2 (10 kg) it could be established that the shock absorbers moved between 10-15 mm. Consequently a much large reserve for the movement is available. An optimisation/sizing of, among other things, shock absorbers, etc. will even reduce damages to the roller, etc., and the unit will become more versatile. (DAN)

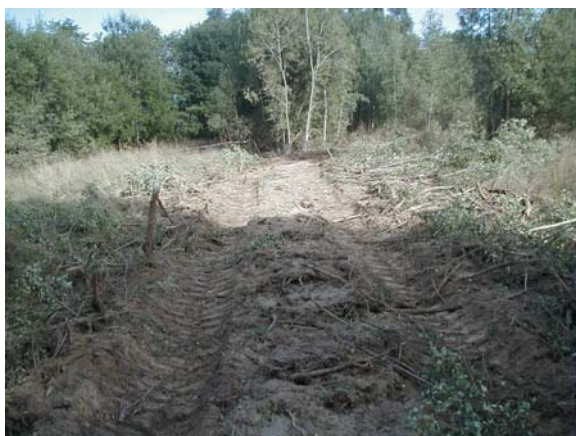
The picture shows cleared range after an action

The machine ploughed through the ground properly. No uncleared sections could be noticed after the test.

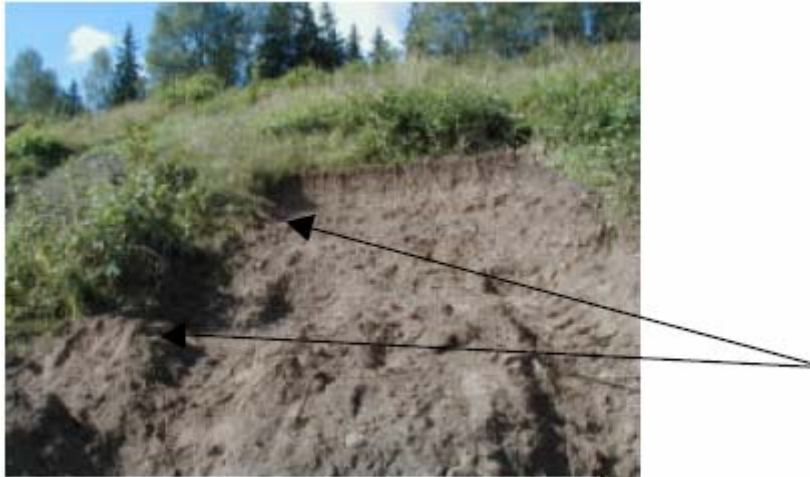
The picture shows cleared surface after upward slope test. Observe wave pattern after compacting actions

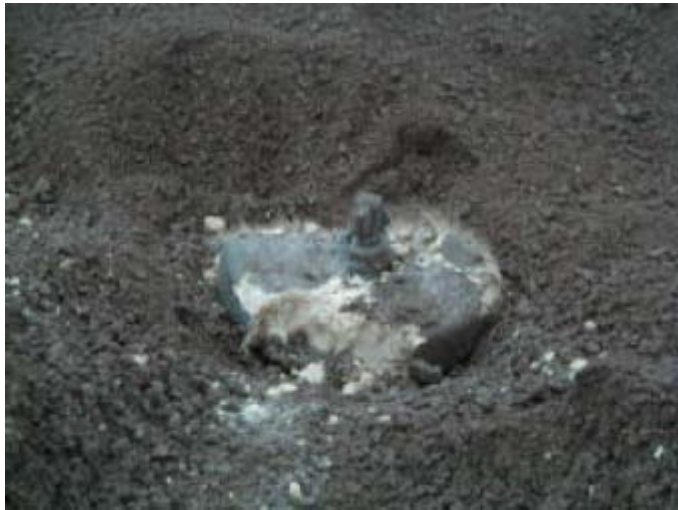
The machine appears to be very robust. The damages after both the 5.5 kg and 10 kg mines are marginal in this case.

The picture shows strvmina 5 after an interrupted test

Roadbed, etc. was restored before new test. The mine was reinforced with a 12 mm nylon sheet in order to induce a detonation.

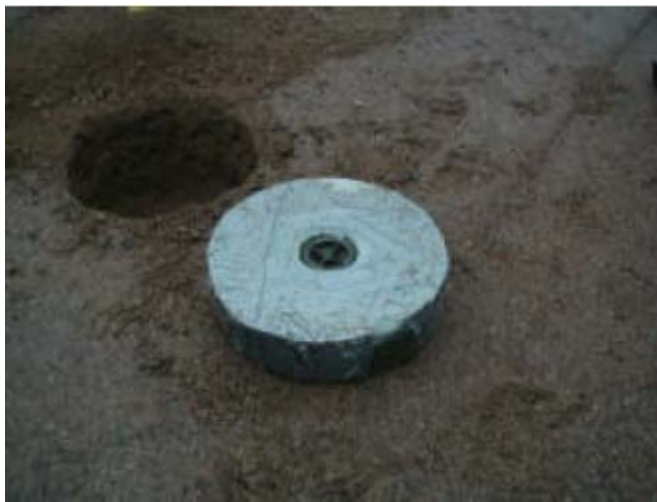
The picture shows strvmina 5 reinforced with nylon sheet compacted with fabric tape

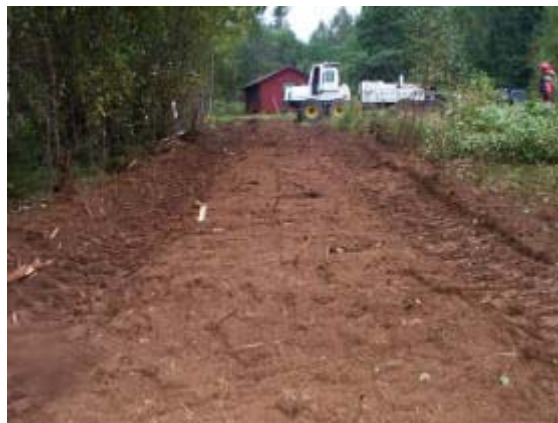
The machine ploughed the ground efficiently. No unclear parts could be retrieved after the test. Depth: approx. 20 cm

The picture shows cleared area after an action

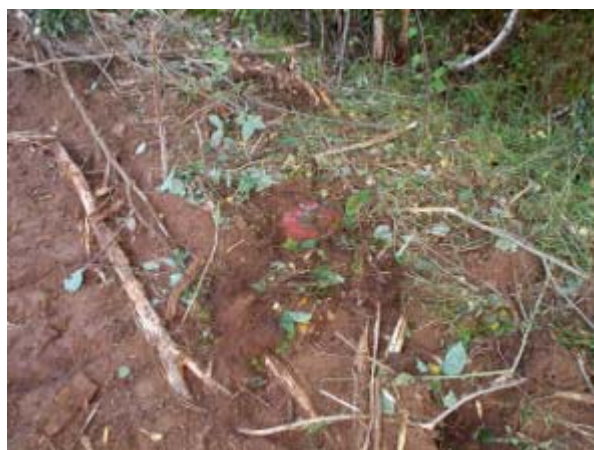
The machine missed the last mine while clearing in the vegetation. This is because the driver tried to avoid a bigger obstacle later on. The DAN testing person had not provided adequate information about how long the machine would take to clear up.

The picture shows mine left behind outside the cleared track

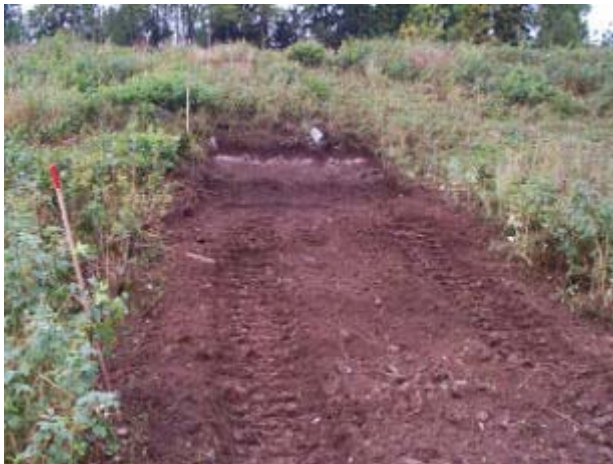
The picture shows cleared surface after the upward slope test

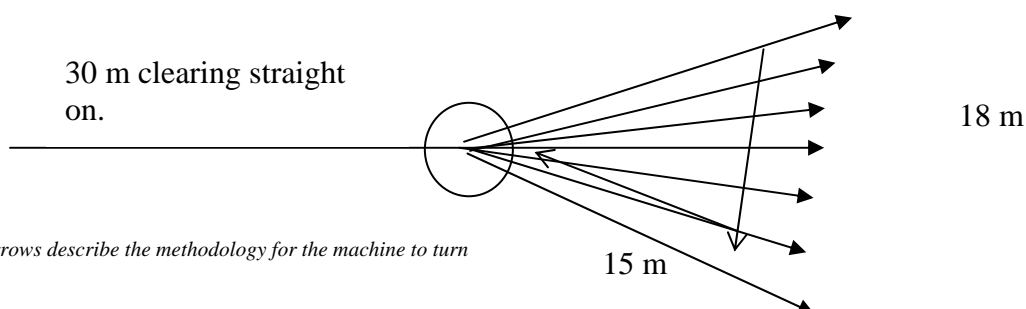
Arrows describe the methodology for the machine to turn

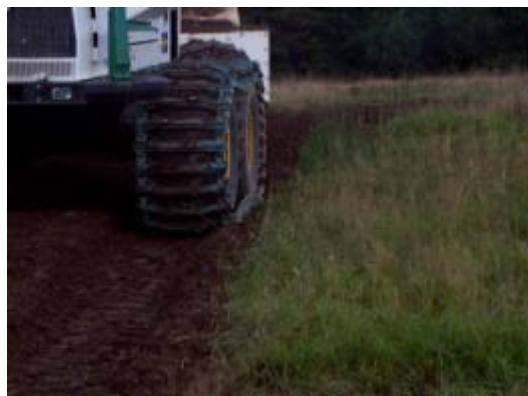
Timewasting and dangerous manoeuvre because of the machine's small overlap between clearance width and wheel base (only 10 cm/side). The machine was climbing on the edge to the uncleared area at several occasion with rear goggie (encircled area)

The picture shows rear bogey wheel while turning on the cleared track

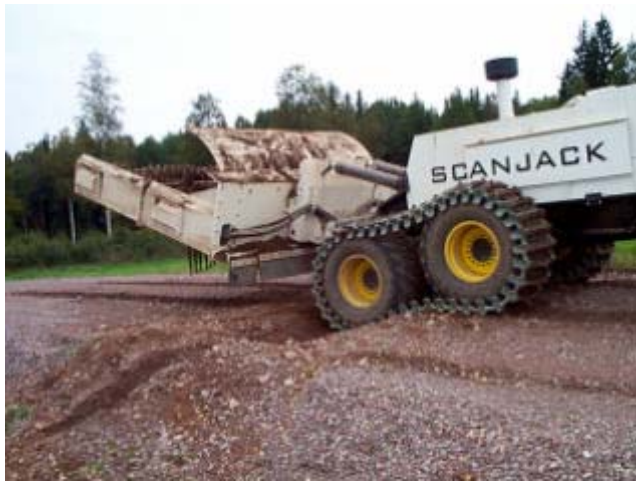
The machine cleared the obstacle in the first attempt both forward as well as backward

The picture shows forward trench stay

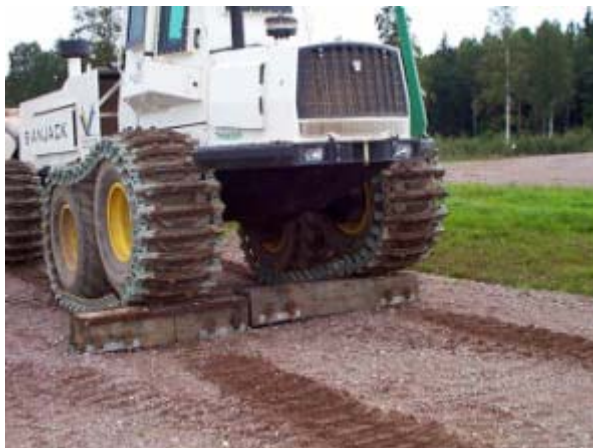
The machine managed the obstacle in the first attempt both forward as well as backward.

The picture shows backwards obstacle test
